SCT Operations Pty Ltd

ULA4958

ASSESSMENT OF ROCK FALLS IN MONA CREEK CLIFF PROTECTION AREA

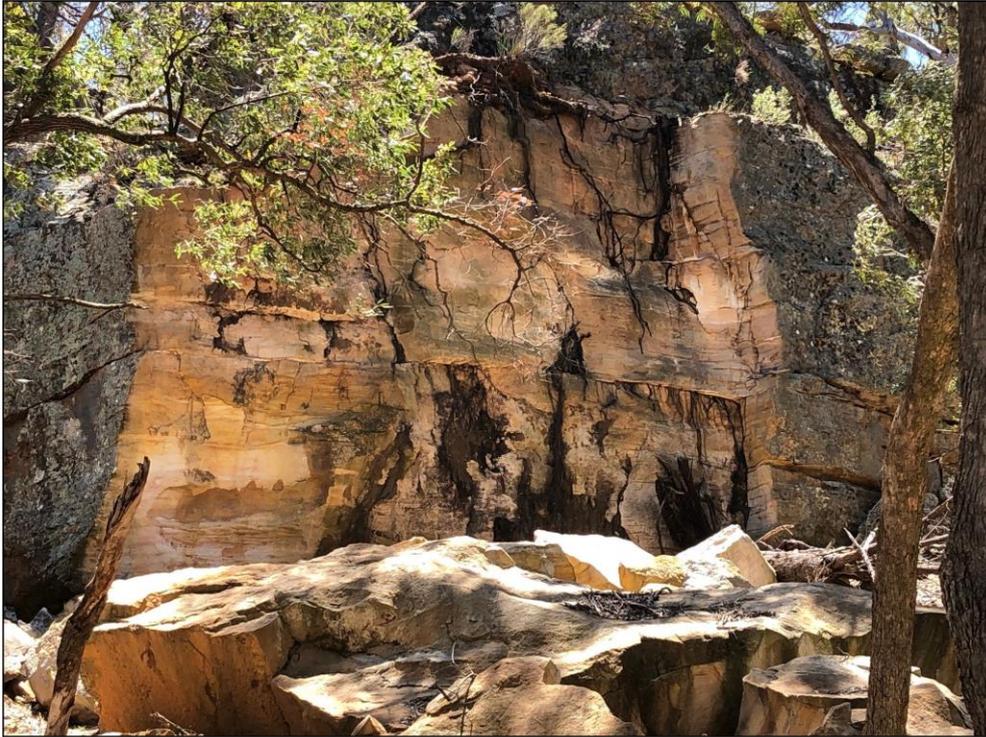
Figure 2: Rock fall that occurred on or around 18 March 2014

Figure 2 shows a photograph of the site of the March 2014 rock fall. An estimated 300 tonnes of sandstone material detached from the cliff face along a surface that had been extensively invaded by tree roots. Two small areas of fresh rock appear to have fractured at the time of the rock fall leading to the event. It is considered likely that inflow into the top of the crack during a high intensity rainfall event allowed water pressure to build up in the joint wedged apart by tree roots. Although short in duration, this additional pressure is likely to have triggered failure of the remaining fresh rock leading to the rock fall.

The rock fall site is located a short distance to the east of Cultural Site #184. The cultural site does not appear to have been directly impacted, but it is likely that all the cultural sites in the area have natural joints in the rock strata behind and are similarly vulnerable to tree root invasion over time.

Both events are considered to initially caused by toppling failure. Toppling failures open up natural joints parallel to the face of the cliff. Tree root invasion of the open joint then causes further jacking. The triggering event is likely to have been a high intensity rainfall event that instantaneously adds water pressure to the back of cliff to destabilise it.

The consequence of the rock fall is that the remaining cliff is now more stable than it was prior to the event. The greater than 0.7 times depth protection barrier afforded to the cliff by the MOD4 mining proposal is expected to be more effective now than it would have been prior to the rock fall because the cliff formation is now more stable than it was prior to the rock fall.

The March 2014 rock fall occurred prior to any construction work being undertaken adjacent to site so vibration from this activity could not be the cause of the rock fall. Although no significant vibration is expected during construction of the ventilation shaft, it may be prudent to install a vibration monitoring system near the cliff line along which the rock falls have occurred so that it can be demonstrated that no significant vibrations have occurred for this or any other reason. Installation of a weather station at the ventilation shaft may also be prudent for similar reasons.

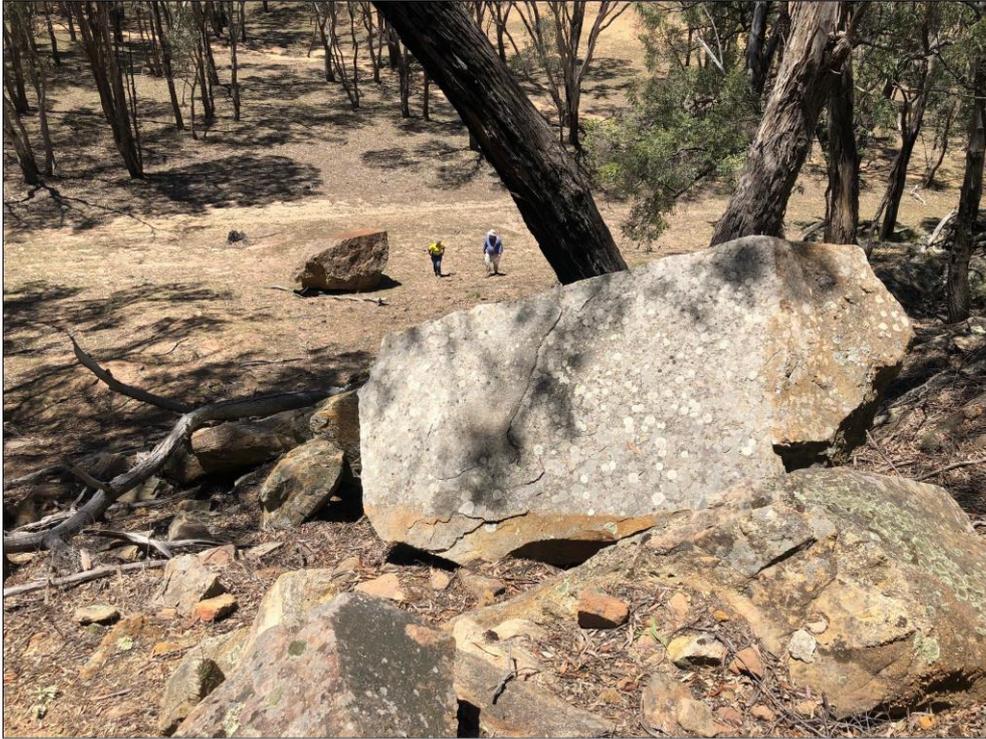
Figure 3: Rock fall that occurred around 1993 further along the same formation as the March 2014 rock fall

Figure 3 shows a photograph of a rock fall further to the east near Cultural Site #180. Mr Mitchell recalls this rock fall occurring some 25 years ago (around 1993). An estimated 60 tonnes of sandstone material detached from the cliff and rolled down onto the slope below as several large boulders.
