## Supplementary Submission to IPC on Narrabri Gas Project

Supplementary Submission to be included with the original submission - by Tony Pickard

### Well Cementing.

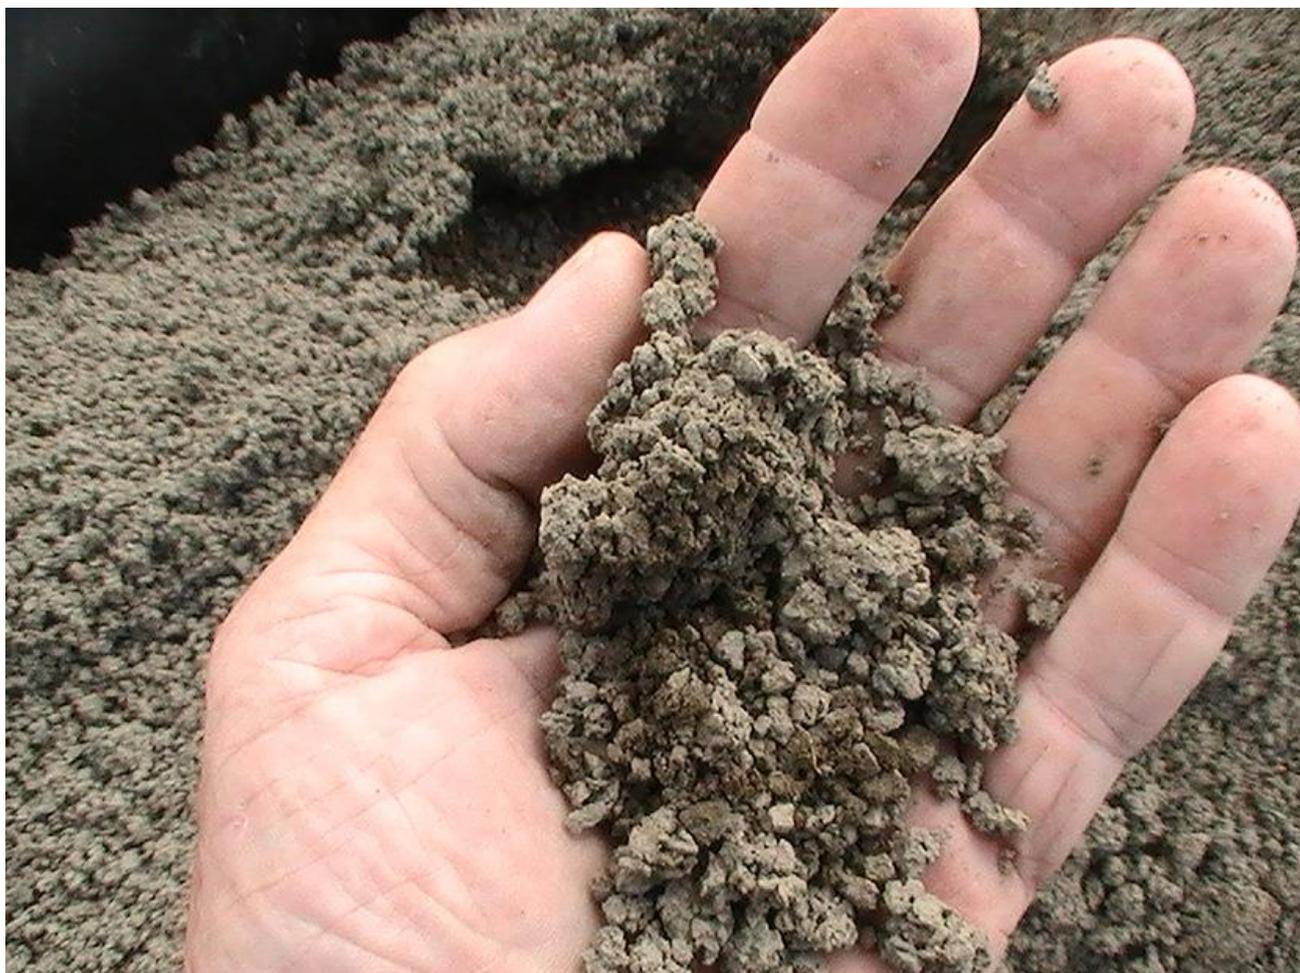
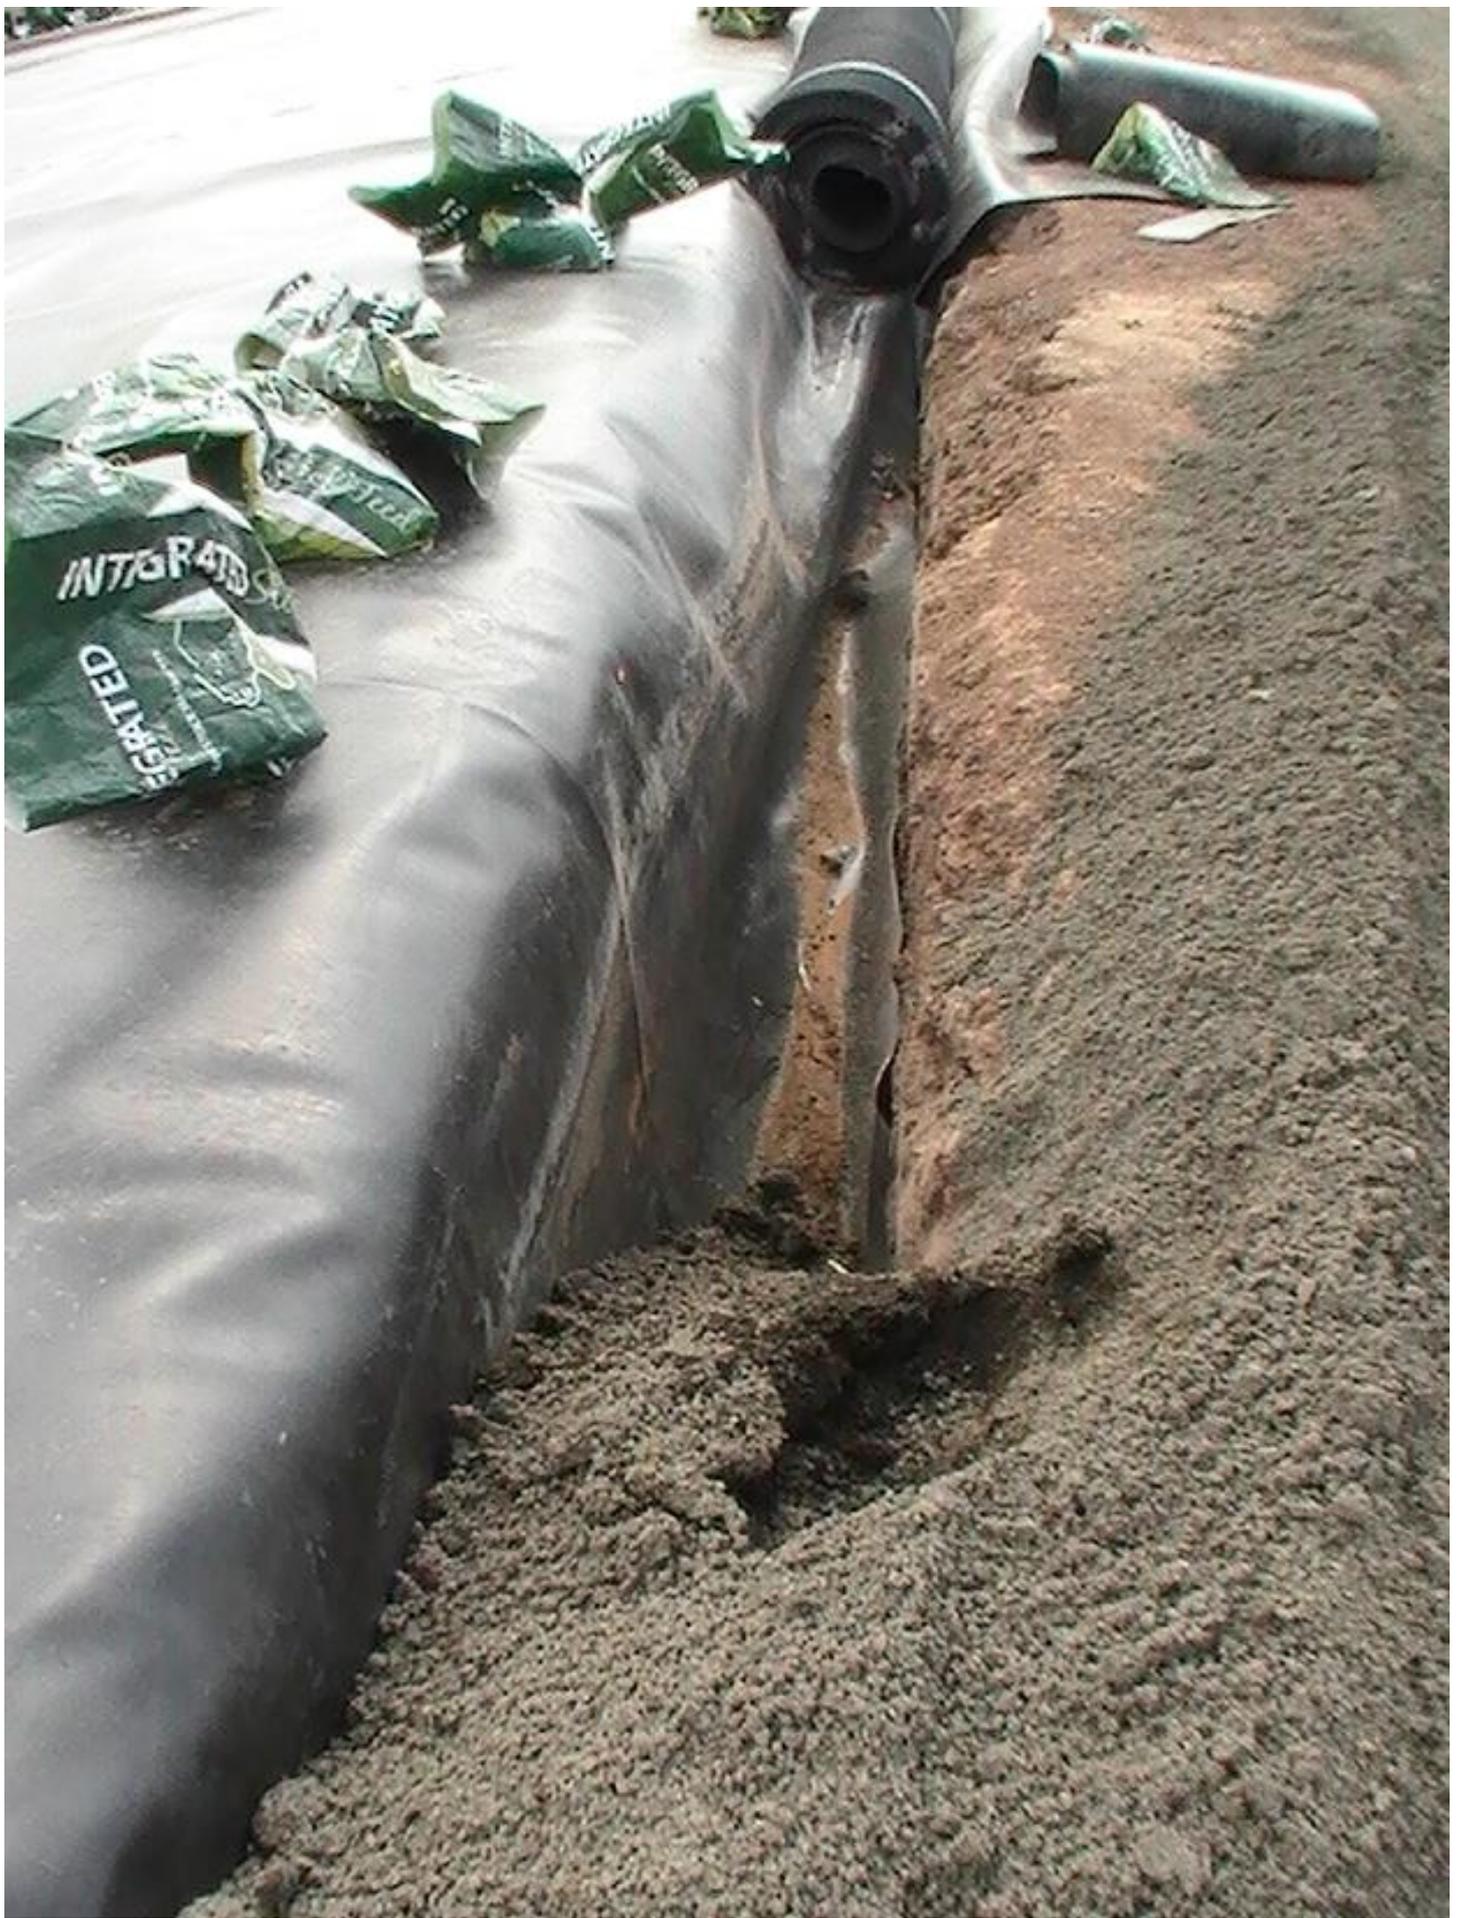
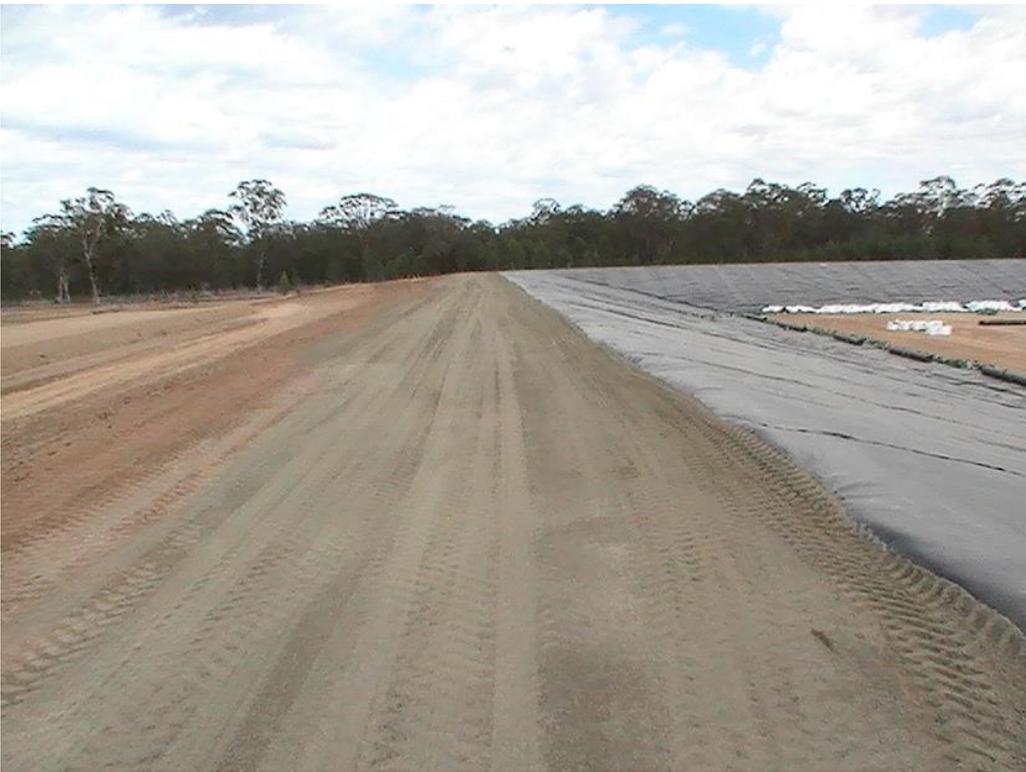
During the IPC Tour of July 6<sup>th</sup> 2020 of the Leewood Facility notably the 'Ponds' it was observed that a large amount of loose cement was at the top of the liner at a location where a trench was dug and the liner end was secured.

If my memory serves me correctly the liner was held in place by a fill that consisted of dry cement being mixed with a crusher material being placed in the trench and then watered to set the cement/crusher material mix. This material can be seen in the first lot of photographs, along with the trench with the liner in it and the trench once filled with the dry cement/small crusher material compacted by rolling awaiting 'watering'.

How do I know all this and have legal photographs? Because on the 8<sup>th</sup> of January 2014 Santos took only me on an extended tour of the Leewood Ponds site while they were being constructed. I had a full briefing on all aspects of the ponds and how they were constructed including the way the liner sections were joined (a process not unlike that which carpet layers use), how the leak detection system was intended to operate. I have 18 video and 70 images of the personalised tour all totalling 447 Mb. This tour was in the days when I believe Santos was trying to "groom" me.

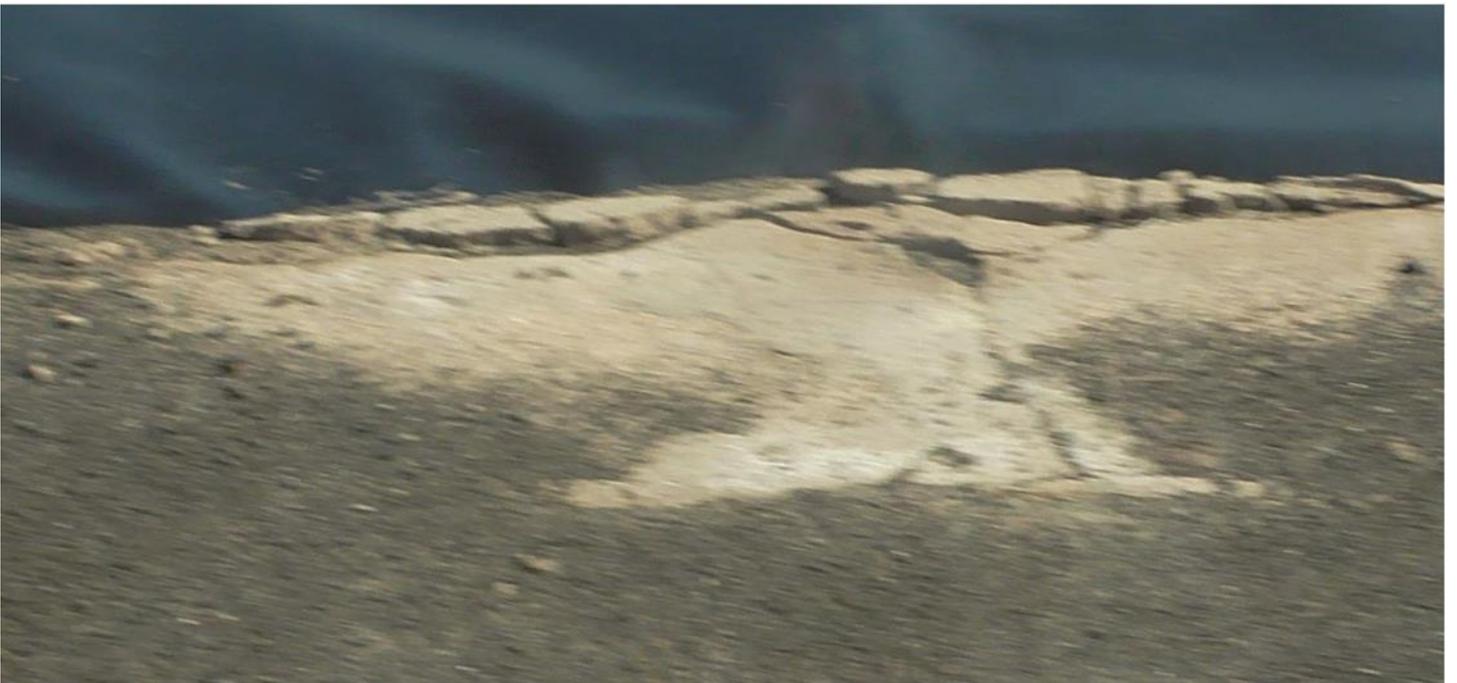
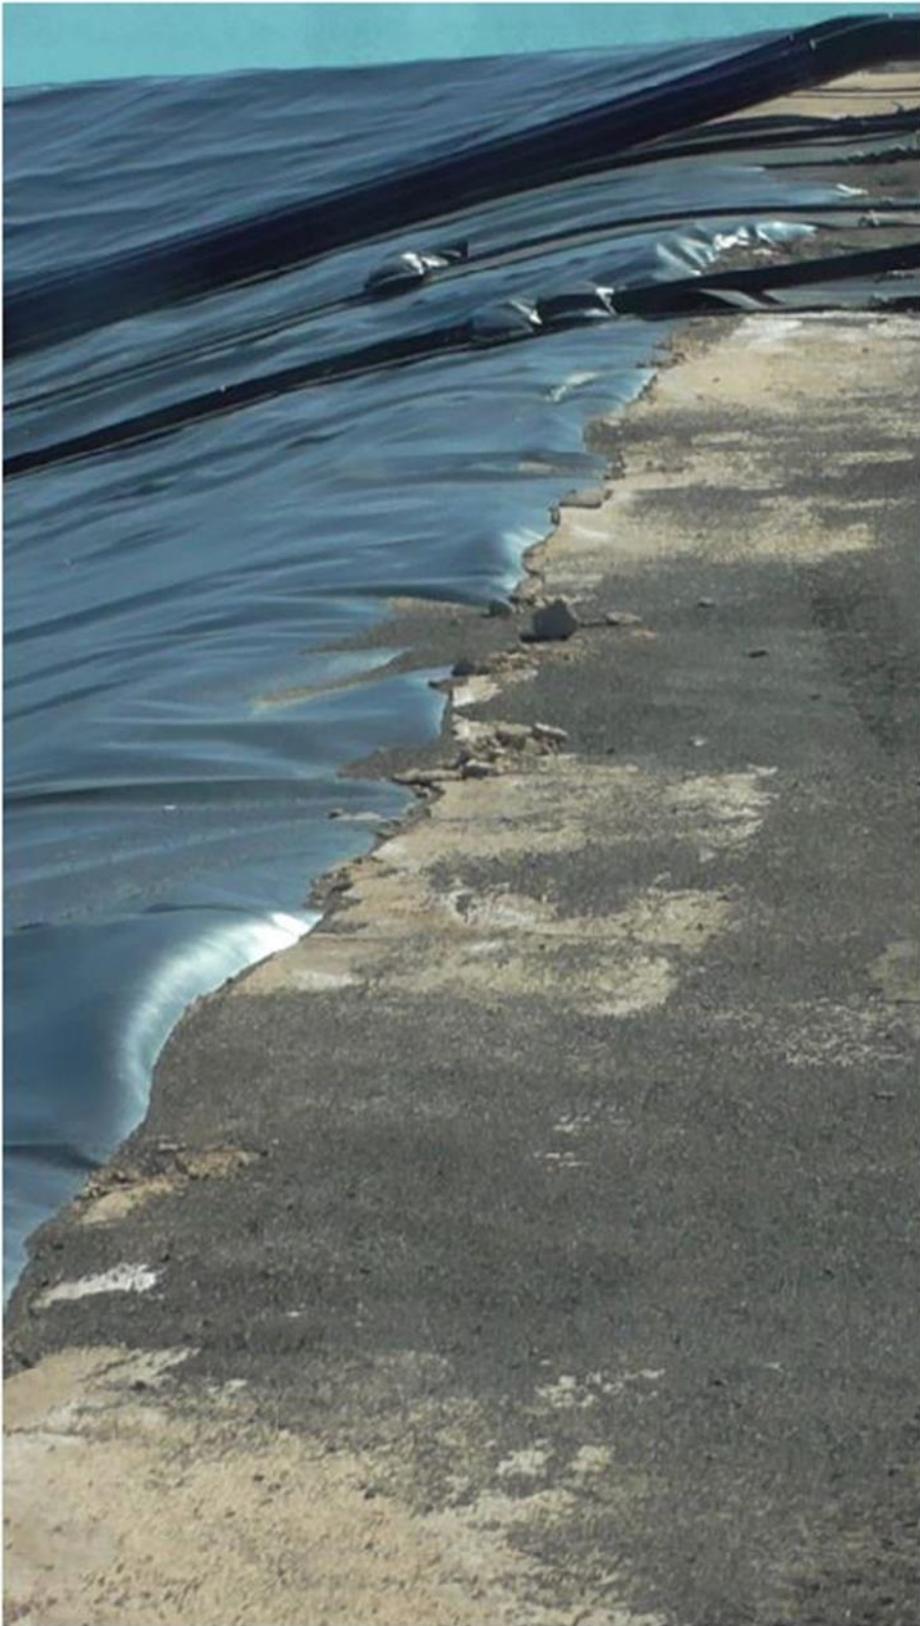
The following are pictures of the same trench taken on the IPC Tour of 6<sup>th</sup> July 2020.

So what is my concern? That the liner is shifting due to expansion caused by temperature changes and wind also water movement when filled, this movement has caused the liner to pull away from the cement/crusher material as a result this movement has caused the cement combination to break up into pieces which are large enough (see image) to puncture the liner material should they roll down the dam wall and strike the base at the right angle.

The Leewood ponds have the potential to be an accident waiting to happen in regards to liner leakage into the water table below.

Just seeing the broken cement mixture adjacent to and on the top of the ponds walls must be ringing alarm bells with the IPC in regards to the attitude Santos has towards preventative maintenance, because they should have removed any material that could potentially cause damage to the ponds Integratory and they did not.
