### Road safety audit finding

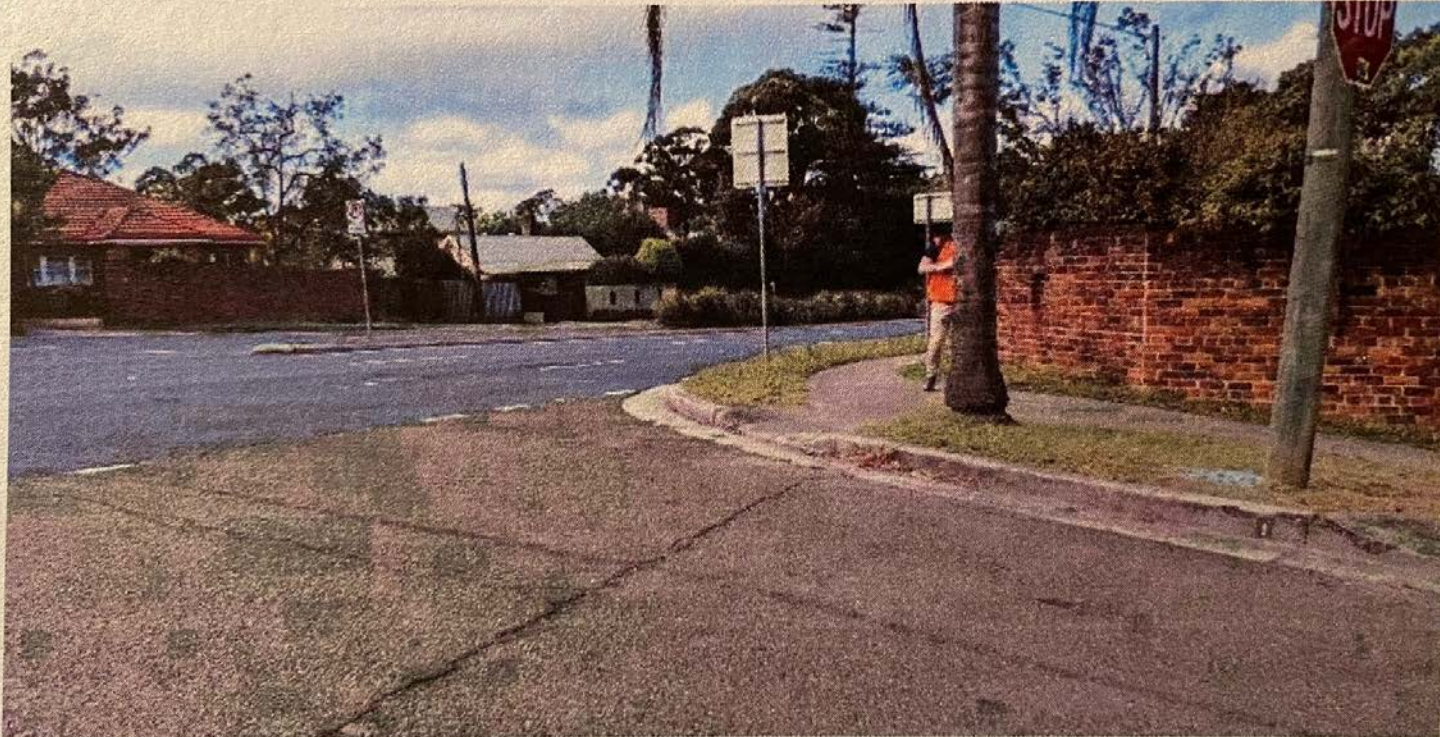
th- The kerb ramps at both of these corners of the intersection are poorly aligned and direct pedestrians to  
Road. This is especially the case for vision impaired pedestrians who rely on the alignment of the ramp  
/ direction. Mobility-impaired pedestrians may also be affected, especially if using a wheeled device, since  
tendency to roll down or up the ramp in a perpendicular trajectory to the ramp.

*Above: The kerb ramp on the south-eastern corner of the intersection.*

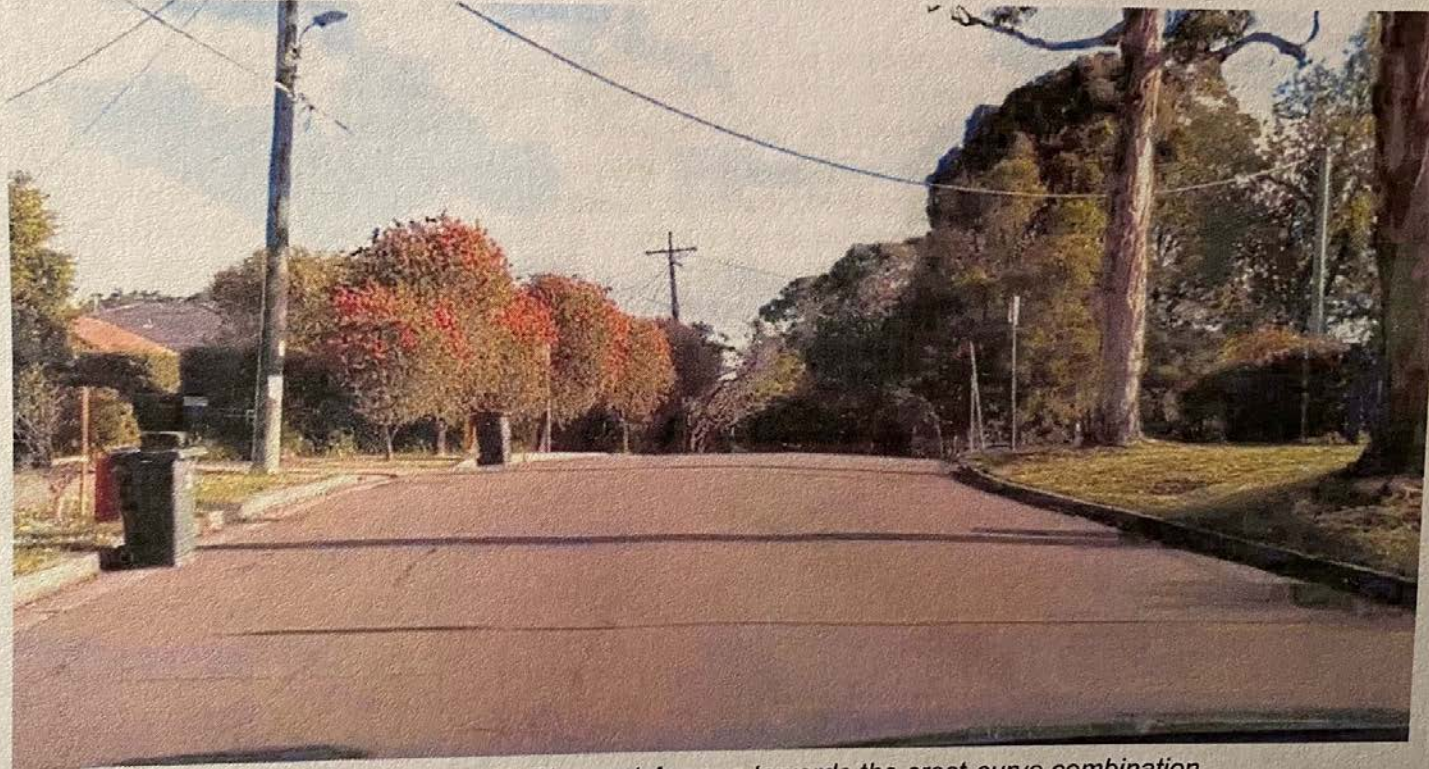
There is a pair of right-left reverse curves in combination with a crest vertical curve. The combined effect of the horizontal curve and the crest has reduced driver visibility to the road ahead. As such, drivers may not be aware of the road alignment ahead. This is particularly critical if drivers in either direction drift towards the midline of the road where there could be corresponding *head-on* crash risks with opposing vehicles. Consideration should be given to providing a centreline to separate opposing traffic streams.

**Above:** Looking southbound along Mt Pleasant Avenue towards the crest-curve combination.
