Yeshiva College, Bondi Structural Condition Assessment

Karimbla Properties (No 10) Pty Ltd

Job No: 23014

DATE: 21/03/2023

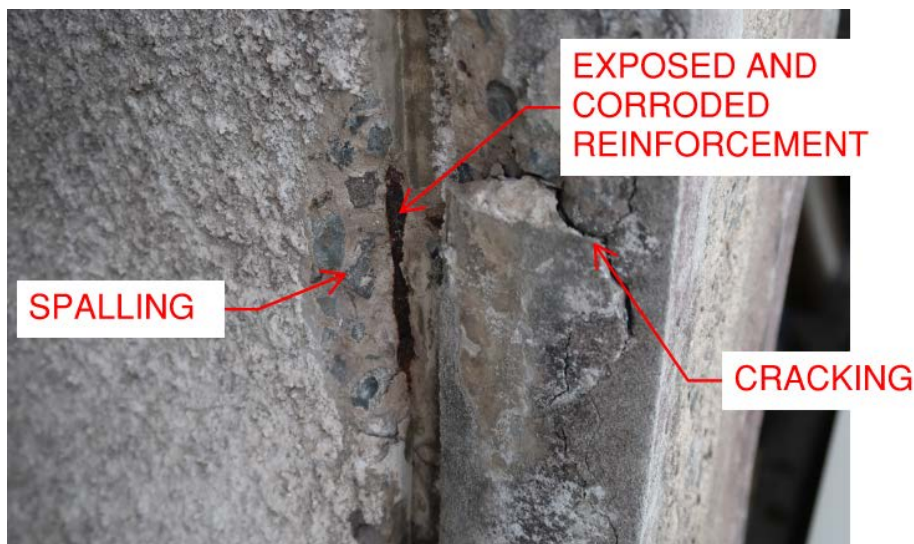
- Cracking, concrete spalling and corrosion of exposed reinforcement at the Southern end of the concrete arches adjacent to the fire escape passage. This was evident in multiple locations along this end. Refer to Figure 5 below and Photos S01-13 of the photographic record in the Appendix.

Figure 5 – Cracking and Spalling of the Concrete Arches

- This is an indication of apparent “concrete cancer” whereby exposed reinforcement corrodes and expands, therefore inducing internal stresses within the concrete due to the reinforcement volume change. The build-up of these increased internal stresses over time leads to further

cracking and concrete spalling resulting in further exposure of reinforcement to the elements and therefore continuing the corrosion and repeating the process.

- 1) The significant and widespread cracking, spalling and corrosion of exposed reinforcement indicates the apparent onset of “concrete cancer” to the arch roof structure.

- 6) Remedial measures of the affected areas may include the following procedure:
 - Removal of any loose or spalled concrete in the damaged areas identified

- Assessment of the extent of the corrosion of the rebar. Rebar may be retained and surface rust removed. If rust has penetrated the re-bar, then this needs to be cut out and replaced. Bars replaced will then be site welded to the existing reinforcement. All site welds and surface rust must be treated with a non-corrosive agent.

- Removal of spalled concrete and concrete removed for the treatment of the reinforcement must be replaced and be made good with an approved concrete repair mortar such as the Fosroc Renderoc products.

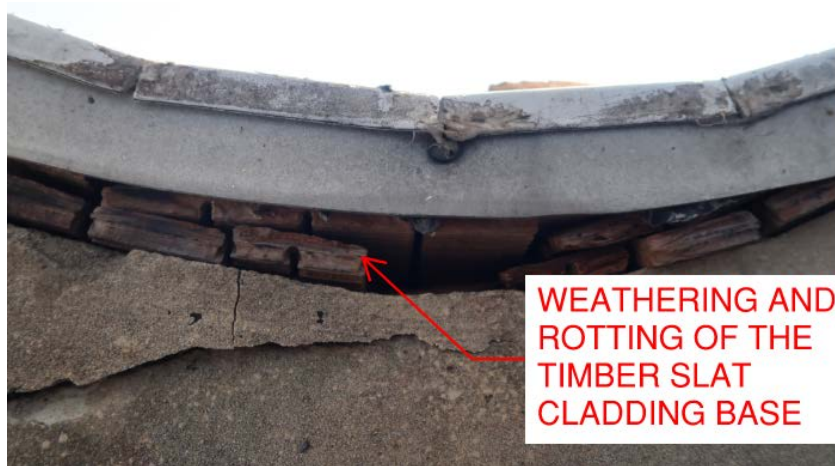
- Weathering and rotting of the timber slat roof cladding base were also observed on the Southern end of the Synagogue building. The ends of these slats appear to have been exposed to rainwater over the years, which appears to have rotted the timber. The gap between the slats and the top of the concrete surface appears to be a water ingress path, which may have further damaged these timber slats. This could not be viewed during the inspection as these are covered by the roof membrane. Refer to Figure 6 below and Photographs S05 and S07 in the Appendix of this report.

Figure 6 – Weathering of the Timber Slat Cladding Base

- 8) Remedial works appear to be also required in terms of providing satisfactory waterproofing. Potential water ingress paths were identified between the top of the concrete arch and the timber slats supporting the roof membrane. Slats have weathered and rotted as a result of this water exposure and require removal and replacement.

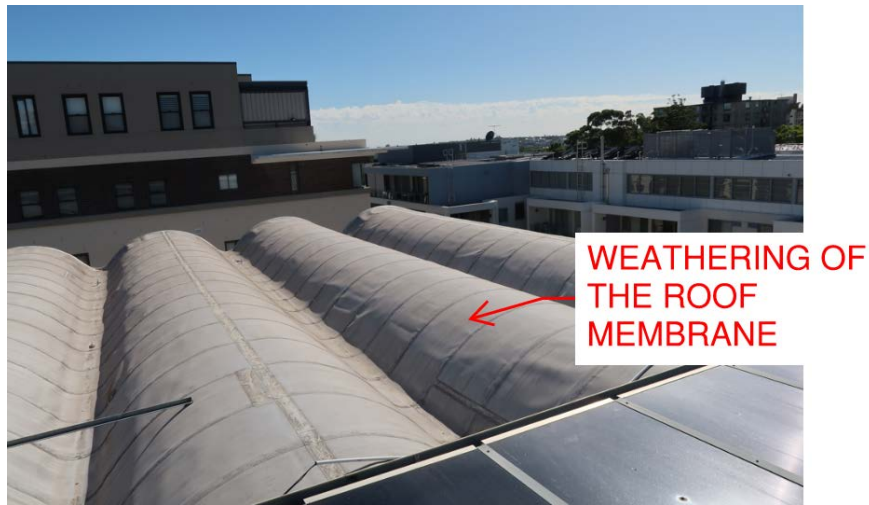
- Weathering of the Synagogue roof membrane was observed. Weathering was in the form of discoloration, surface irregularity, and weathering at the membrane joints. Refer to Figure 7 below and Photos S14-15 in the Appendix of this report.

Figure 7 – Weathering of the Roof Membrane

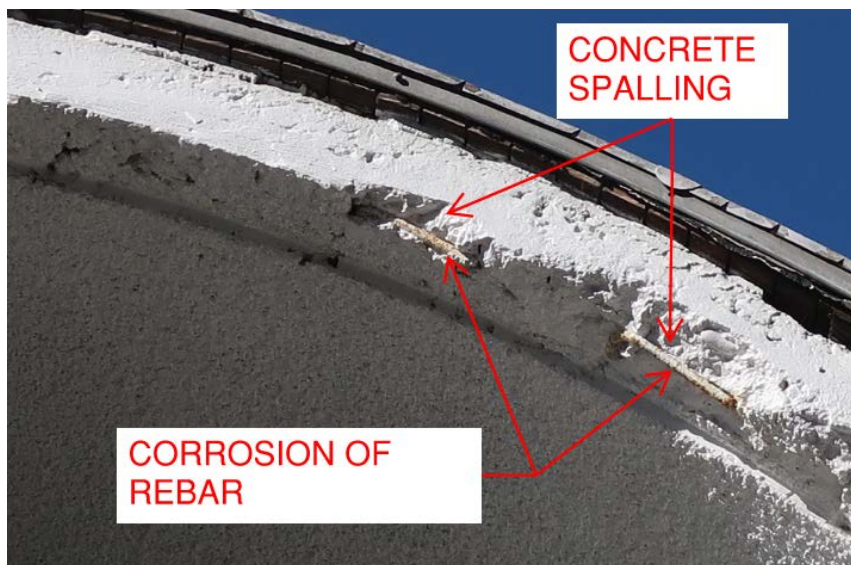
- Exposed electrical wiring and scattered service conduits were observed above the roof arches. Refer to Photos S14-16.
- Cracking, concrete spalling and corrosion of exposed reinforcement at the Northern side of the concrete arches, at the side of the entry ramp from Flood St was observed. This was evident in multiple locations along this side also. Refer to Figure 8 below and Photos S18-23 of the photographic record in the Appendix

Figure 8 – Cracking and Spalling of the Concrete Arches at the Northern End

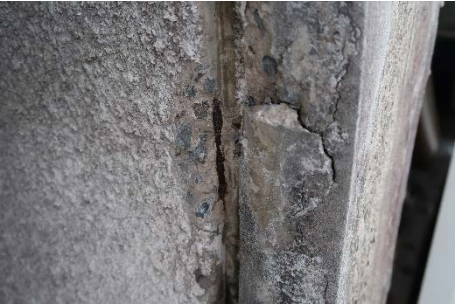
<p>S01 – Concrete spalling, cracking and corrosion of exposed rebar Southern end</p>	<p>S02 – Concrete spalling at edge of arch Southern end</p>

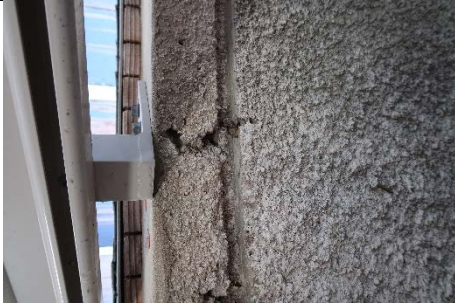
- Honey combing of the concrete at the arches was also observed. This is due to insufficient vibrating of the concrete at the time of construction, where air voids are left resulting in the honey comb effect observed. The issue with this is that reinforcement at these locations is exposed or has insufficient cover resulting in the corrosion of the reinforcement. Refer to Photos S03, S09, S012

<p>S03 – Honey combing of concrete at concrete arch at Southern end</p>	<p>S04 – Cracking of concrete arch at Southern end</p>

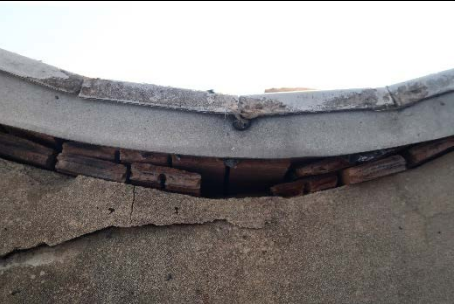
<p>S05 – Rotting of timber slat roof cladding base</p>	<p>S06 – Corrosion of exposed rebar and concrete spalling of arch at Southern end</p>

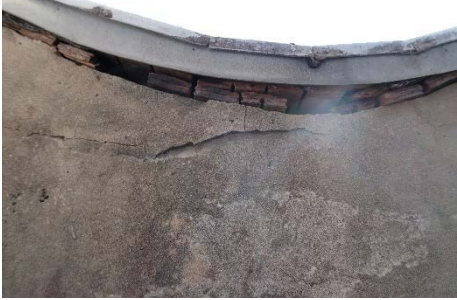
<p>S07 – Rotting of timber slat roof cladding base</p>	<p>S08 – Corrosion of exposed rebar and concrete spalling of arch at Southern end</p>

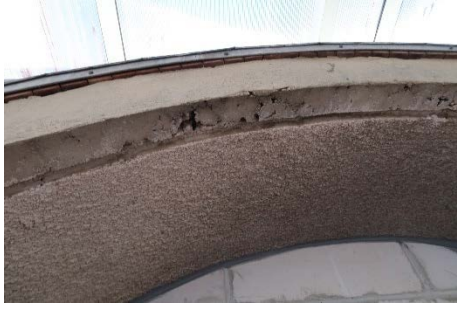
<p>S09 – Honey combing at concrete arch and corrosion of exposed rebar</p>	<p>S10 – Corrosion of exposed rebar and concrete spalling of arch at Southern end</p>

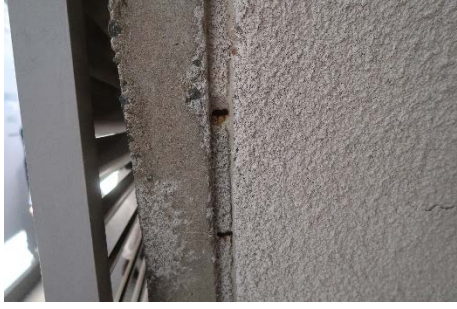
<p>S11 – Corrosion of exposed rebar and concrete spalling of arch at Southern end</p>	<p>S12 – Honey combing and cracking at concrete arch at Southern end</p>

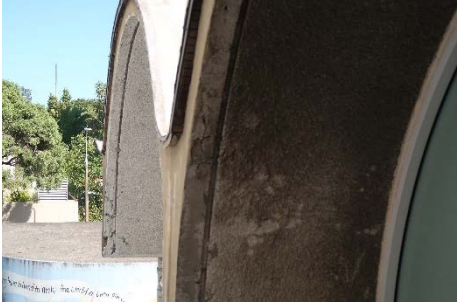
<p>S13 – Cracking and spalling of the concrete arch at the Southern end</p>	<p>S14- View of the roof membrane over the concrete roof arches looking North</p>

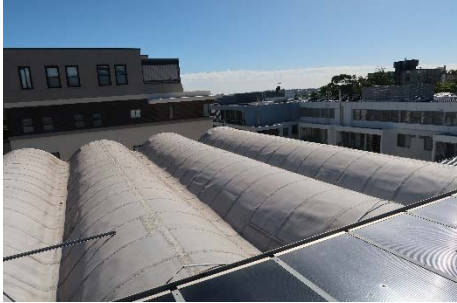
<p>S15 – Wearing of the roof membrane</p>	<p>S16 – View of both the college and synagogue roofs</p>

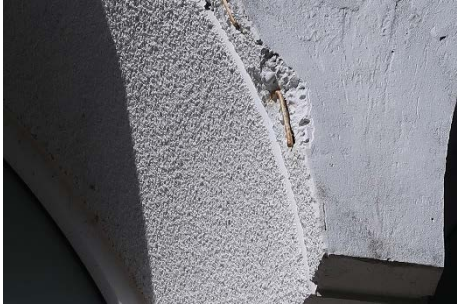
<p>S17 – View of the Northern façade of the synagogue building</p>	<p>S18 – Corrosion of exposed rebar and concrete spalling of arch at Northern end</p>

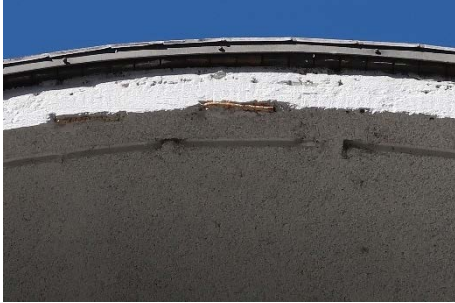
S19 – Corrosion of exposed rebar and concrete spalling of arch at Northern end

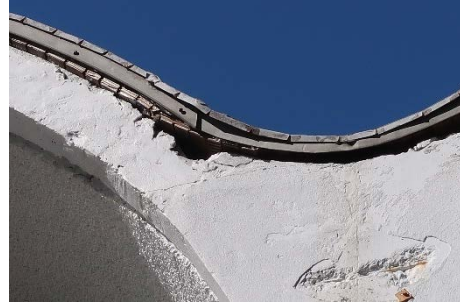
S20 – Significant concrete spalling of the concrete arch at the Northern end

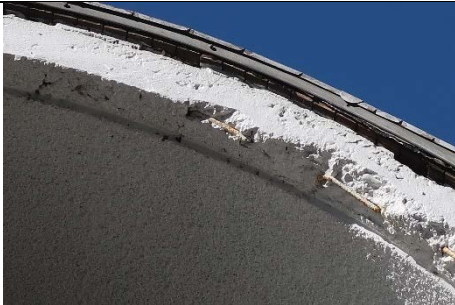
S21 – Corrosion of exposed rebar and concrete spalling of arch at Northern end

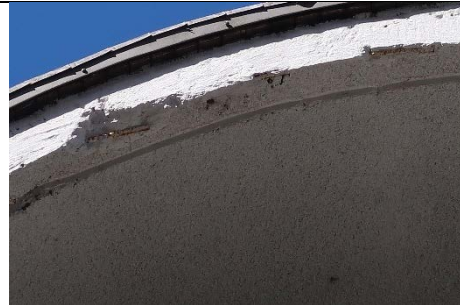
S22 - Corrosion of exposed rebar and concrete spalling of arch at Northern end

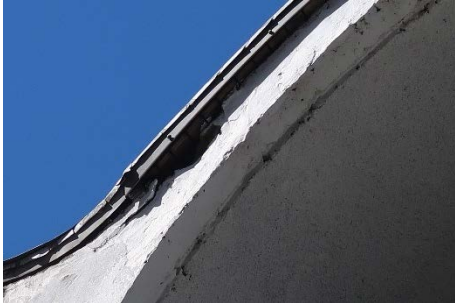
S23 – Significant concrete spalling of the concrete arch at the Northern end

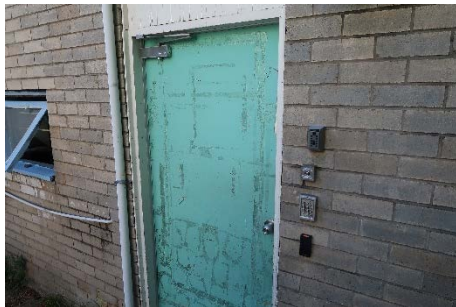
S31 – Damaged front entry door of the storage building

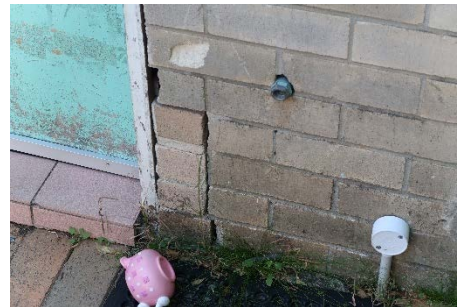
S32 – Cracking along the masonry joints at the base of the masonry wall of the storage building

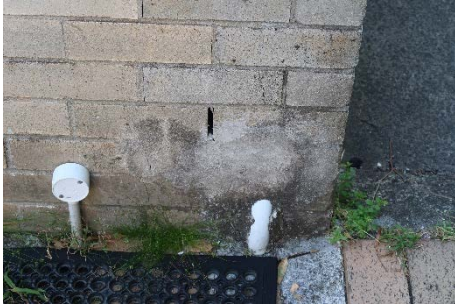
S33 – Cracking of the storage building masonry wall

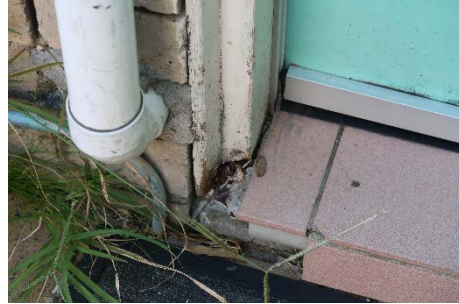
S34- Rotting of the storage building door entry timber framing

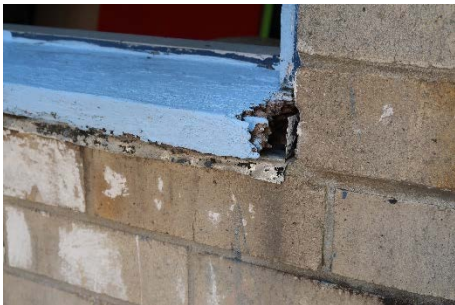
S35 – Rotting of the timber window frames of the storage building

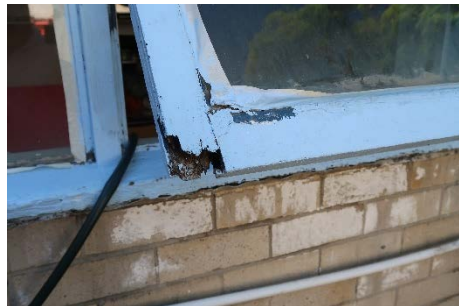
S36 – Rotting of the timber window frames of the storage building

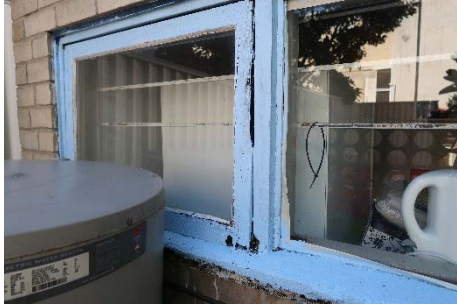
S37 – Rotting of the timber window frames of the storage building

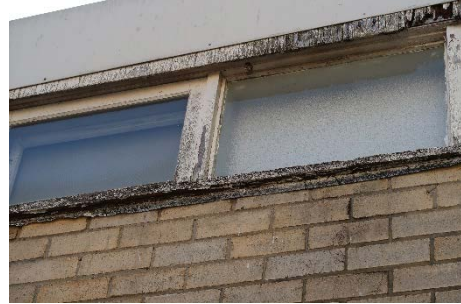
S38- Rotting of the timber window frames of the storage building

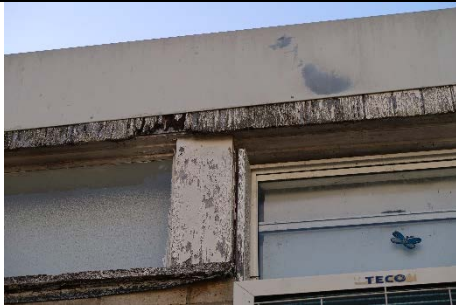
S39 – Rotting of the timber window frames of the storage building

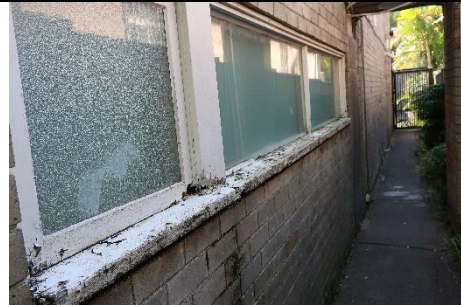
S40 – Rotting of the timber window frames of the storage building

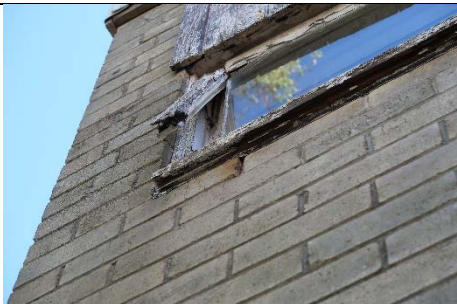
S41 – Rotting of the timber window frames of the storage building

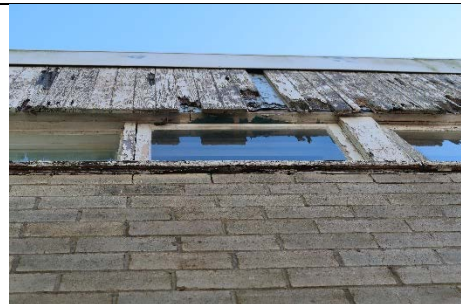
S42 – Rotting of the timber window frames of the storage building

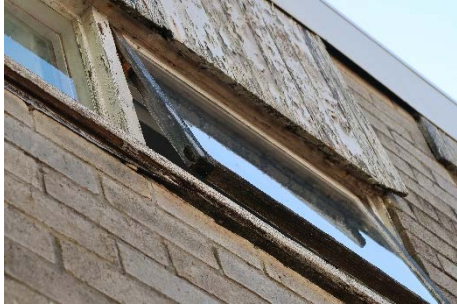
S43 – Rotting of the timber window frames of the storage building

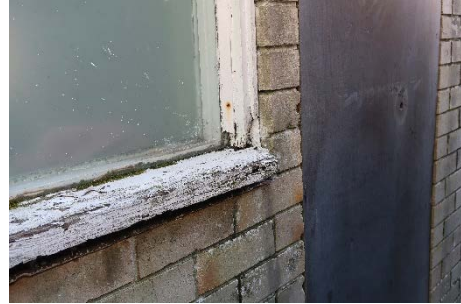
S44- Rotting of the timber window frames of the storage building

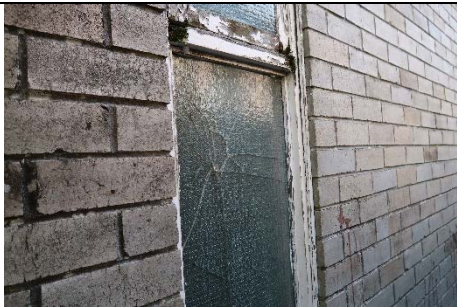
S45 – Rotting of the timber window frames and window cracking at the storage building

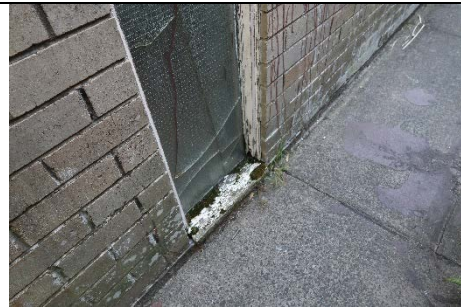
S46 – Rotting of the timber window frames and window cracking at the storage building

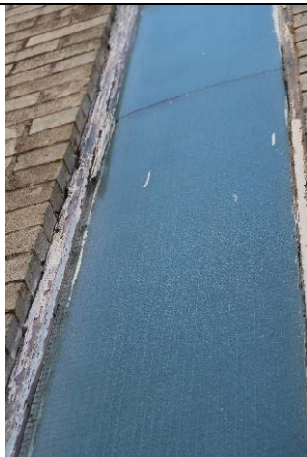
S47 – Rotting of the timber window frames of the storage building

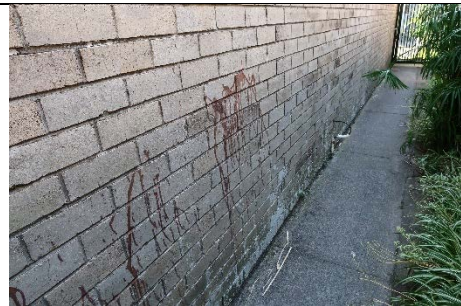
S48 – Staining of the brick wall façade of the storage building
