REPORT
TO
CATHOLIC METROPOLITAN CEMETERIES TRUST
ON
GEOTECHNICAL ASSESSMENT
OF
EXISTING DAMS
AT
166-176 ST ANDREWS ROAD, VARROVILLE, NSW

10 January 2018
Ref: 30510ZArpt

Date: 10 January 2018
Report No: 30510ZArpt
Revision No: 0

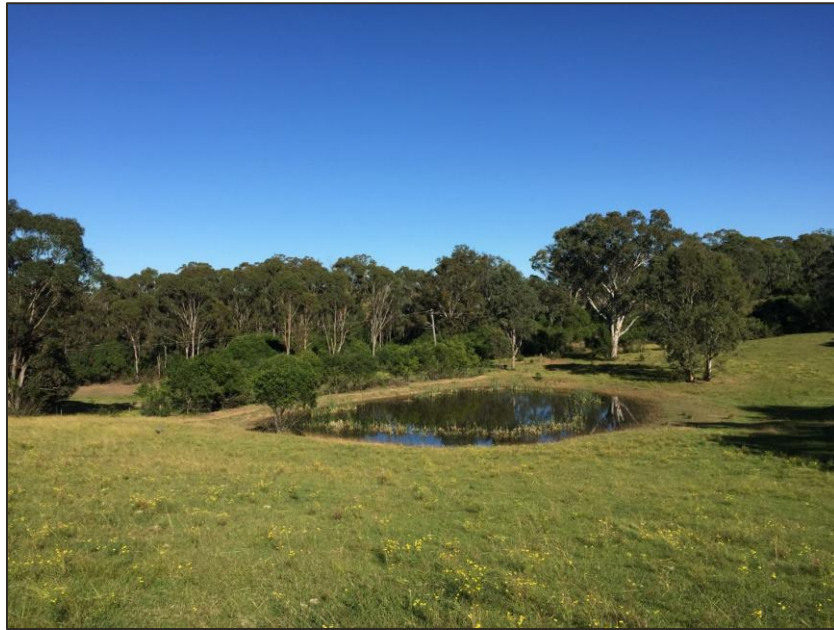
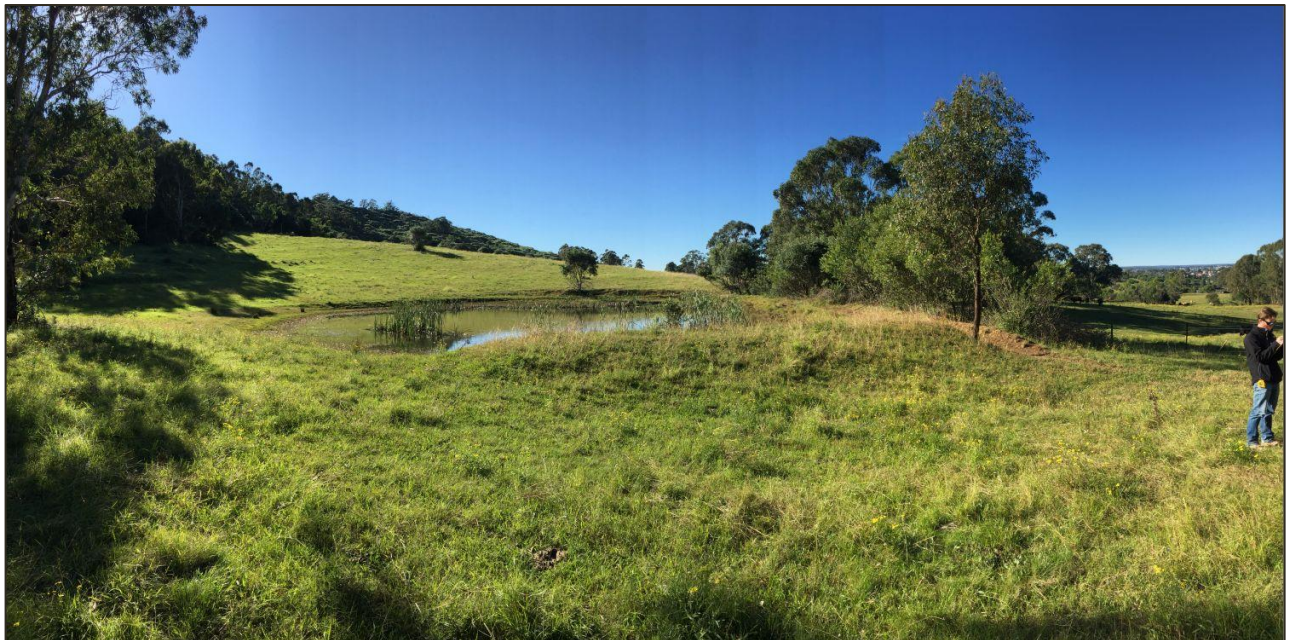
DAM 1

Looking south-west at Dam 1

Looking east at Dam 1

6. The upstream shoulder was grass covered and contained scattered weeds.
7. The weeds extending several metres along the base of the gully, beyond the downstream toe of the embankment. Immediately downstream of the weeds, the base of the gully was moist under foot, indicating dam leakage.

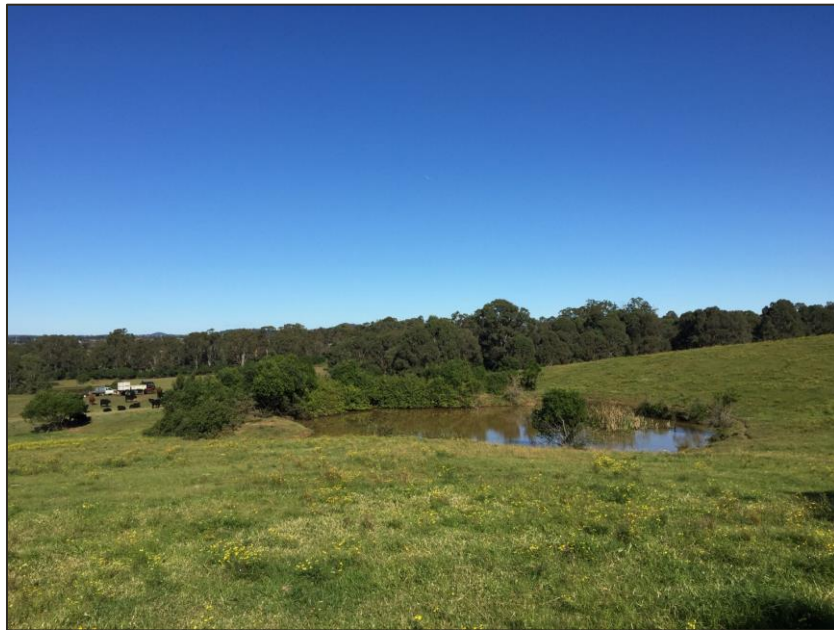
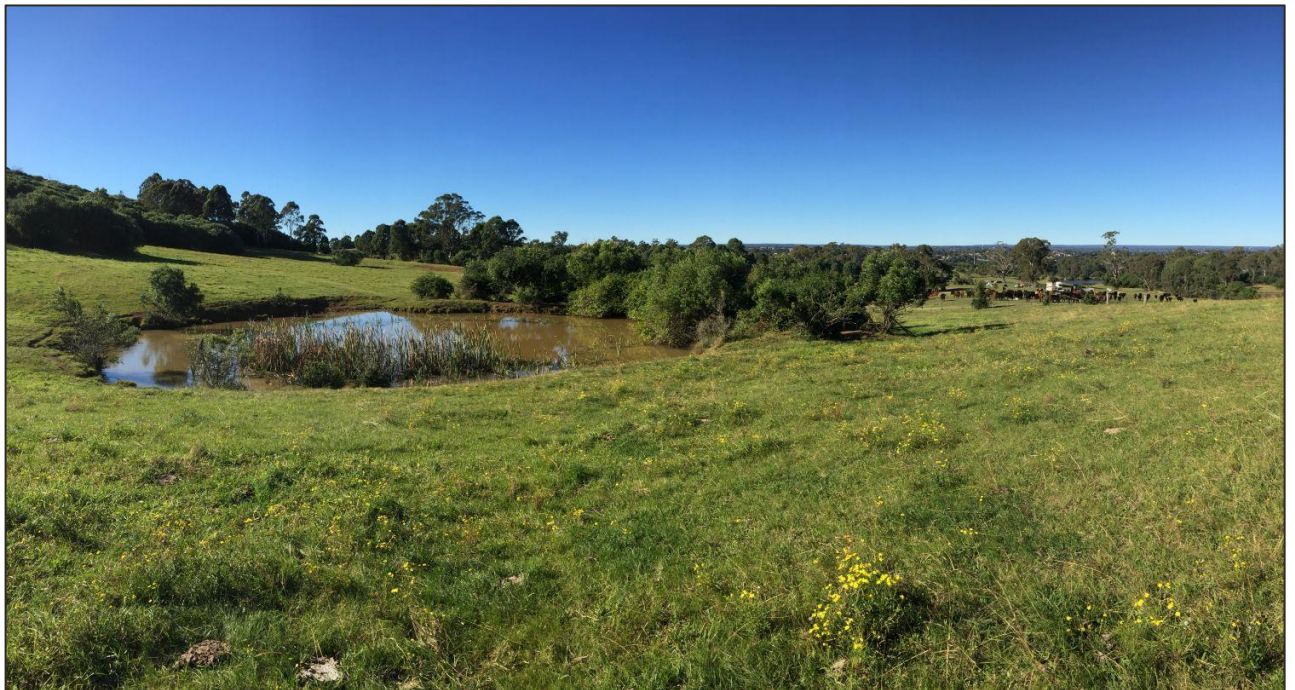
DAM 2

Looking south-west at Dam 2

Looking south-east at Dam 2

6. The base of the gully, immediately beyond the downstream toe of the embankment, was 'boggy' under foot, indicating dam leakage.

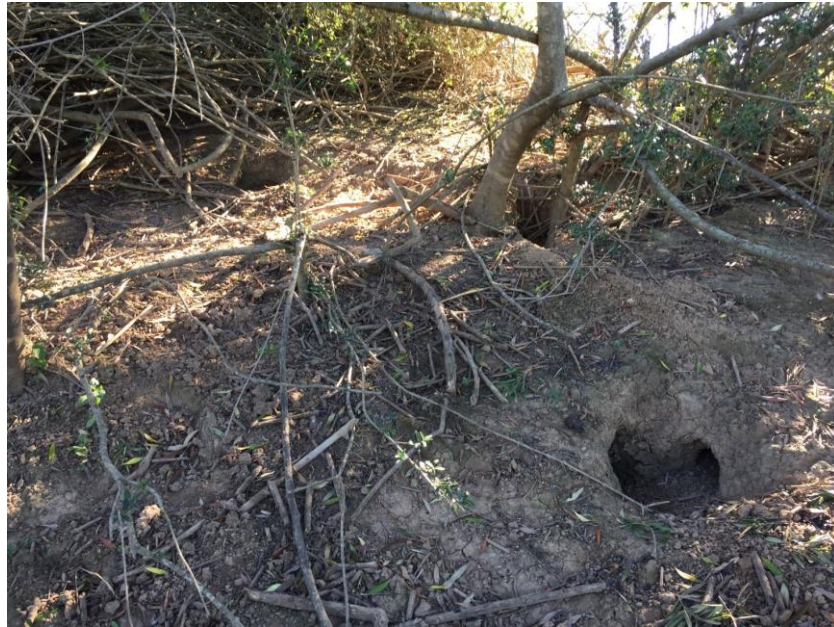
7. Six burrows were observed along the downstream shoulder (refer to photograph below), some of which appeared to be interconnected.
8. The base of the gully flanking the creek, immediately beyond the downstream toe of the embankment, was 'boggy' under foot and the creek itself contained pools of stagnant water (refer to photograph below), indicating dam leakage.

Burrows in downstream shoulder of Dam 4 embankment

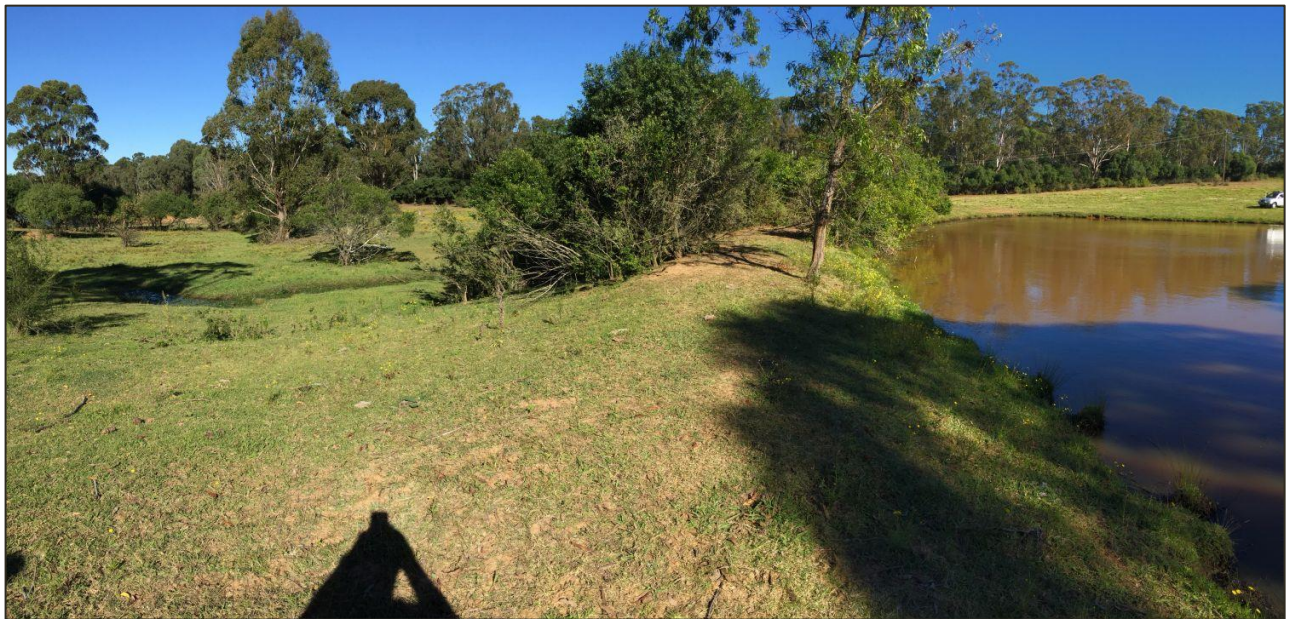
6. The crest and shoulders were grass covered, however, some areas were devoid of grass; at least partially due to cattle tracks. The central portion of the embankment contained a dense coverage of small to medium size trees and weeds. Some trees on the downstream shoulder had fallen out.

Dam 4 embankment looking south-west

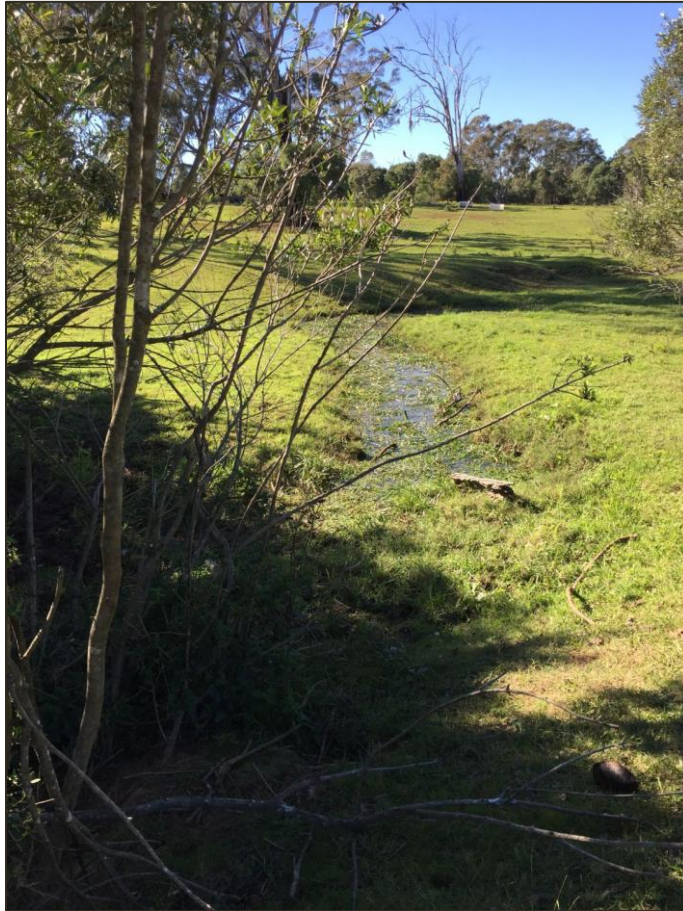
Stagnant water in creek beyond downstream toe of Dam 4 embankment

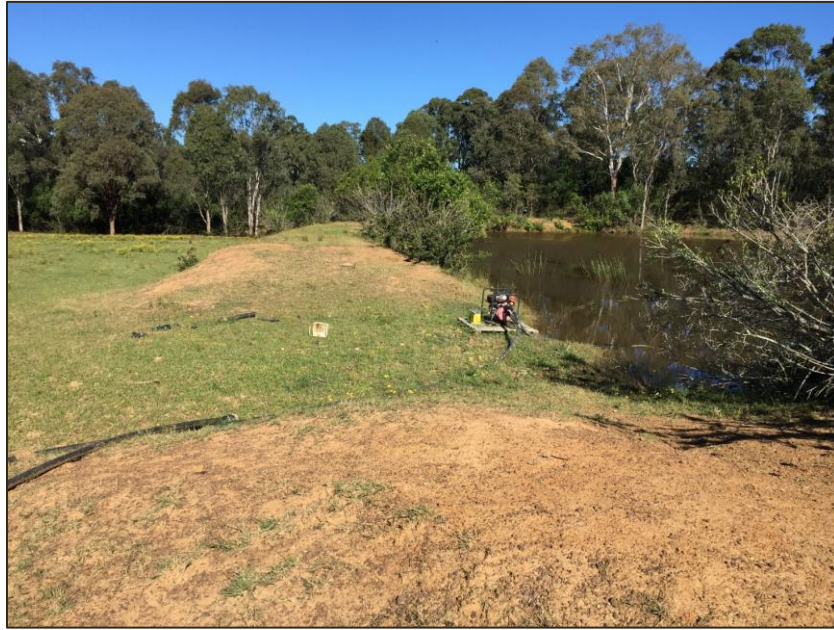
Informal spillway at north-eastern of Dam 5 embankment, looking south-west

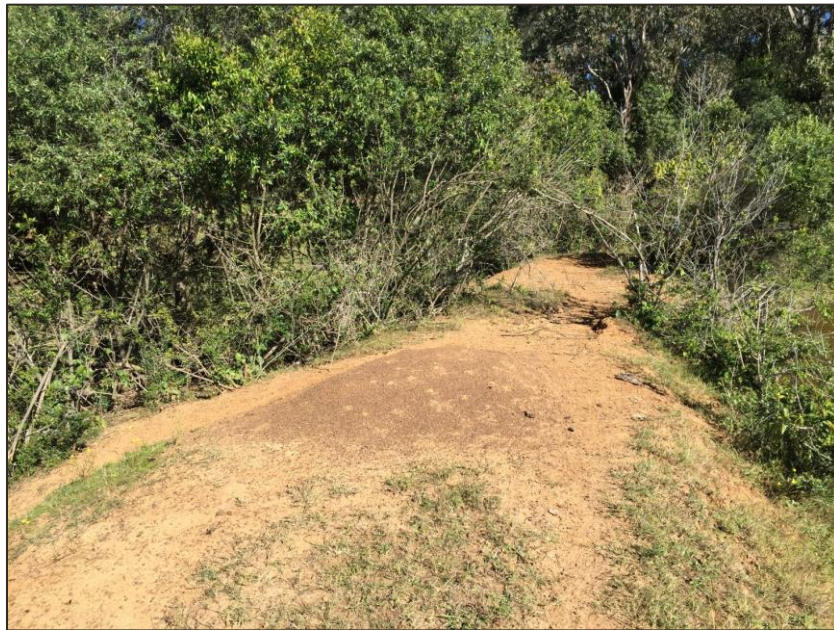
7. Two burrows were observed along the toe of the downstream shoulder, in the vicinity of the base of the gully. Two ant hills were observed along the crest of the embankment (refer to photograph below).

Ant hill on Dam 5 embankment crest

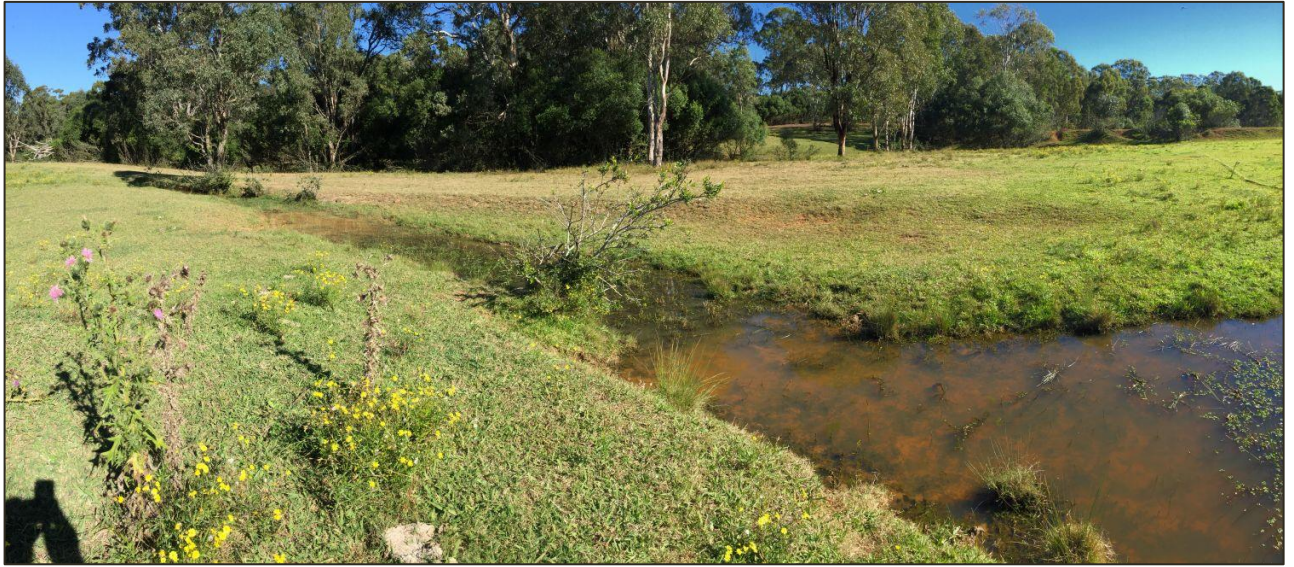
Informal spillway/drainage channel at western of Dam 6 embankment, looking south-west

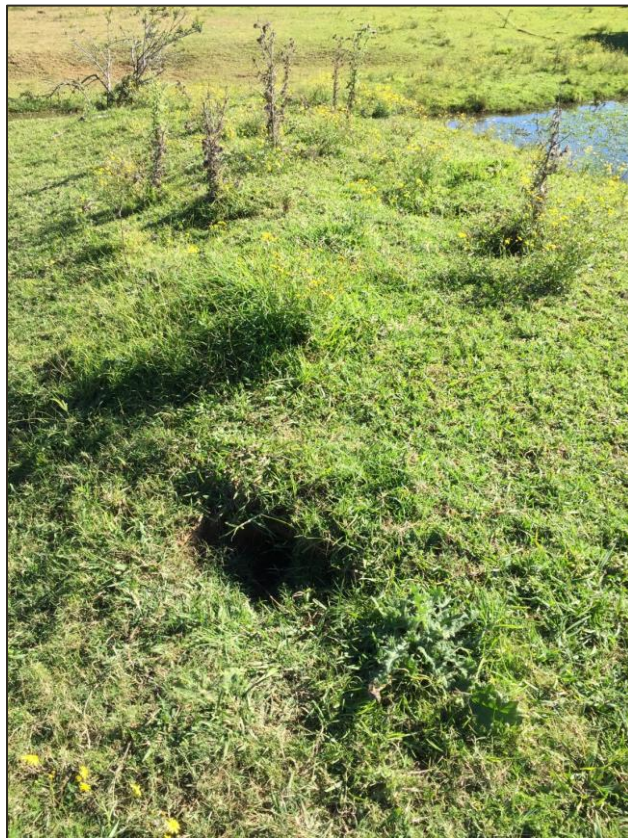
8. Five burrows were observed towards the western end of the embankment (refer to photograph below).

Burrow at western end of Dam 6 embankment

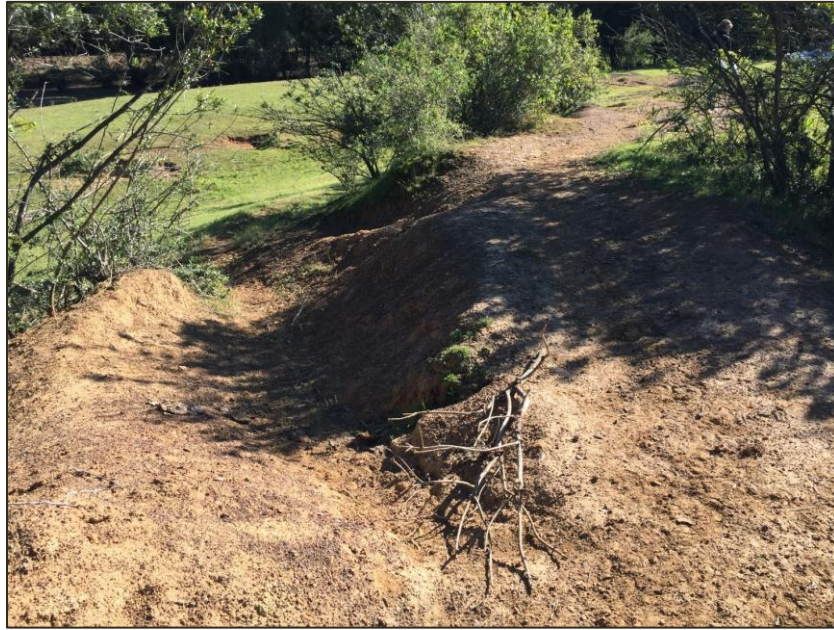
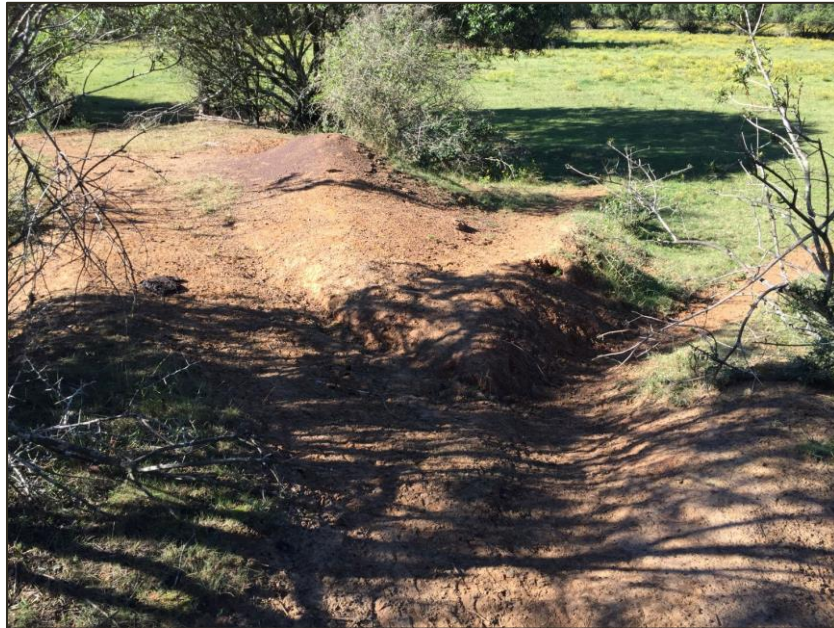
Erosion features on downstream shoulder of Dam 7 embankment

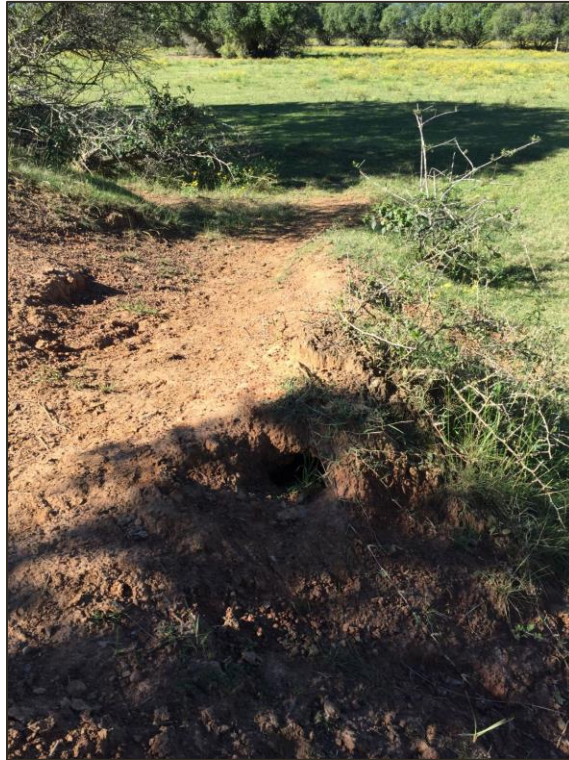
8. A burrow was observed towards the south-eastern end of the downstream shoulder. Ant hills were also observed towards the ends of the embankment (refer to photographs below).
9. On the south-eastern flank of the gully feature immediately downstream of Dam 7, was a deeply incised erosion rill along the downstream toe of the embankment.
10. At the base of the gully, the toe of the downstream shoulder was sub-vertical to a maximum height of about 1m (refer to photograph below). At one section, boulders had been placed up against the sub-vertical face.
11. The base of the gully, immediately beyond the downstream toe of the embankment, was 'boggy' under foot and contained pools of stagnant water, indicating dam leakage.

Burrow at south-eastern end of downstream shoulder

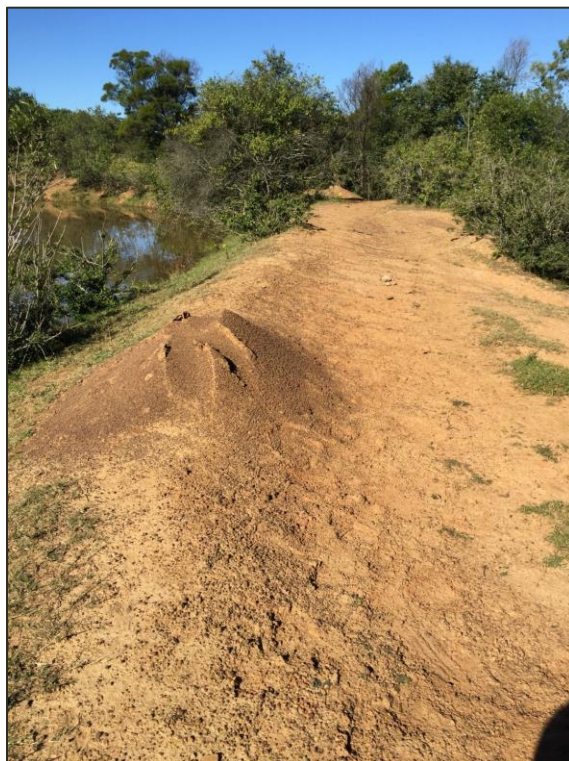
Ant hill at north-western end of Dam 7 embankment

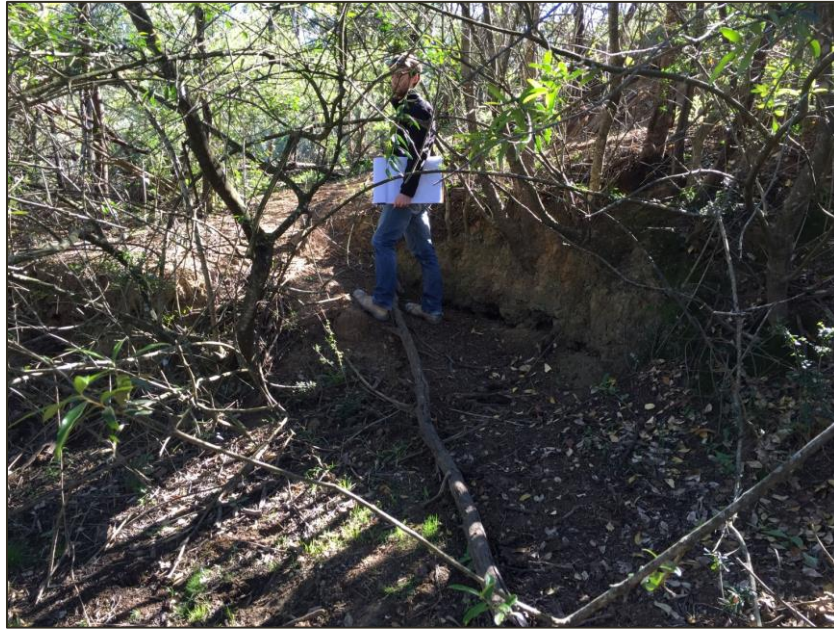
5. **Evidence of scour and erosion along the toe of the downstream shoulder:** The toe of the downstream shoulder at Dams 7 & 10 was sub-vertical in places due to scour and erosion. Regression of this erosion feature could ultimately cause a breach of the embankment.

Sub-vertical toe along downstream shoulder of Dam 7 embankment

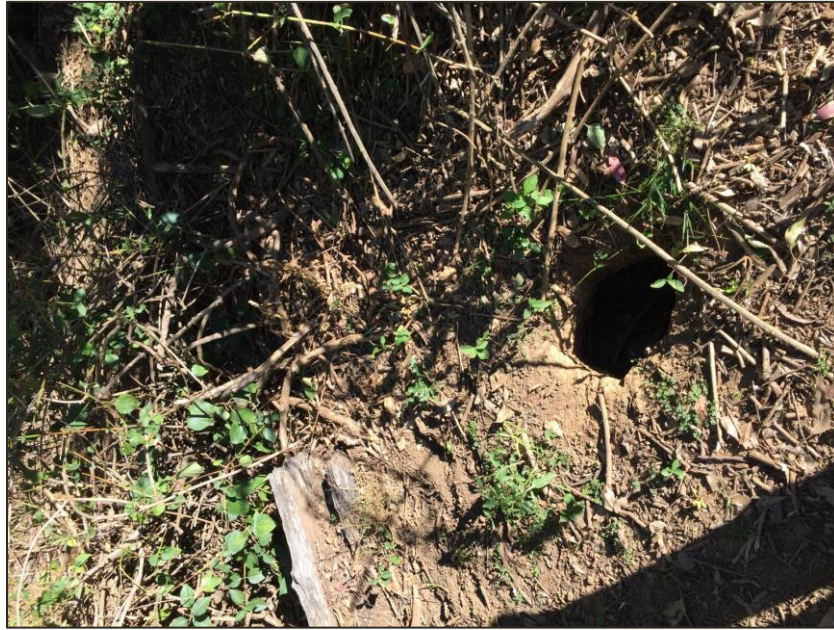
6. There were erosion features along the downstream shoulder. They appeared to have been initiated by cattle tracks and/or previously fallen trees.
7. Numerous burrows were observed along the crest and downstream shoulder of the embankment (refer to photograph below). An ant hill was also observed towards the eastern end of the embankment.

Burrow in Dam 8 embankment

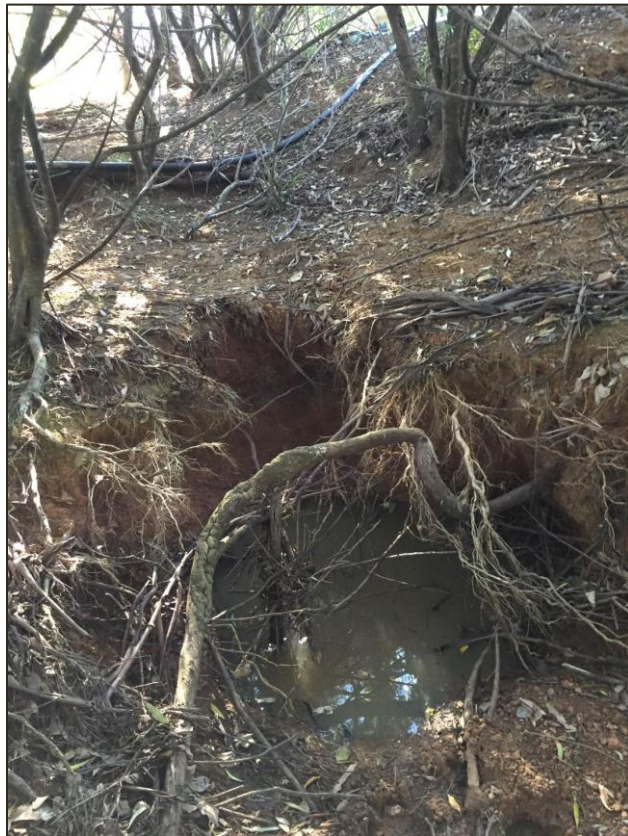
8. Towards the western end of the embankment, was a deeply incised, 0.8m deep erosion feature at the toe of the downstream shoulder. At the time of our inspection, this feature contained a stagnant pool of water; indicating dam leakage. Further downstream was a creek, which also contained stagnant water (refer to photographs below).

Deeply incised erosion feature at downstream toe of Dam 8 embankment

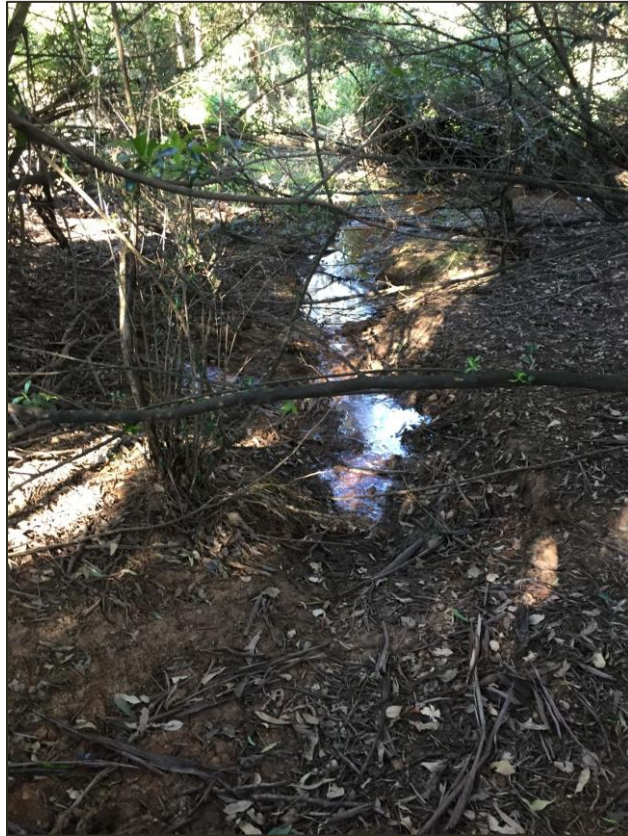
Stagnant water in creek beyond downstream toe

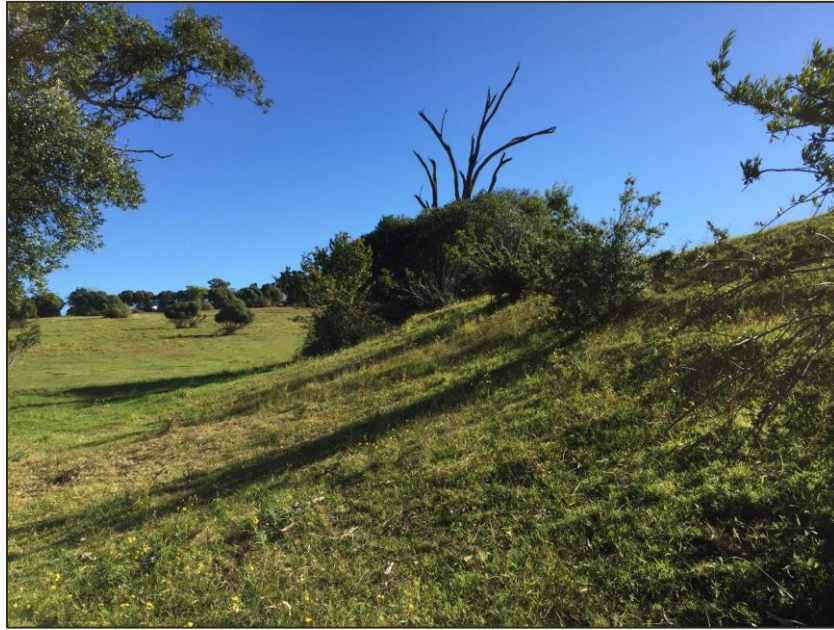
Downstream shoulder of Dam 9 embankment and dead large tree, looking west

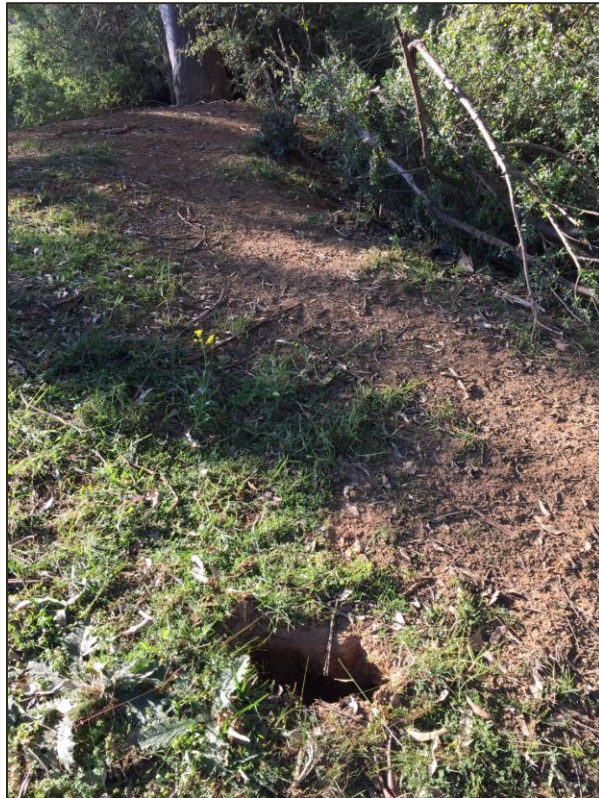
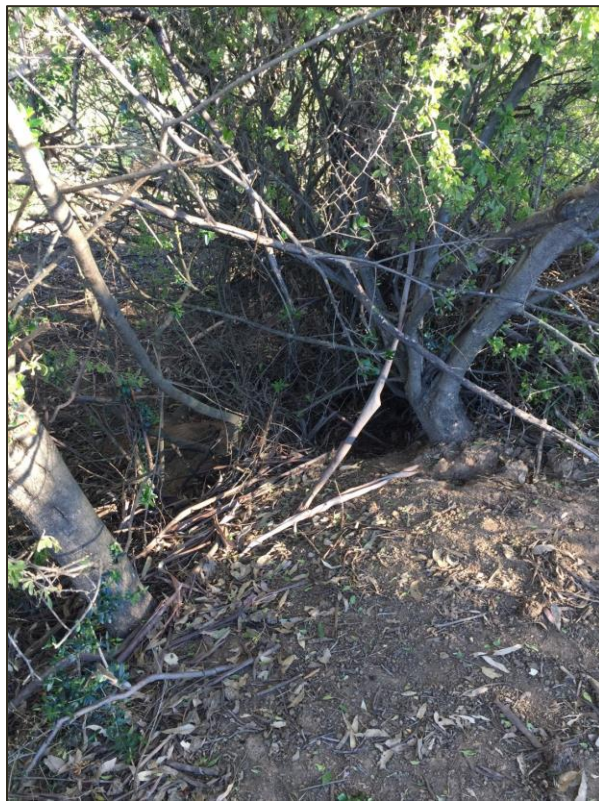
7. Numerous burrows were observed along the downstream shoulder, some of which appeared to be interconnected (refer to photographs below).

Burrows in downstream shoulder of Dam 10 embankment
