RECORD OF SITE INSPECTION

SITE INSPECTION NOTES		
Project:	Glendell Continued Operations Project (SSD-9349) and Mount Owen Continued Operations Mod 4 Project (SSD-5850-Mod-4)	
Meeting Location:	The Glendell and Mount Owen sites and surrounding areas	
Date:	Friday, 25 March 2022	
Time:	9.00am – 1.30pm	
ATTENDEES		
Commissioners:	Dianne Leeson Professor Snow Barlow Adrian Pilton	Chair
Office of the IPC:	Casey Joshua Jane Anderson	Principal Case Manager Senior Planning Officer
Applicant:	Jason Desmond Brad Snedden Xavier Wagner Mike Carrucan Andrew Roxburgh Tim Walls Barbara Crossley Bridie McWhirter Ian Stapleton	Environment & Community Manager, Mount Owen Complex Approvals Manager, Glendell Continued Operations Project Regional General Manager, Glencore Director of Projects and Technical Support, Glencore General Manager, Business Development and Technical Services, Glencore NSW Approval Manager, Glencore Managing Director, Umwelt Senior Environmental Consultant, Umwelt Heritage Architect, Lucas Stapleton Johnson (part of visit)

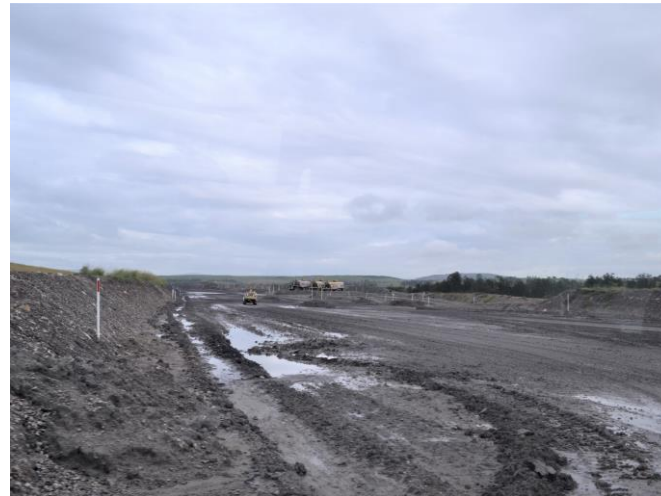
View of a cleared area and parked mining vehicles to the south of Swamp Creek, near the Glendell Mine Infrastructure Area. View looking west.

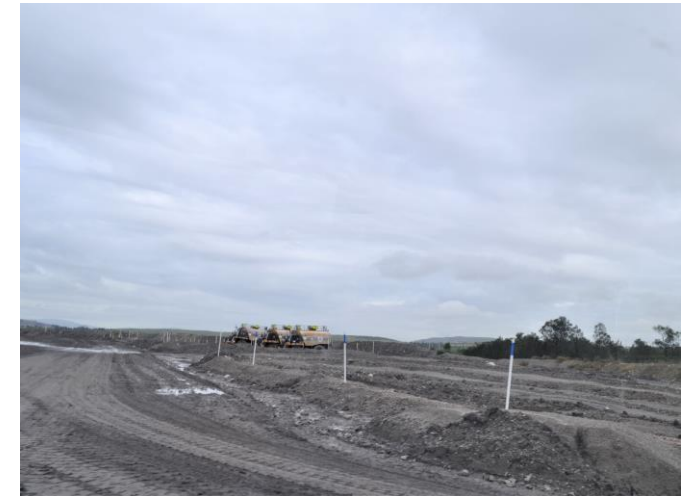
View of a cleared area and parked mining vehicles to the south of Swamp Creek, near the Glendell Mine Infrastructure Area. View looking west.

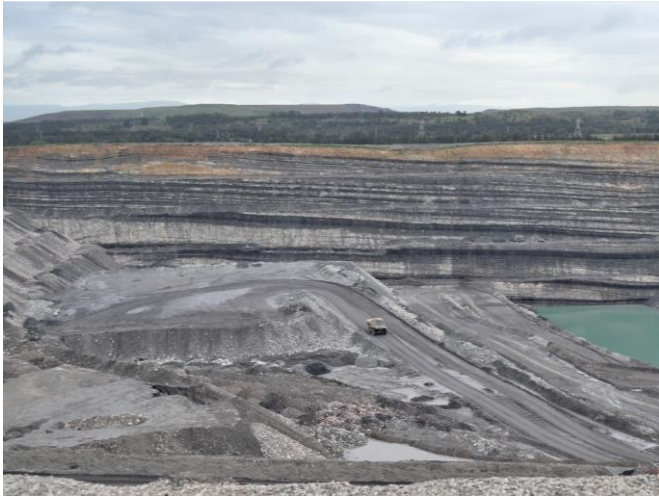
Location 2 **Glendell Pit**

View of the existing Glendell Pit looking south-west.

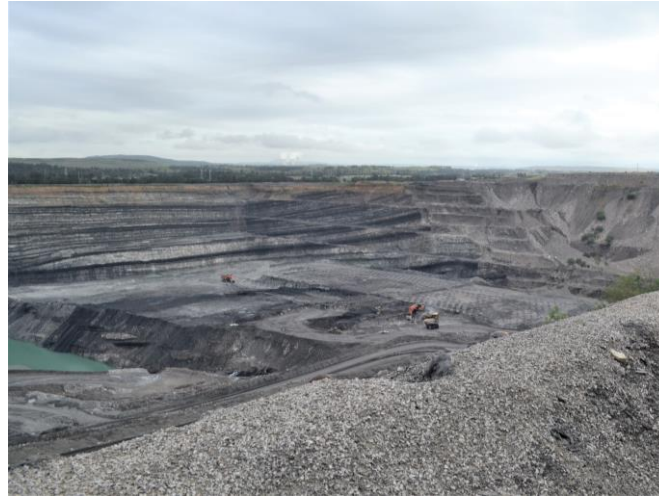
View of the existing Glendell Pit looking north-west.

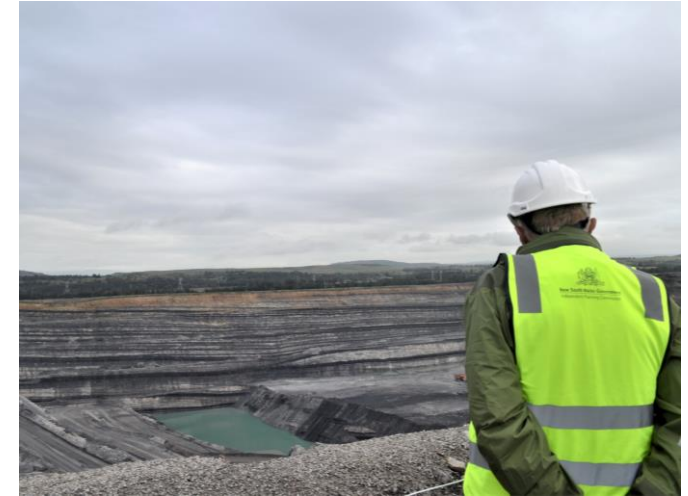
View of the existing Glendell Pit looking west.

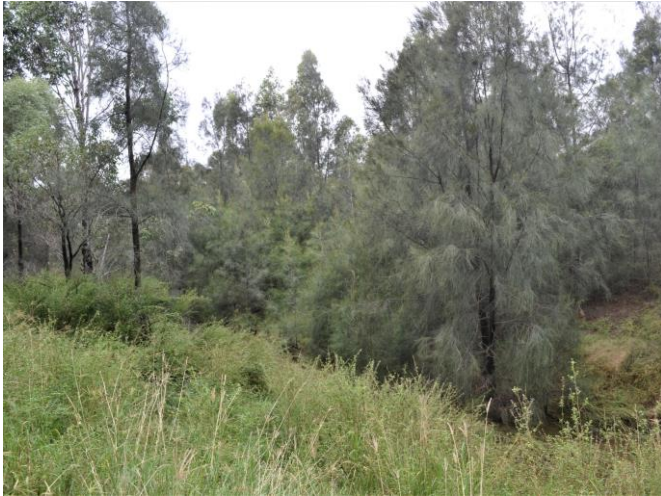
View of the existing Swamp Creek diversion looking south-east.

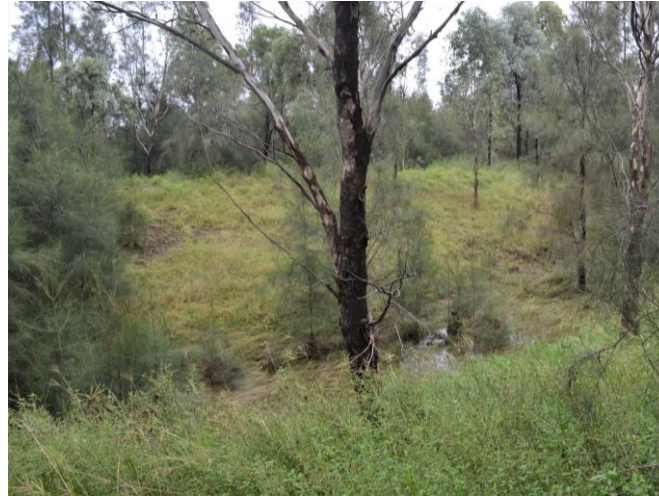
View of the existing Swamp Creek diversion looking south-west.

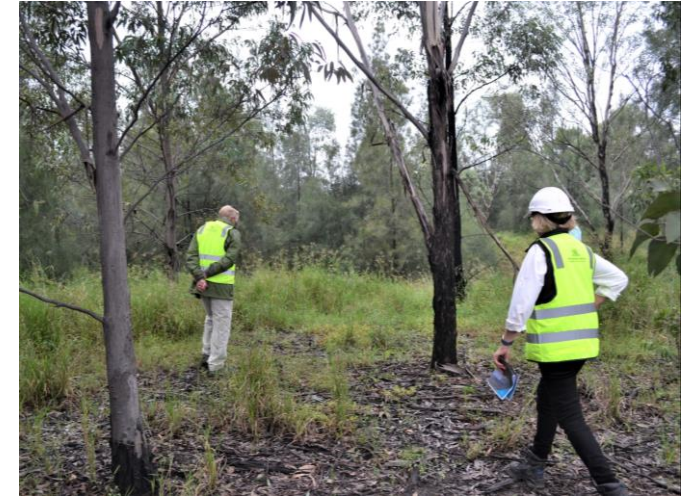
View of the vegetation surrounding the existing Swamp Creek diversion.

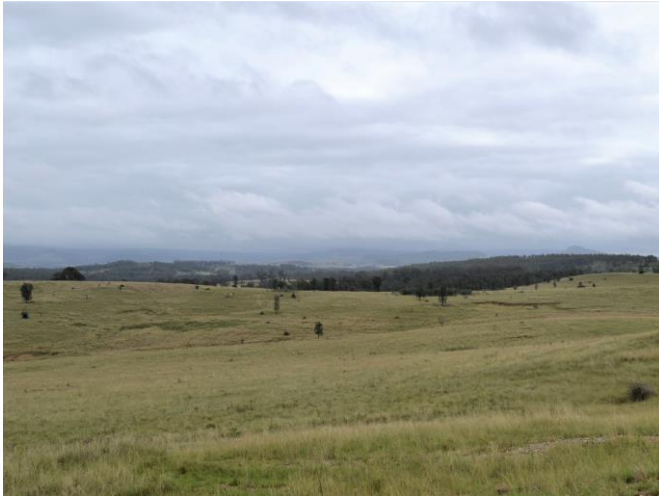
View looking north across the proposed pit extension area (with Ravensworth Homestead beyond the visible hills).

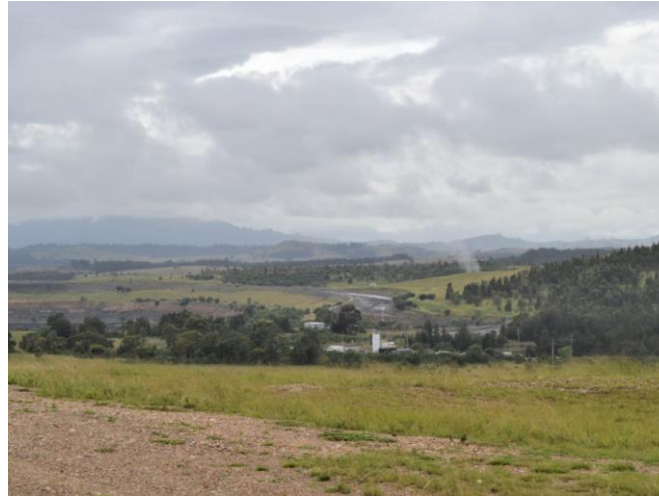
View looking east towards the Ravensworth East Emplacement Area and West Pit.

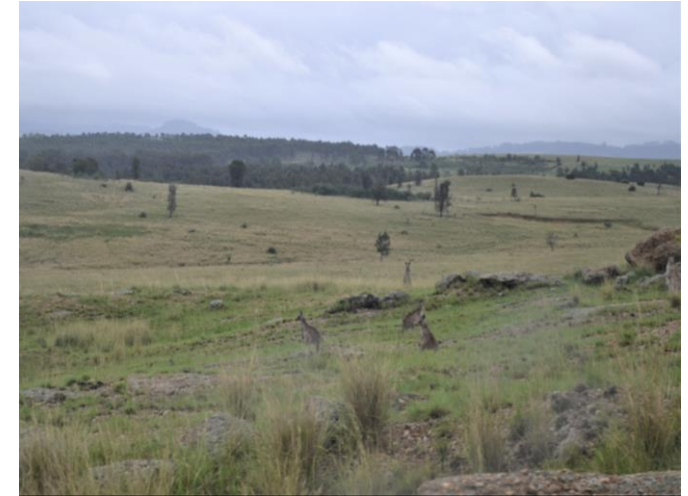
View looking north-east across the proposed pit extension area.

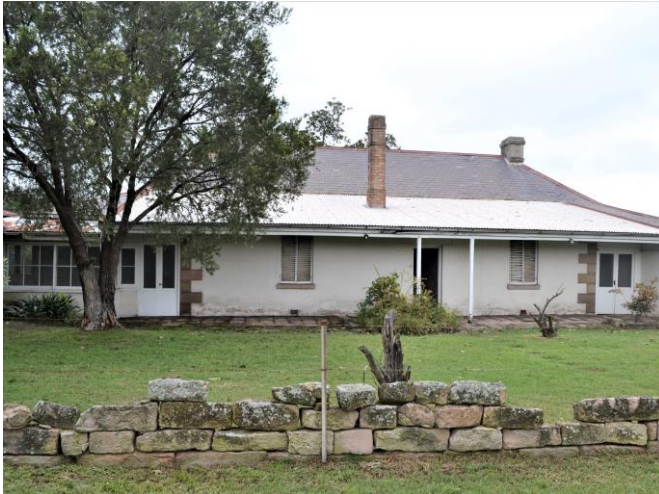
View of the main house building (rear) from within the Ravensworth Homestead farmyard square. View looking south.

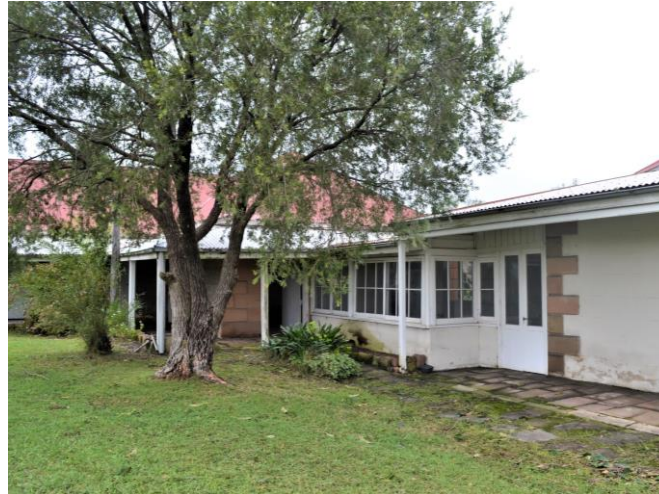
View of the main house building (rear) and later additions from within the Ravensworth Homestead farmyard square. View looking south-east.

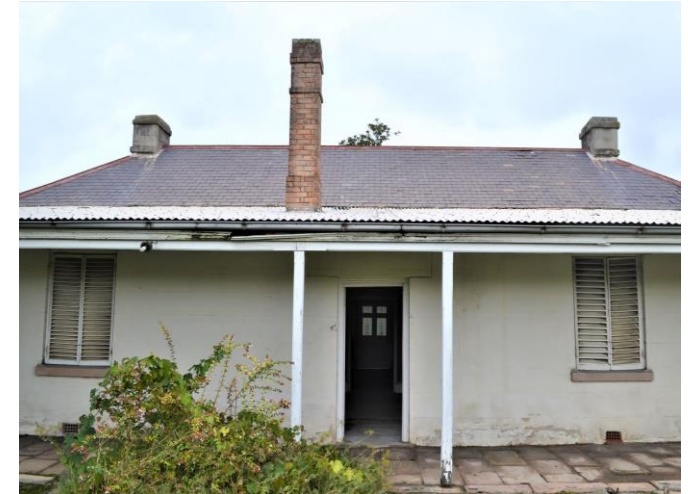
View of the main house building (rear) from within the Ravensworth Homestead farmyard square. View looking south.

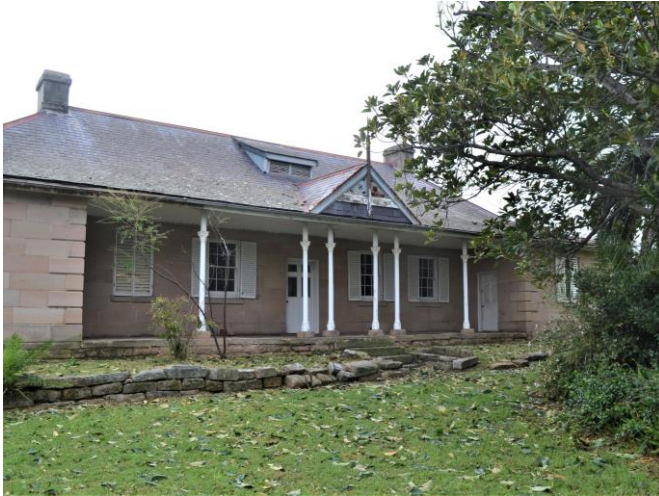
View of the main house building (front) looking north-east.

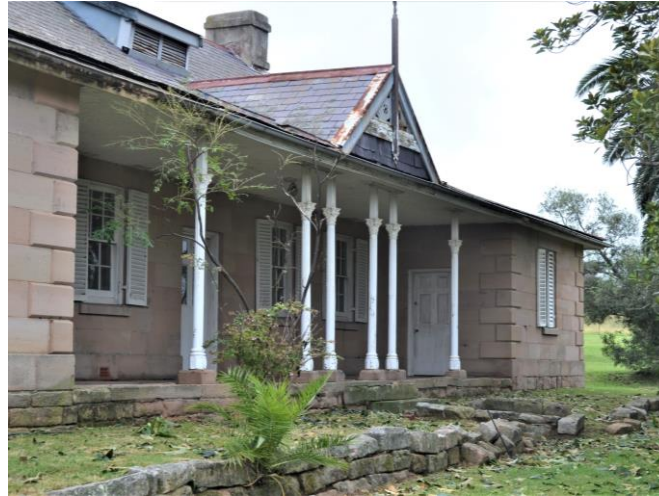
View of the main house building (front) looking north-east.

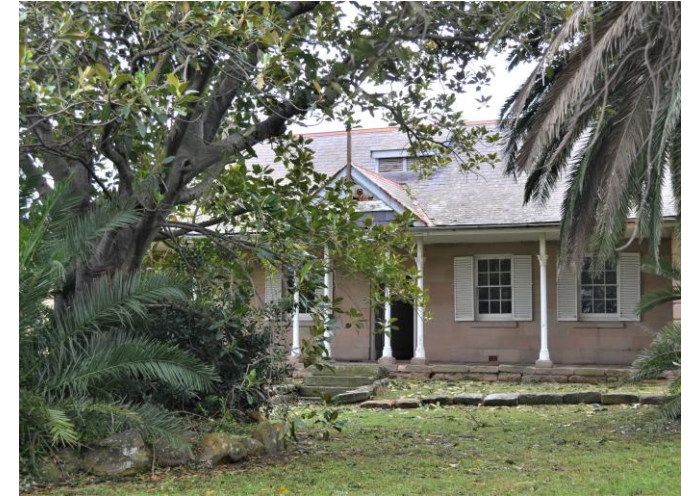
View of the main house building (front) and surrounding house gardens looking north.

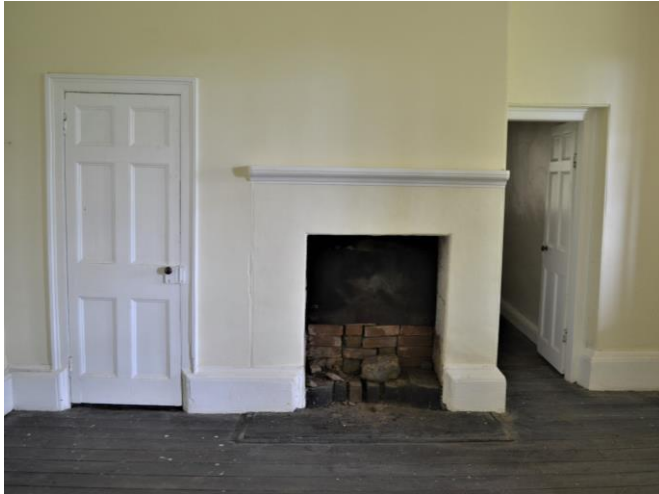
Interior view of the main house building.

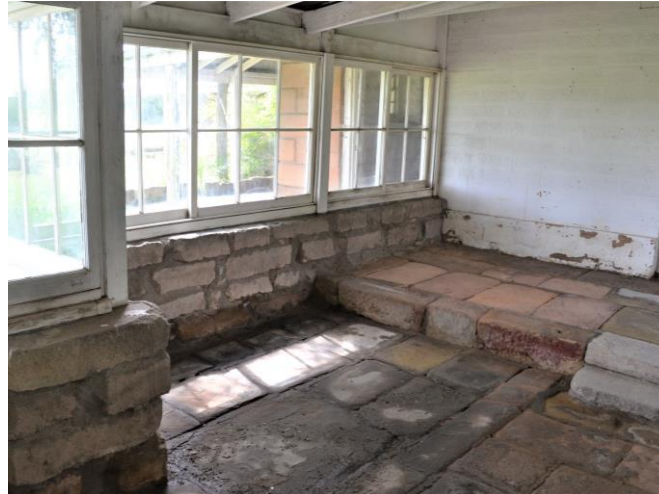
Interior view of the main house building.

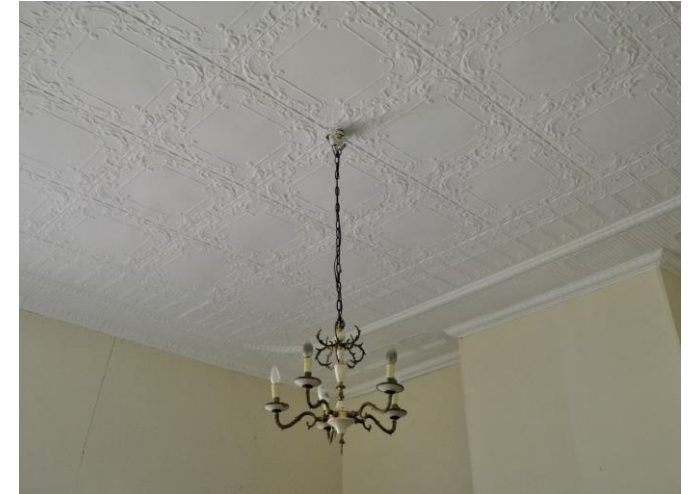
Interior view of the main house building.

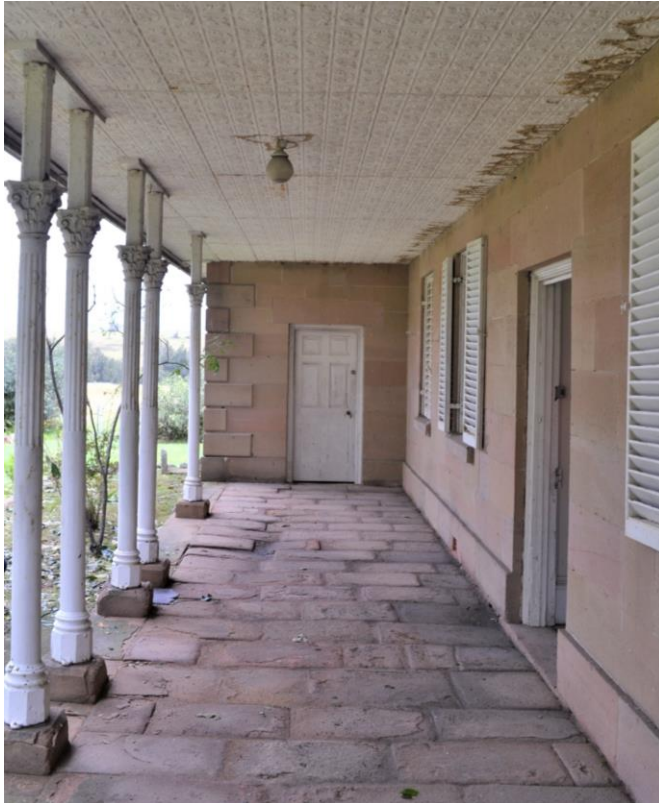
View along the front verandah of the main house building.

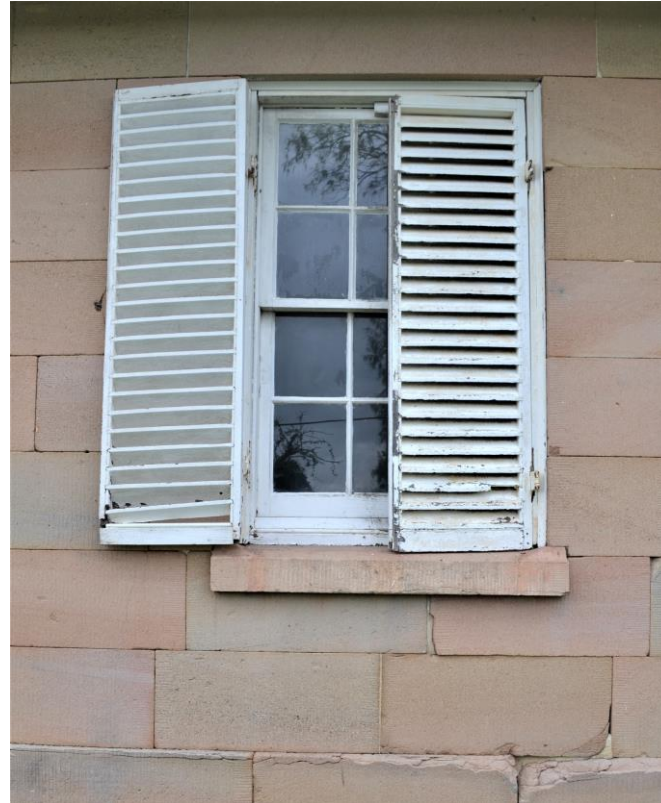
View of exterior window on the western elevation of the main house building.

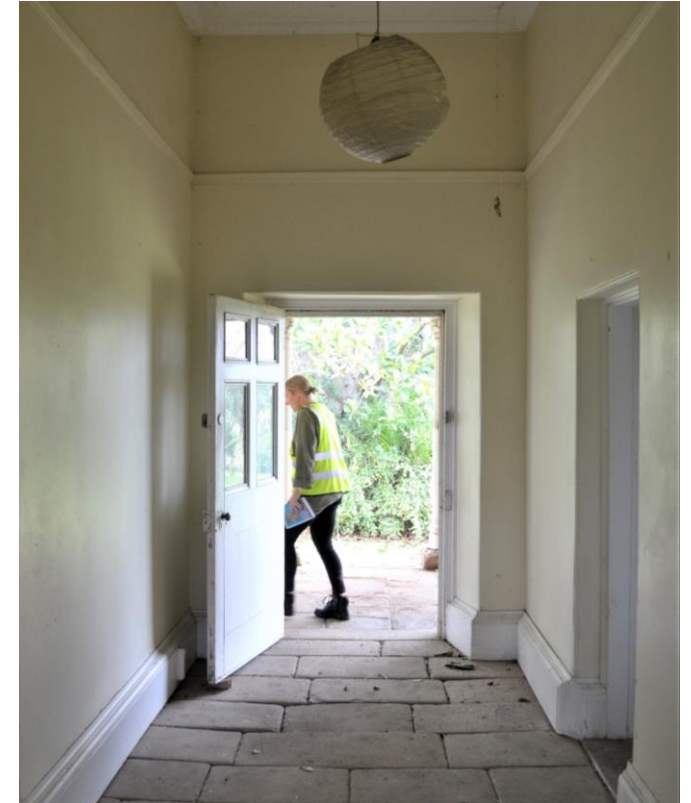
Interior view of the main house building looking south towards the house garden.

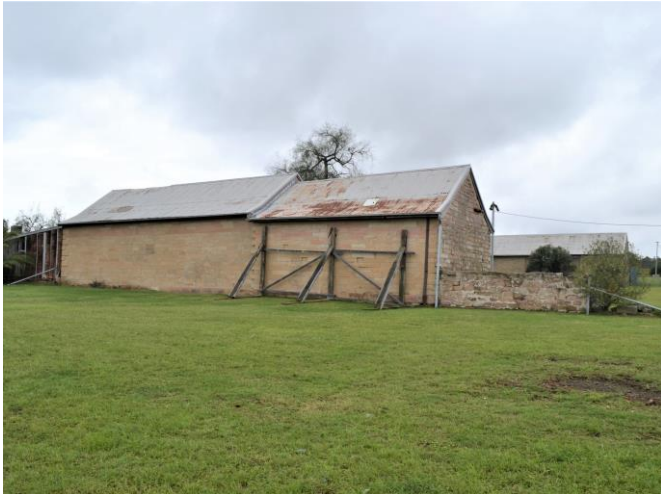
View of the stable building (rear) looking east with the farmyard square beyond.

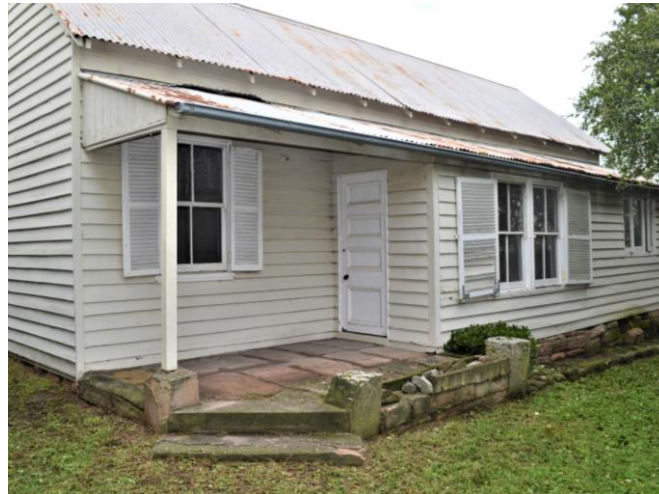
View of the men's quarters cottage looking south-east.

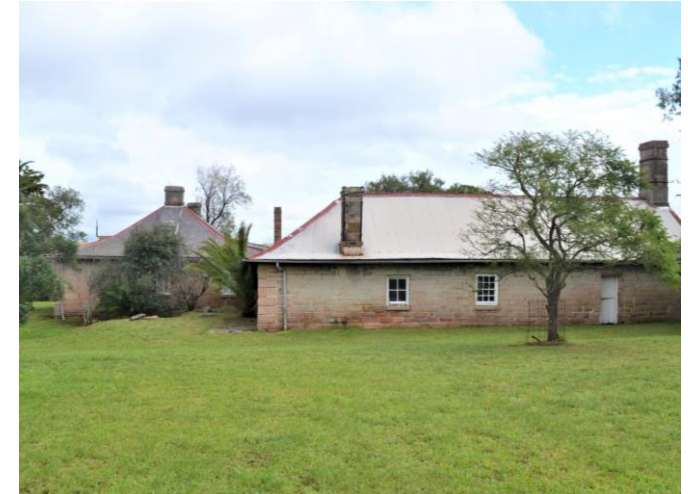
View of the main house building and kitchen wing looking west.

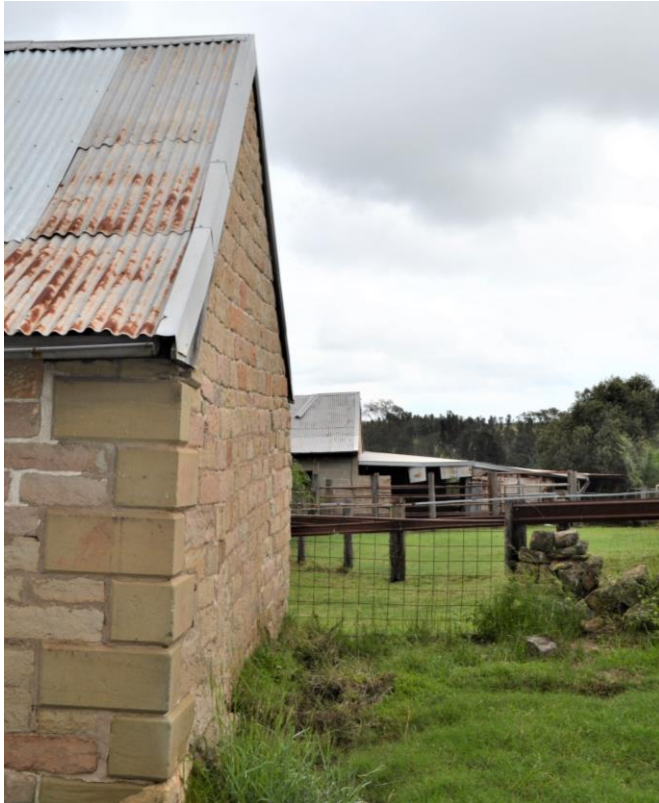
View of the out buildings and farm yards with the barn building (rear) in the foreground and stable building beyond. View looking west.

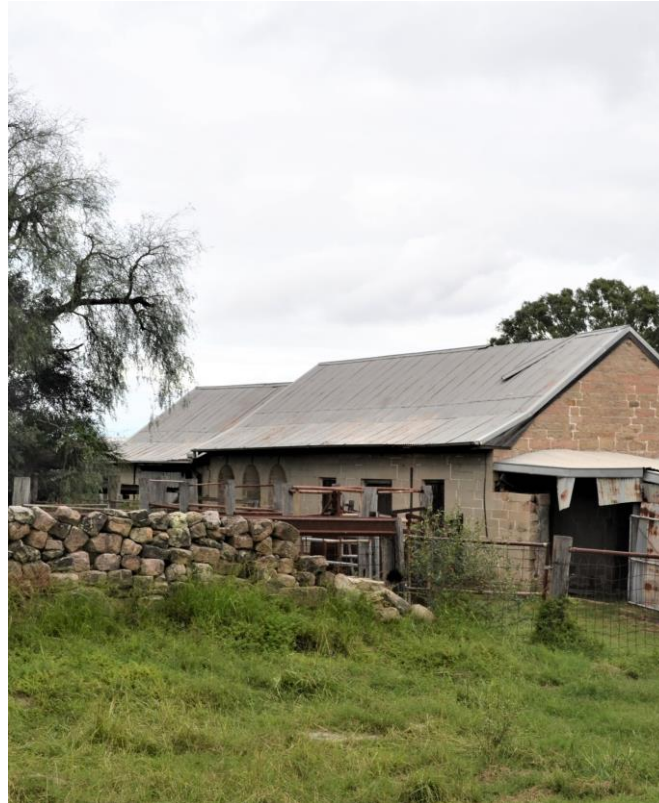
View looking south-west towards the farm yards and stable building.

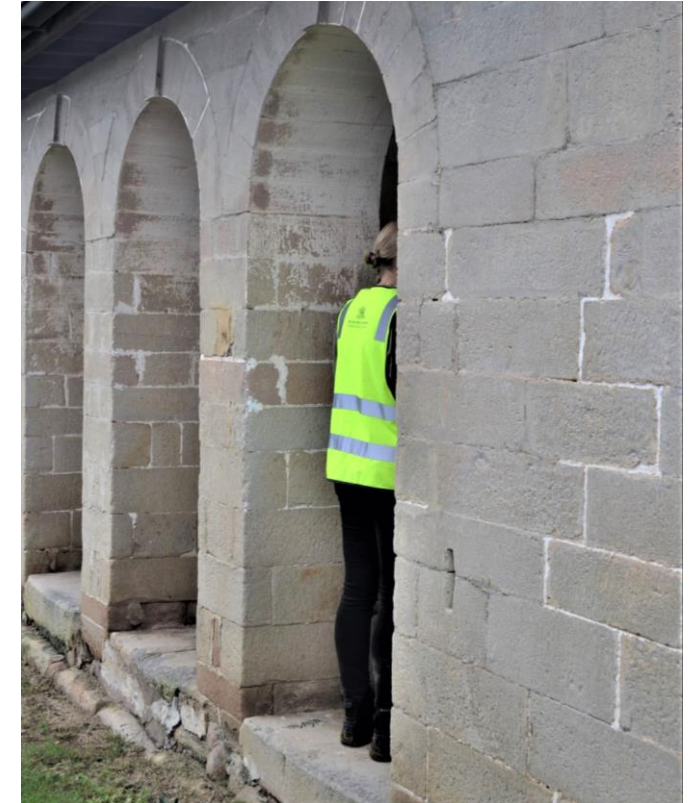
Exterior view of the stable building archway.

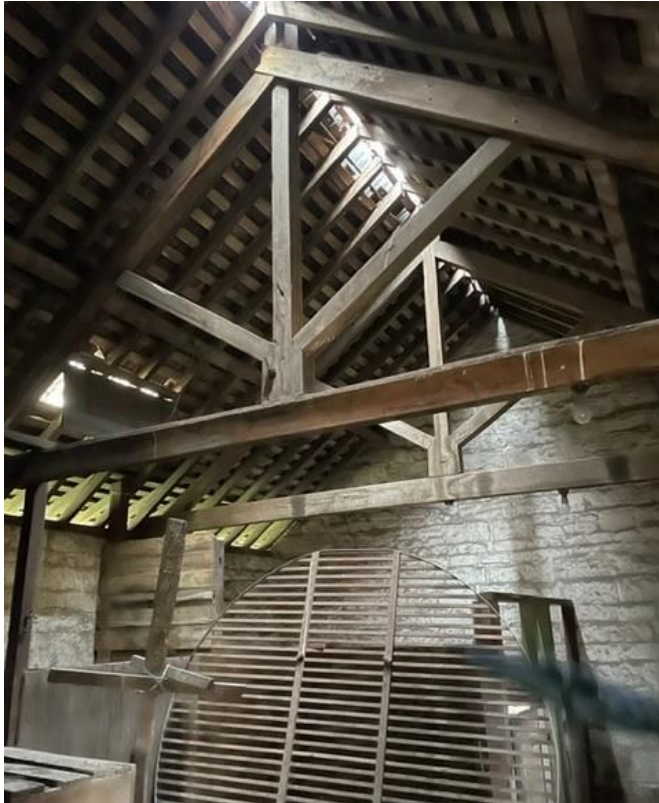
Interior view of the stable building rafters.

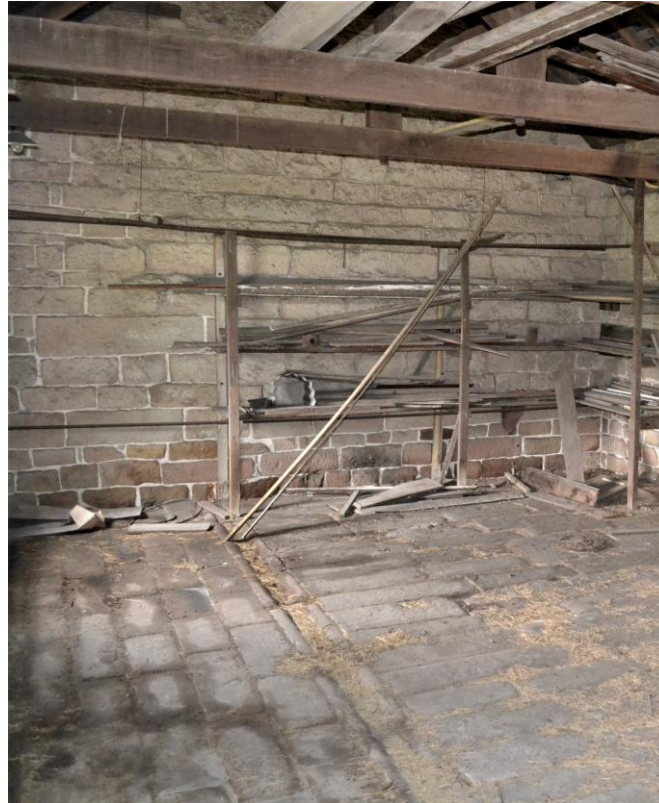
Interior view of the stable building floor.

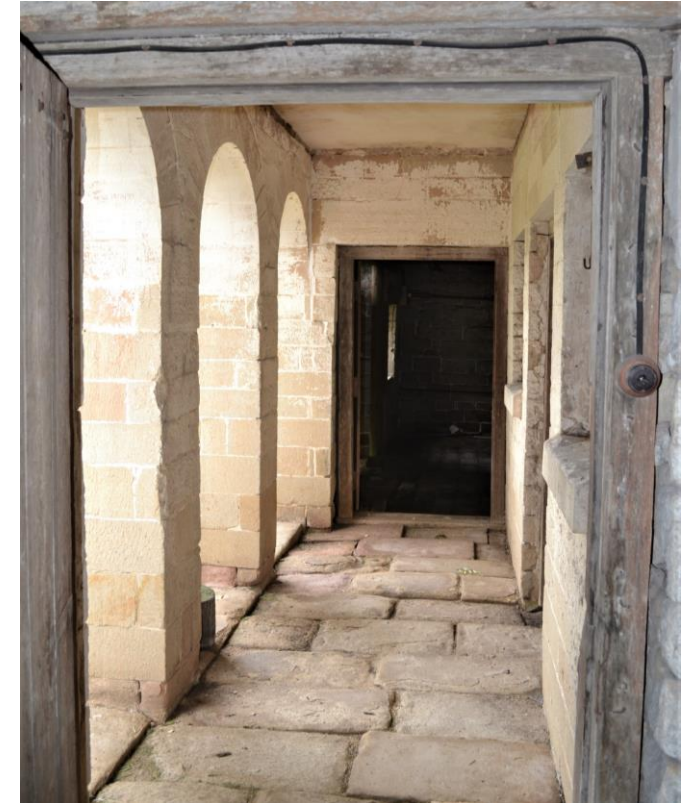
Interior view of the stable building archway.

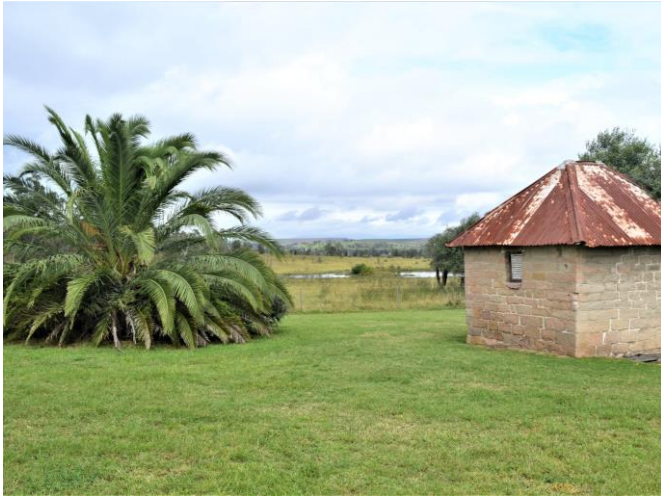
View looking south to the privy (rear) and house dam beyond.

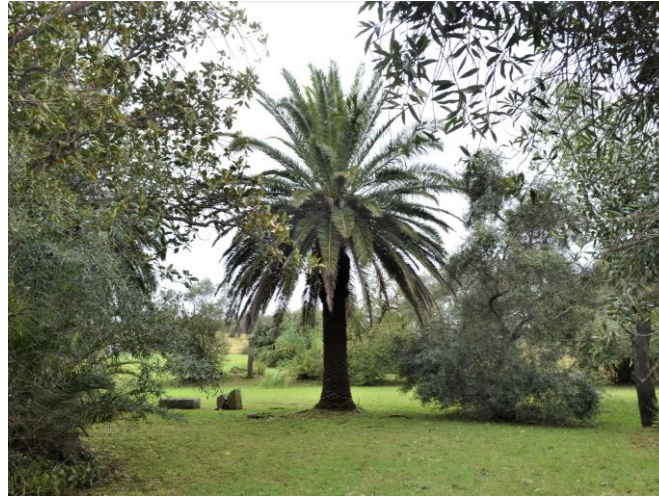
View of the house garden to the south of the main house building. View looking east.

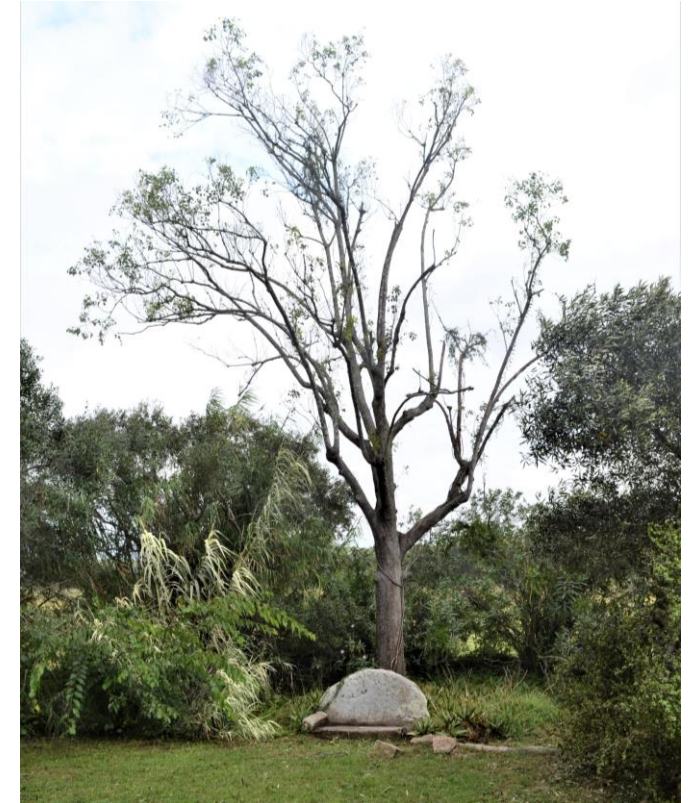
View of the house garden to the south of the main house building. View looking west.

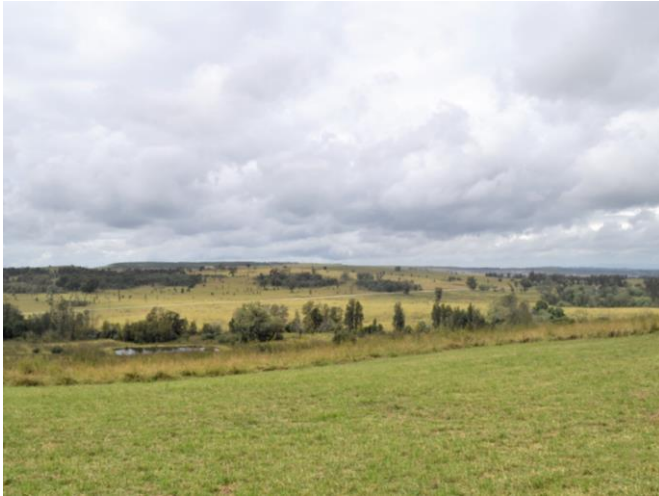
View looking west towards Bowmans Creek.

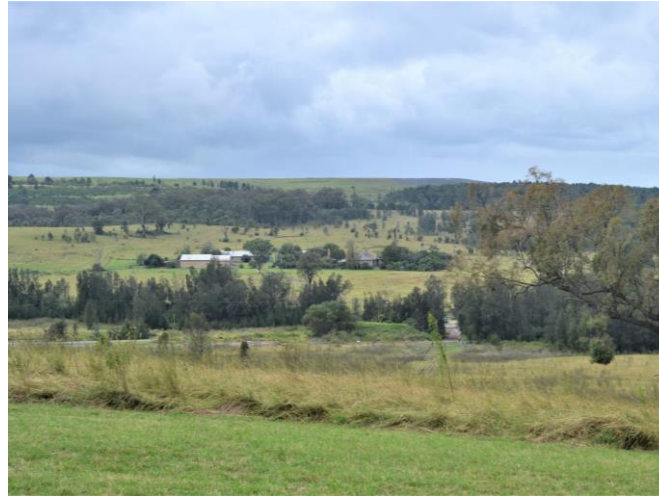
View looking east across the proposed pit extension area with Yorks Creek and Hebden Road in the foreground and the Ravensworth Homestead Complex in the middle distance.

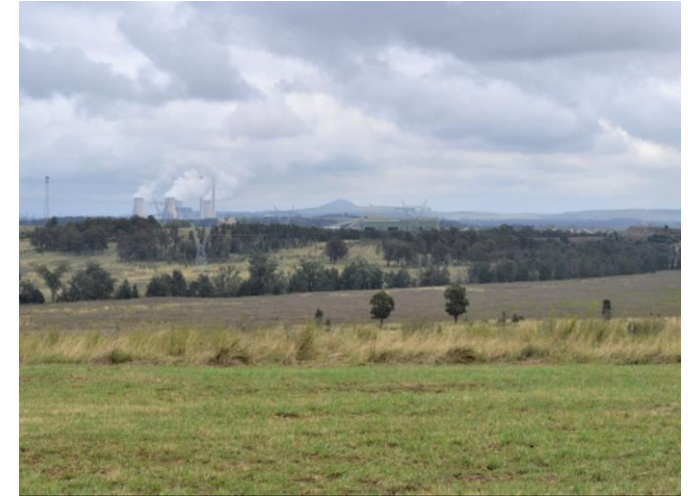
View looking north-west towards Liddell Power Station and Bayswater Power Station.

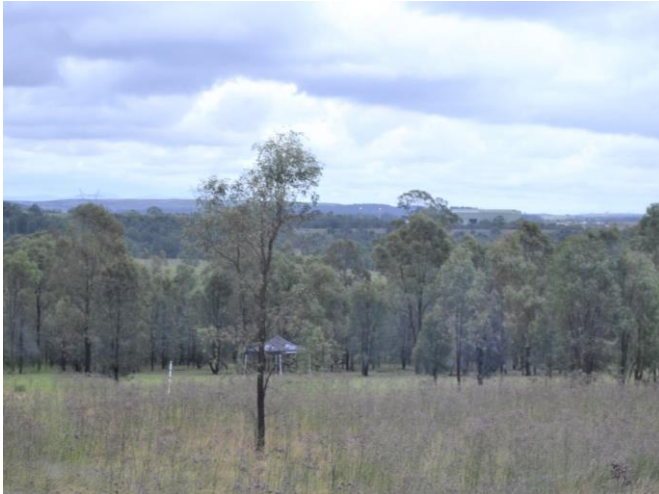
*View of the Ravensworth Farm site
(proposed Ravensworth Homestead
Complex relocation site option).*

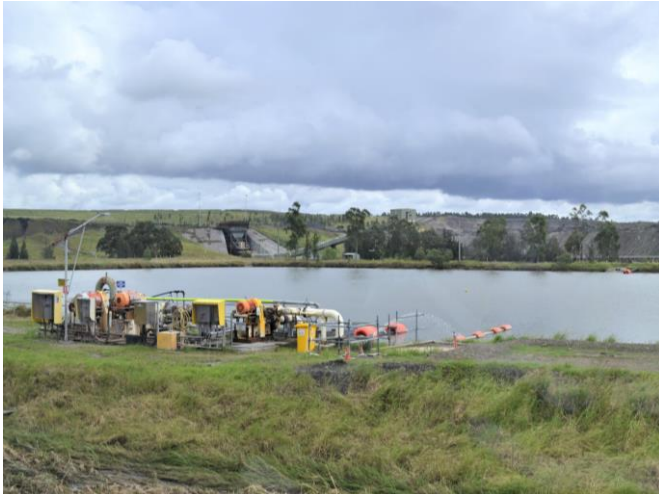
View looking west towards the Mount Owen water management area.

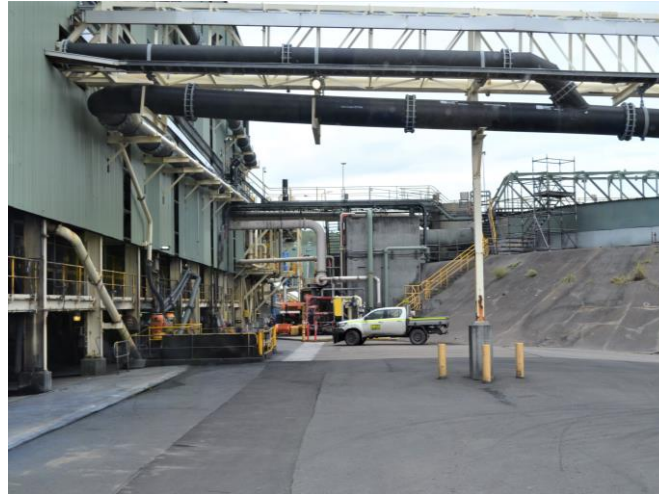
- Mount Owen water management area and the Mount Owen Coal Handling and Preparation Plant (CHPP).
- Noted the CHPP is 25 years old but capable of prolonged use with modest upgrades.

View of the Mount Owen Coal Handling and Preparation Plant.
