**CONTAMINATION MANAGEMENT AND
REMEDIATION ACTION PLAN**

PROPOSED MEMORIAL PARK

167-177 ST ANDREWS ROAD, VARROVILLE, NSW

REF: E30510KPrpt-RAP

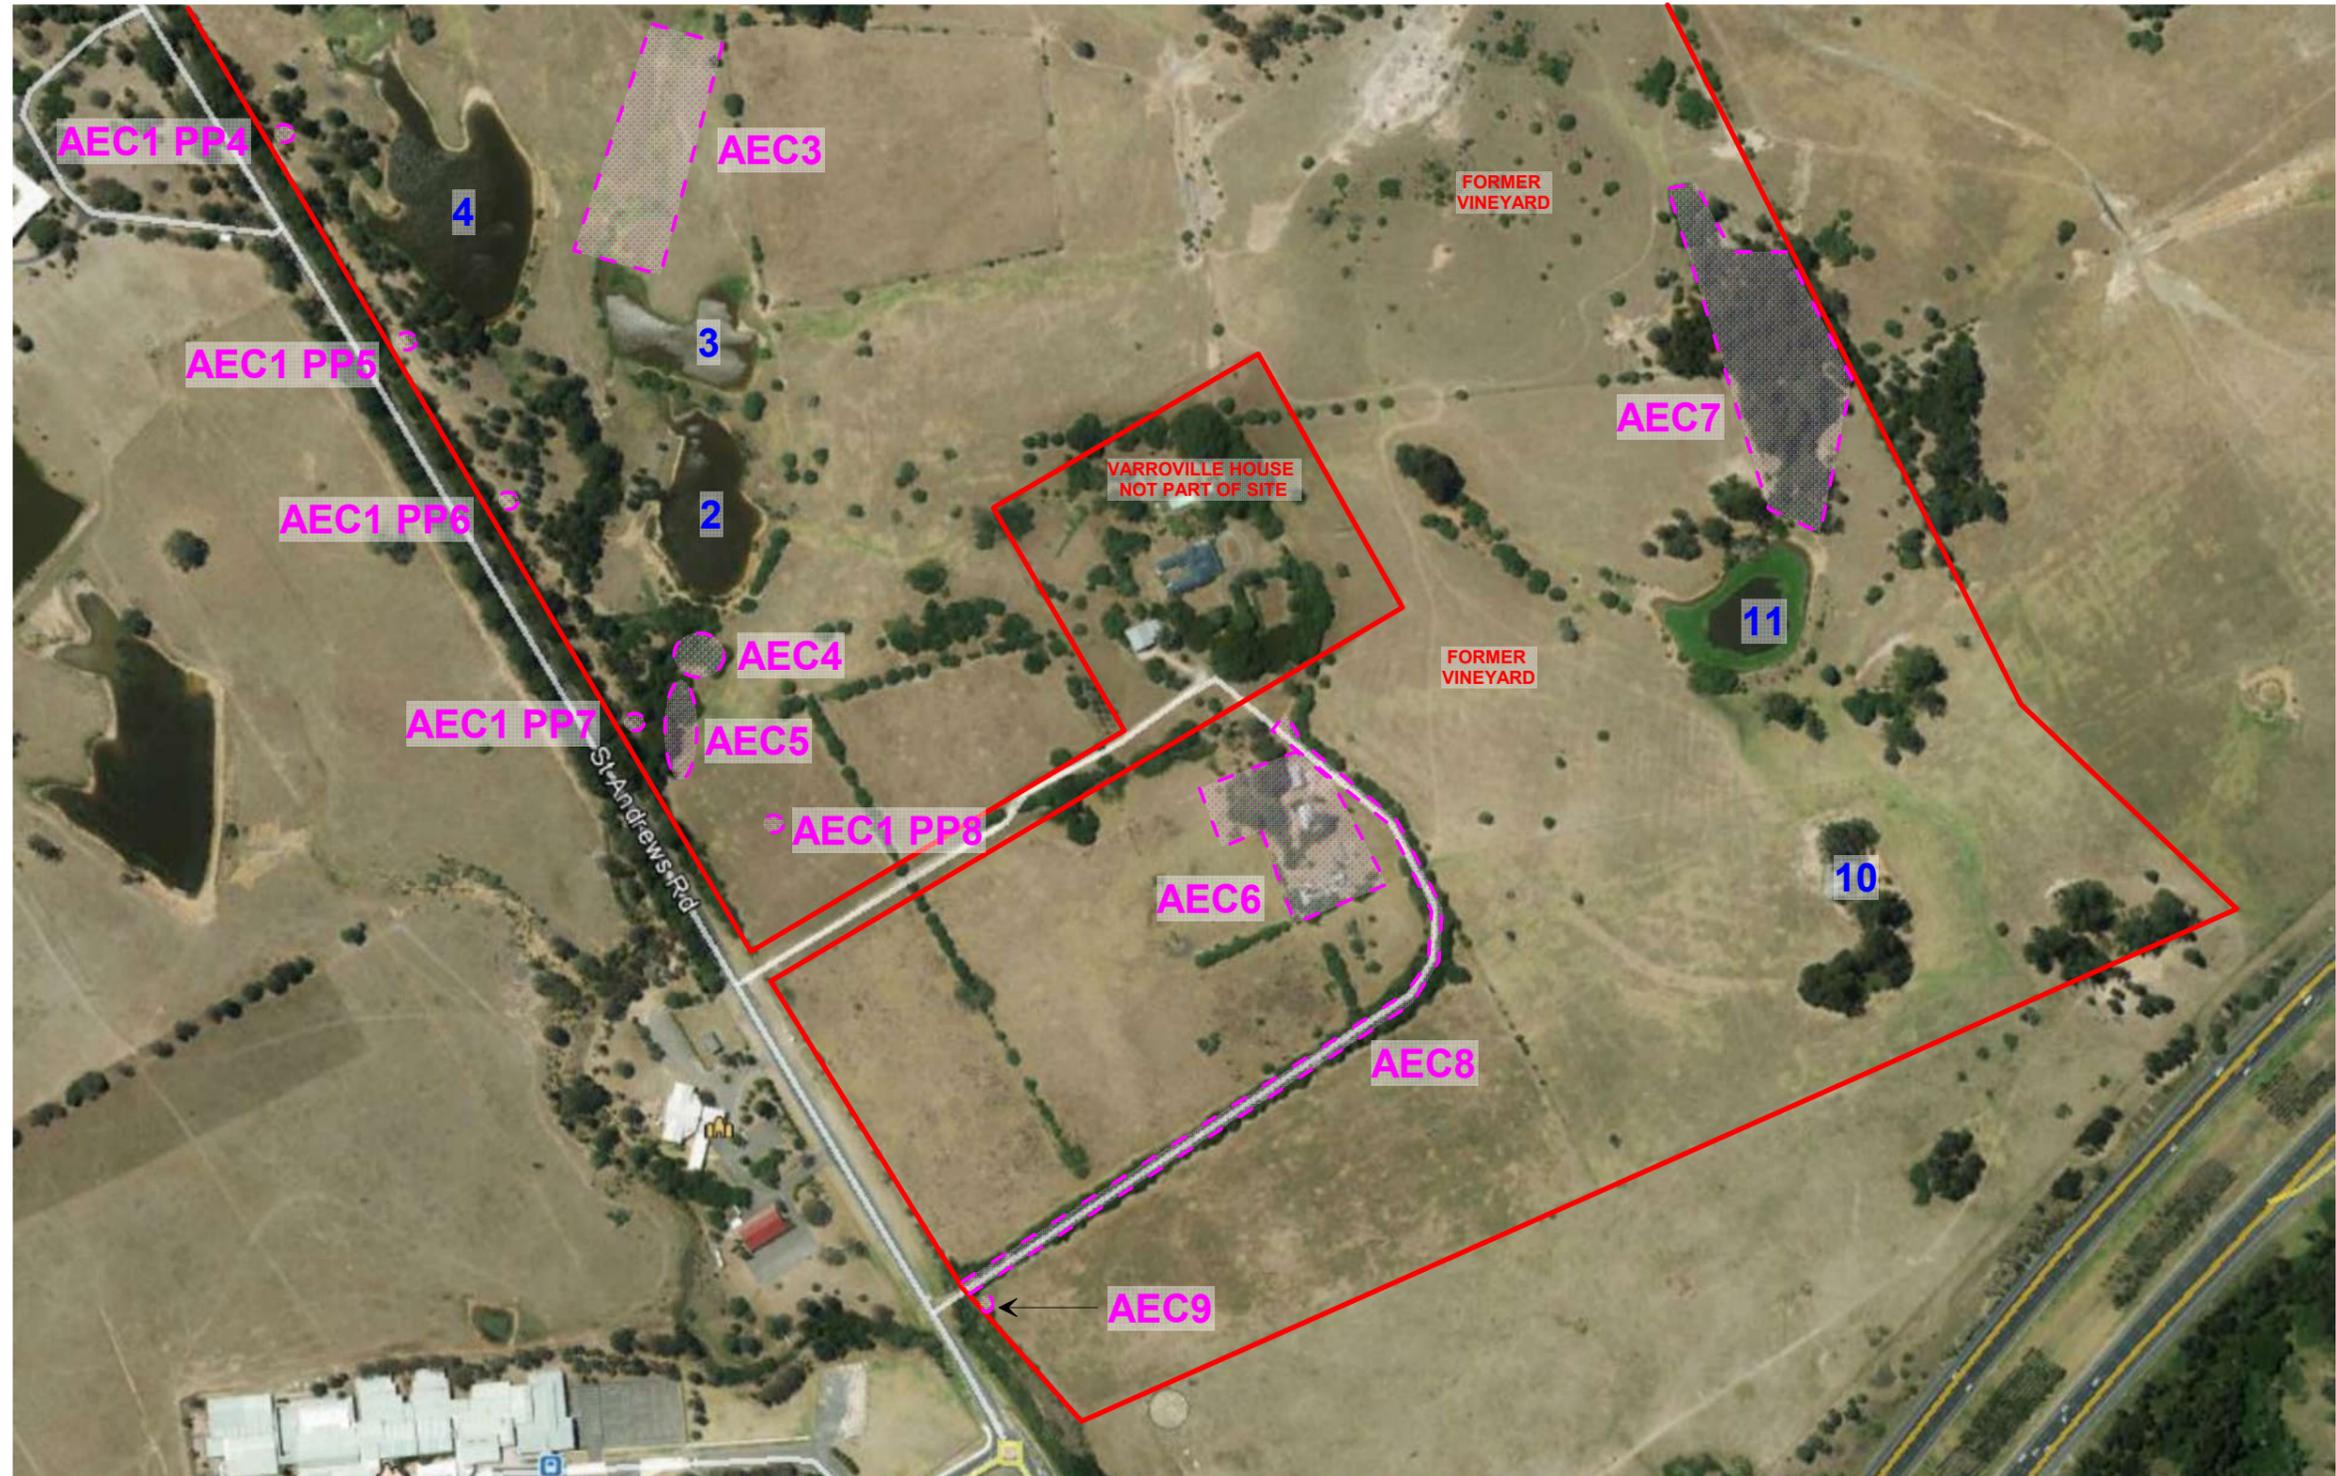
Relatively large quantities of waste were observed in the drainage lines to the north of Dam 3 (see AEC3, Figure 5), south of Dam 2 (see AEC4, Figure 5) and north of Dam 11 (see AEC7, Figure 5). The waste included the following:

A small stockpile (<15m³) of soil was observed in the south-western section of the site (see AEC9, Figure 5). The stockpile comprised clayey soil with inclusions of brick, concrete, metal and sandstone gravel/cobbles.
