Culcairn Solar Farm (SSD 10288)

Neoen Australia would like to provide further clarification to the questions received during the meeting with the Independent Planning Commission on 25 February 2021 as well as following the public meeting on 2 March 2021 in relation to the proposed Culcairn Solar Farm (SSD 10288).

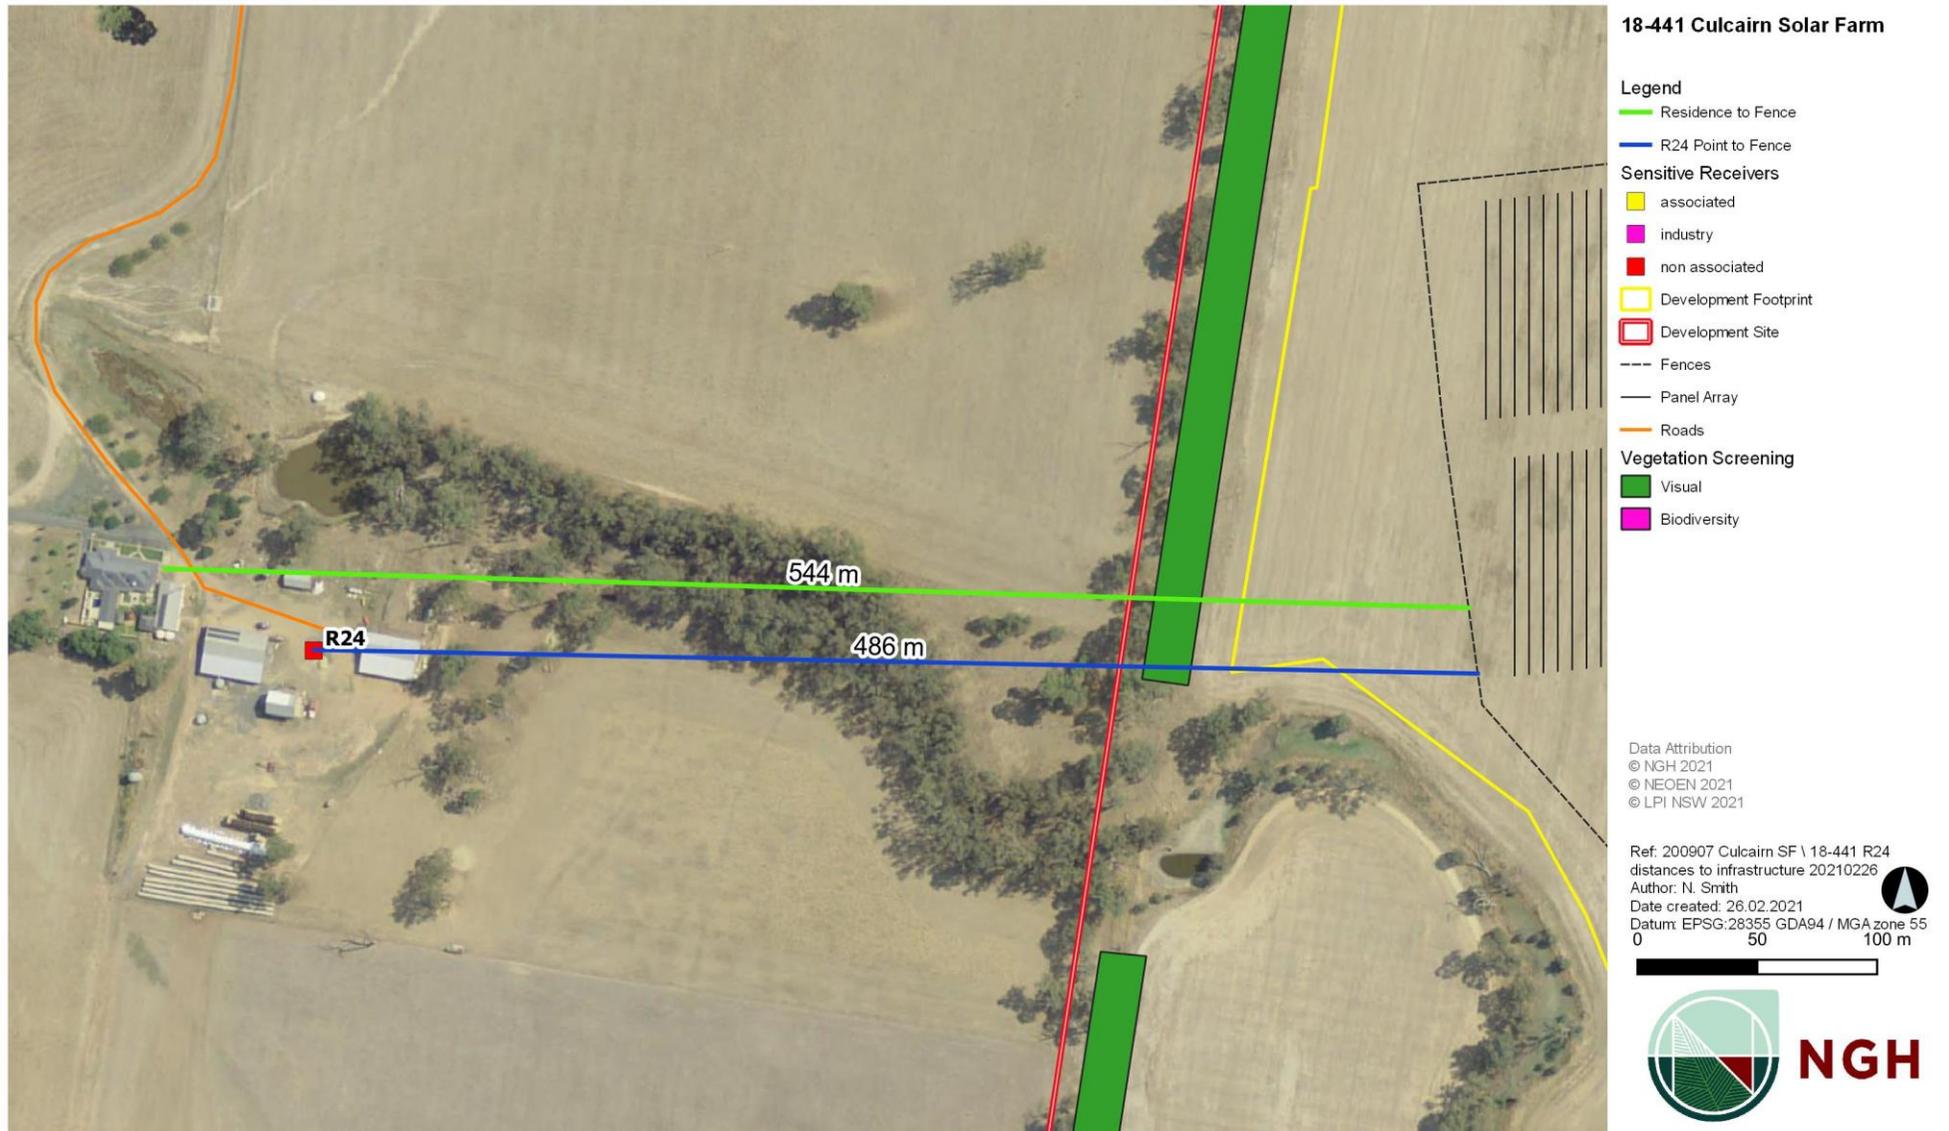
Figure 1 Distance of R24 to the Culcairn Solar Farm (eastern boundary)

The distance to the non-associated receiver R24 located on the western side of the proposed Culcairn Solar Farm is approximately 544 metres. This distance is measured between the residential dwelling of R24 and the proposed security fence within Culcairn Solar Farm's development footprint. The distance of 498 metres may have resulted from measuring the distance from the development footprint to the R24 icon on the map, which is located further away from the house amongst other buildings owned by this receiver. This is shown on Figure 1. The distance from the residential dwelling of R24 to the proposed security fence directly south is 1,155 metres. This is shown on Figure 2.

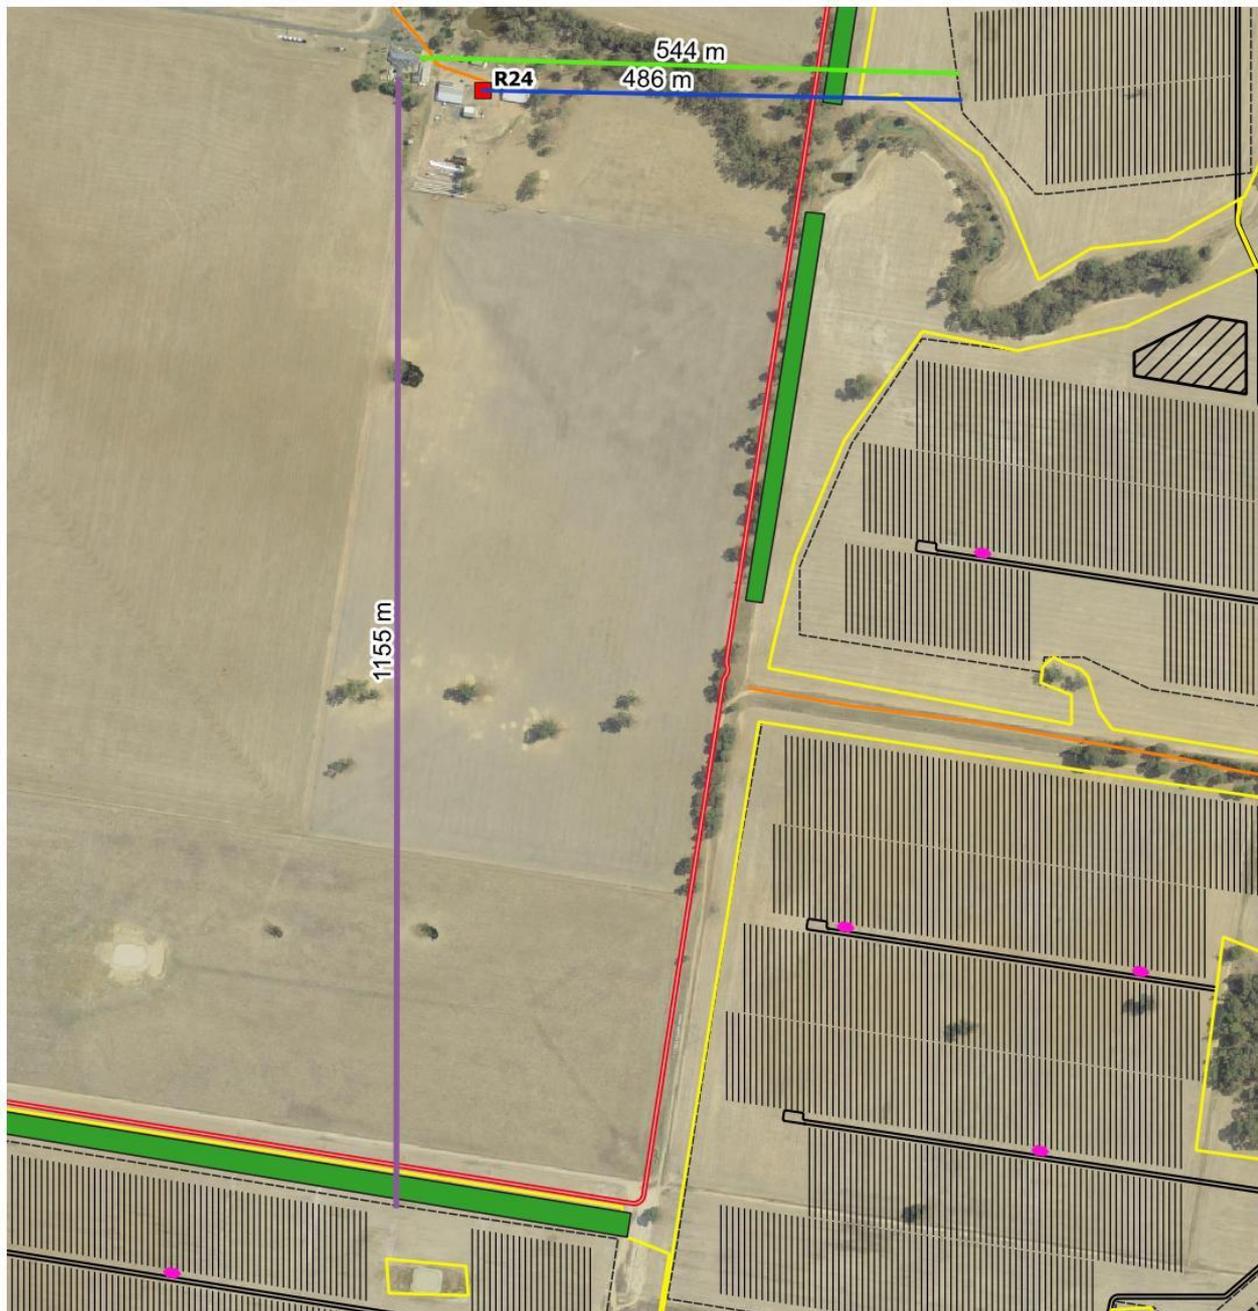
Figure 2 Distance of R24 to the Culcairn Solar Farm (eastern and southern boundaries)

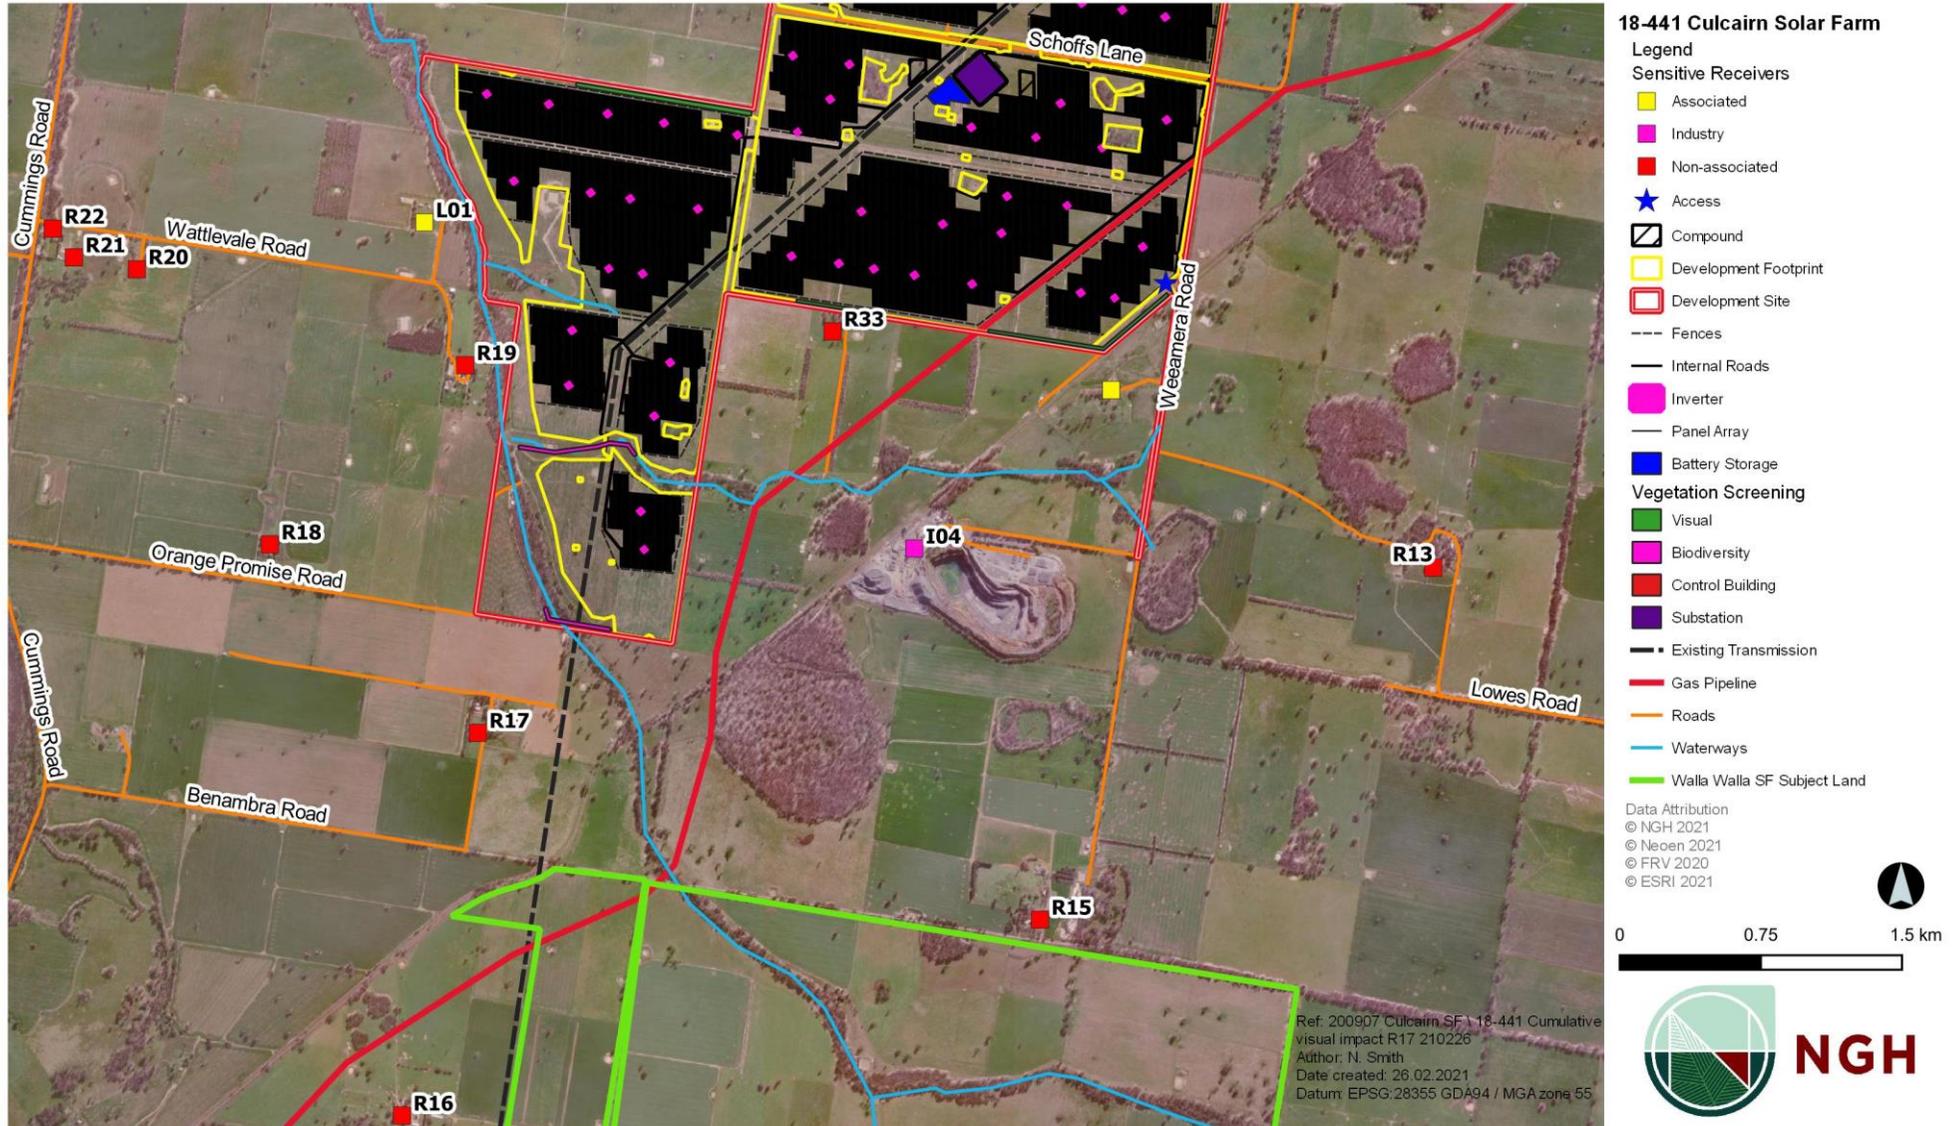
Figure 3 Location of receivers with respect to Culcairn Solar Farm and Walla Walla Solar Farm

The inherent visual impact at R17 is deemed to be low. The residence is around 800 metres from the project to the south-west. Broken views of project infrastructure would be noticeable through the riparian vegetation of Back Creek. R17 is located equidistant between the project and the approved Walla Walla Solar Farm. As a result of the distance to each project, existing vegetation and topography, views to either solar farm from R17 would be limited. Each solar farm would be low lying and maximum tip heights of the panels would be 4.2 metres.

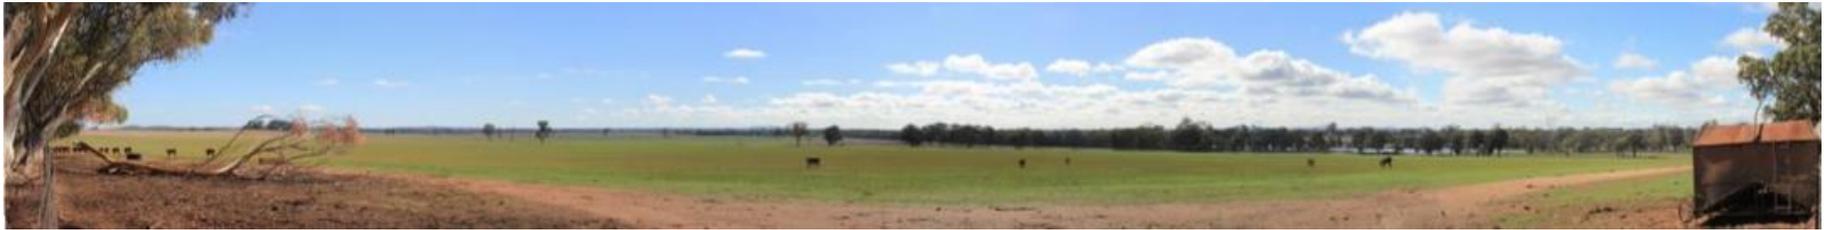
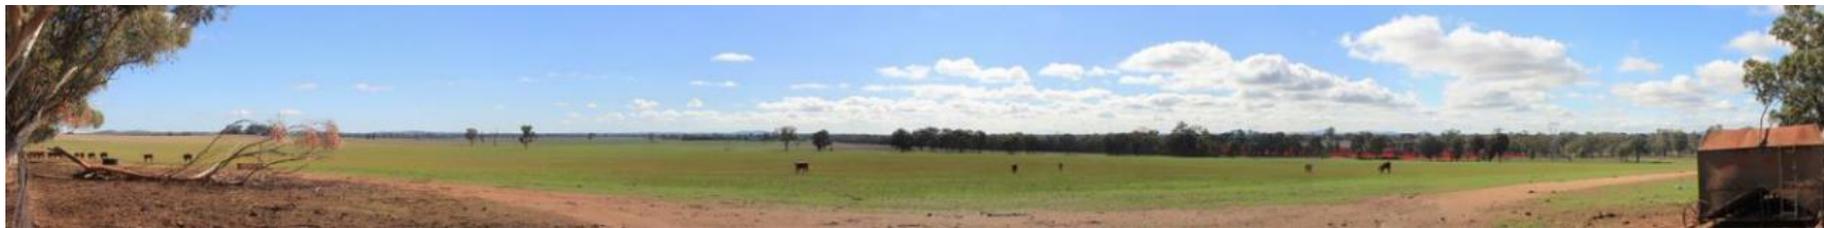
Figure 4 Photomontage from receiver R17 facing the proposed Culcairn Solar Farm

(a) Photomontage view of the proposed infrastructure

(b) Photomontage view of the proposed infrastructure with the proposed infrastructure coloured in red

Neoen has committed to mitigate these broken views with supplementary plantings along the Back Creek riparian corridor. These plantings would enhance the visual screening of solar infrastructure of the project. Additionally, these supplementary plantings would increase habitat connectivity and mitigate the loss of paddock trees. Figure 3 shows R17 in relation to the two solar farm projects and also the supplementary plantings in the Back Creek riparian corridor. Figure 4 shows a photomontage view from R17 towards the proposed Culcairn Solar Farm.
