REPORT TO
HAMMONDCARE

ON
ADDITIONAL GEOTECHNICAL INVESTIGATION

FOR
PROPOSED HOSPITAL REDEVELOPMENT

AT
97-115 RIVER ROAD, GREENWICH, NSW

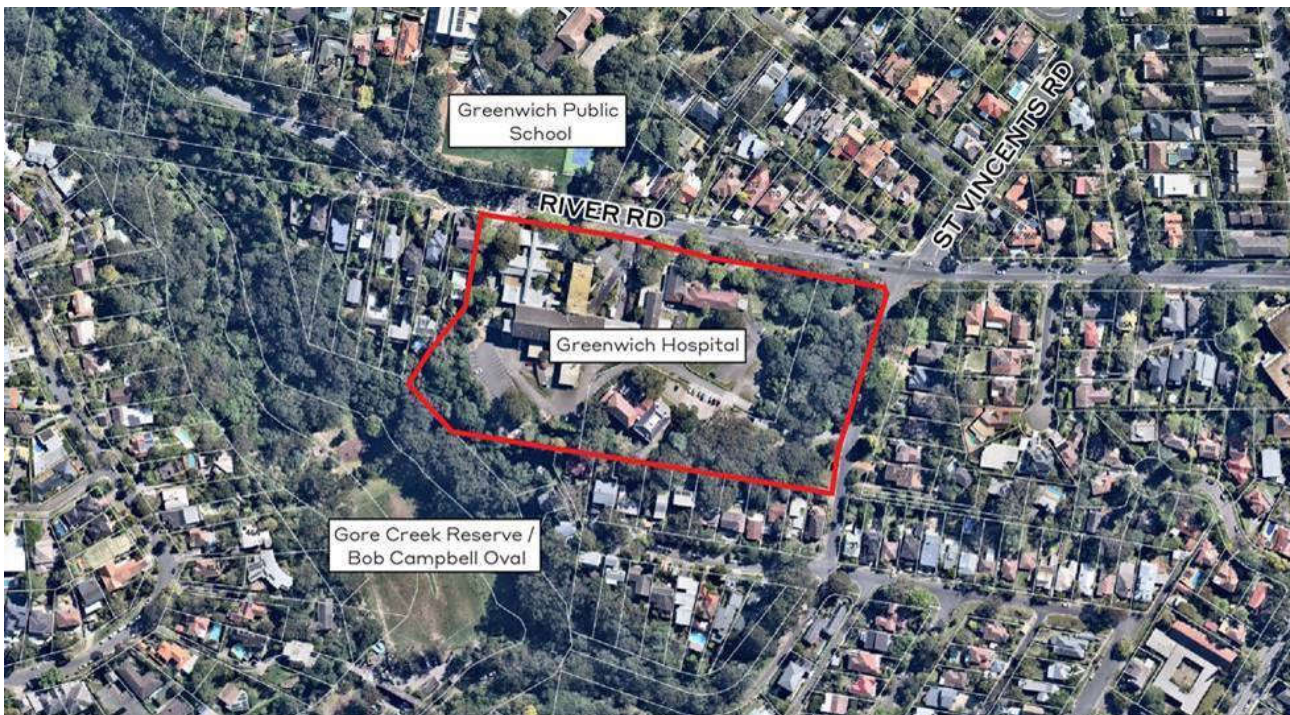
The Site

This Additional Geotechnical Investigation Report is submitted to the Department of Planning, Industry and Environment (DPIE) in support of a State Significant Development Application (SSD-13619238) for the redevelopment of Greenwich Hospital into an integrated hospital and seniors living facility on land identified as 97-115 River Road, Greenwich (the site). The extent of the site is shown below.
