Subject: Muswellbrook Solar Farm – Supplementary Information

# **Preliminary Site Investigation**

Muswellbrook Solar Farm Site Muscle Creek Road, Muswellbrook NSW

7 May 2025

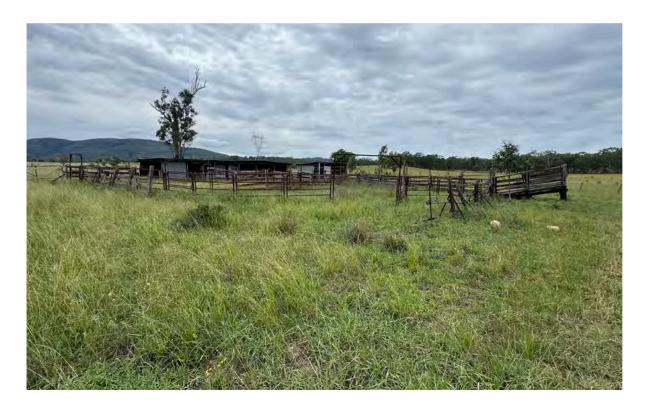
- Some apparent oil staining was observed on the lower sections of the loading ramp of the cattle yards on the eastern side of the SPA.
- While the chemical constituents of the staining compound are not known, the relative extent of impact caused by what may have been a termite control practice is unlikely to be widespread, and most likely contained within the ramp structure itself.

Photo 12: Cattle loading ramp at (TL8). Note possible wood treatment product staining.

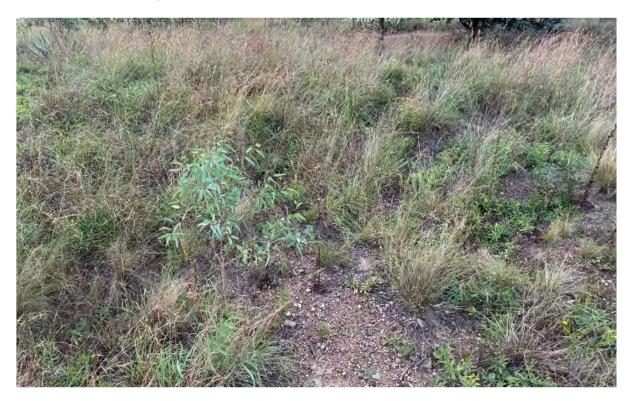
Photo 17: Corrugate cement sheeting piece at former house (TL11), presumed to be ACM.

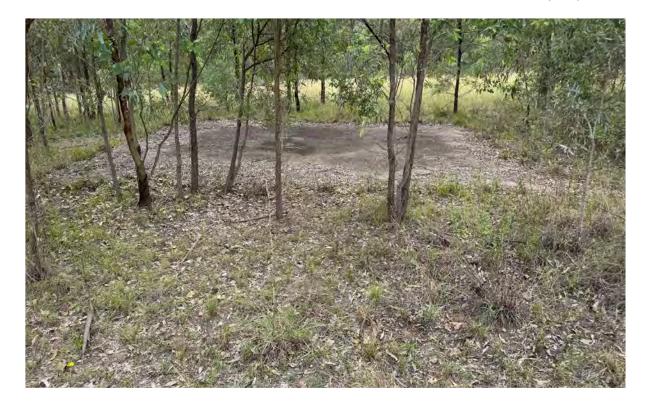
**Photo 25:** Location of former house on western side of the NPA (TL20), looking south. Some probable ACM sheeting pieces noted in this area

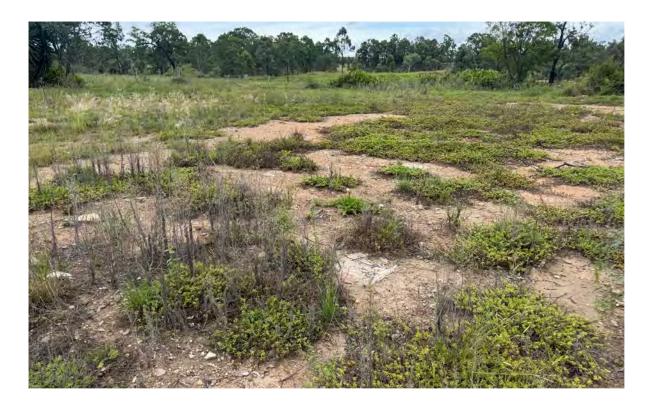
Photo 26: Former domestic waste dump on western end of the NPA (TL21), looking north.

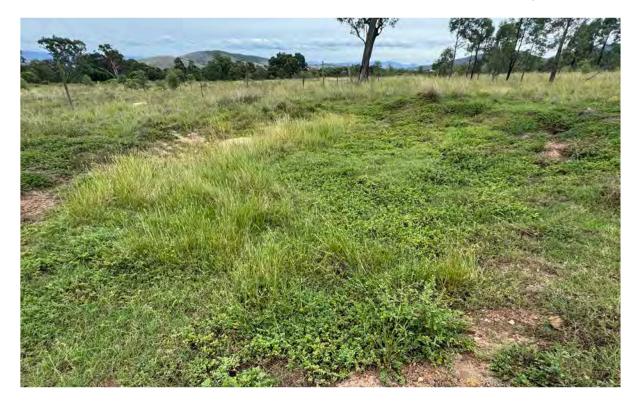
**Photo 27:** Former structures area near western end of the NPA (TL22), looking west. Some probable ACM sheeting pieces noted in this area.

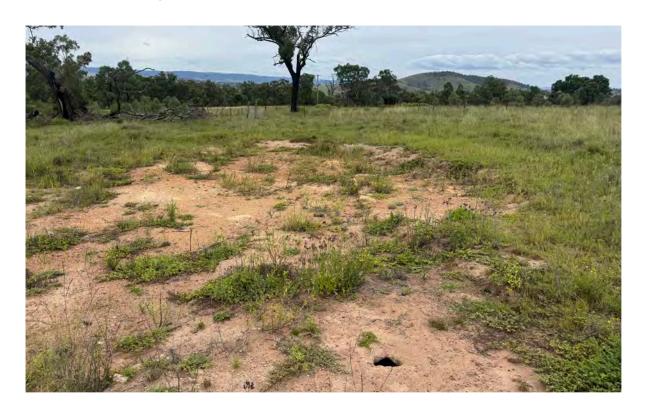
Photo 28: Signs of previous quarrying activity, west of Limestone Road (TL23).

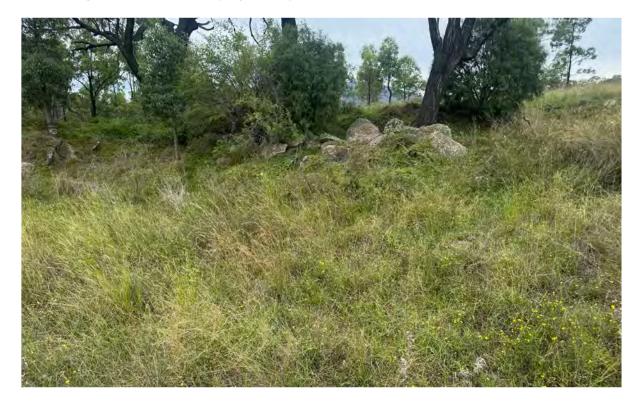
**Photo 29**: Large pieces of suspected ACM on a rocky outcrop on the western side of the NPA (TL24). Smaller pieces of suspected ACM were also observed at this location.

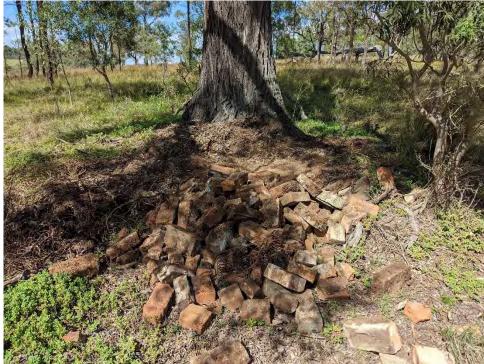
Photo 1:
Location 13 – Orange house brick pile, prior to inspection

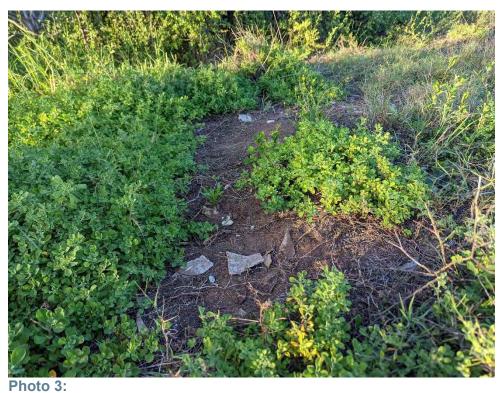
Photo 2:
Location 13 – Orange house brick pile following inspection. No ACM or potentially hazardous material identified
