# Pymble Ladies College Secondary Innovation Precinct (SSD-79146716)

**Department of Planning, Housing and Infrastructure**  
Social Infrastructure Assessments

**Prepared for IPC Meeting**  
2 July 2026

# Project overview - Secondary Innovation Precinct (SIP)

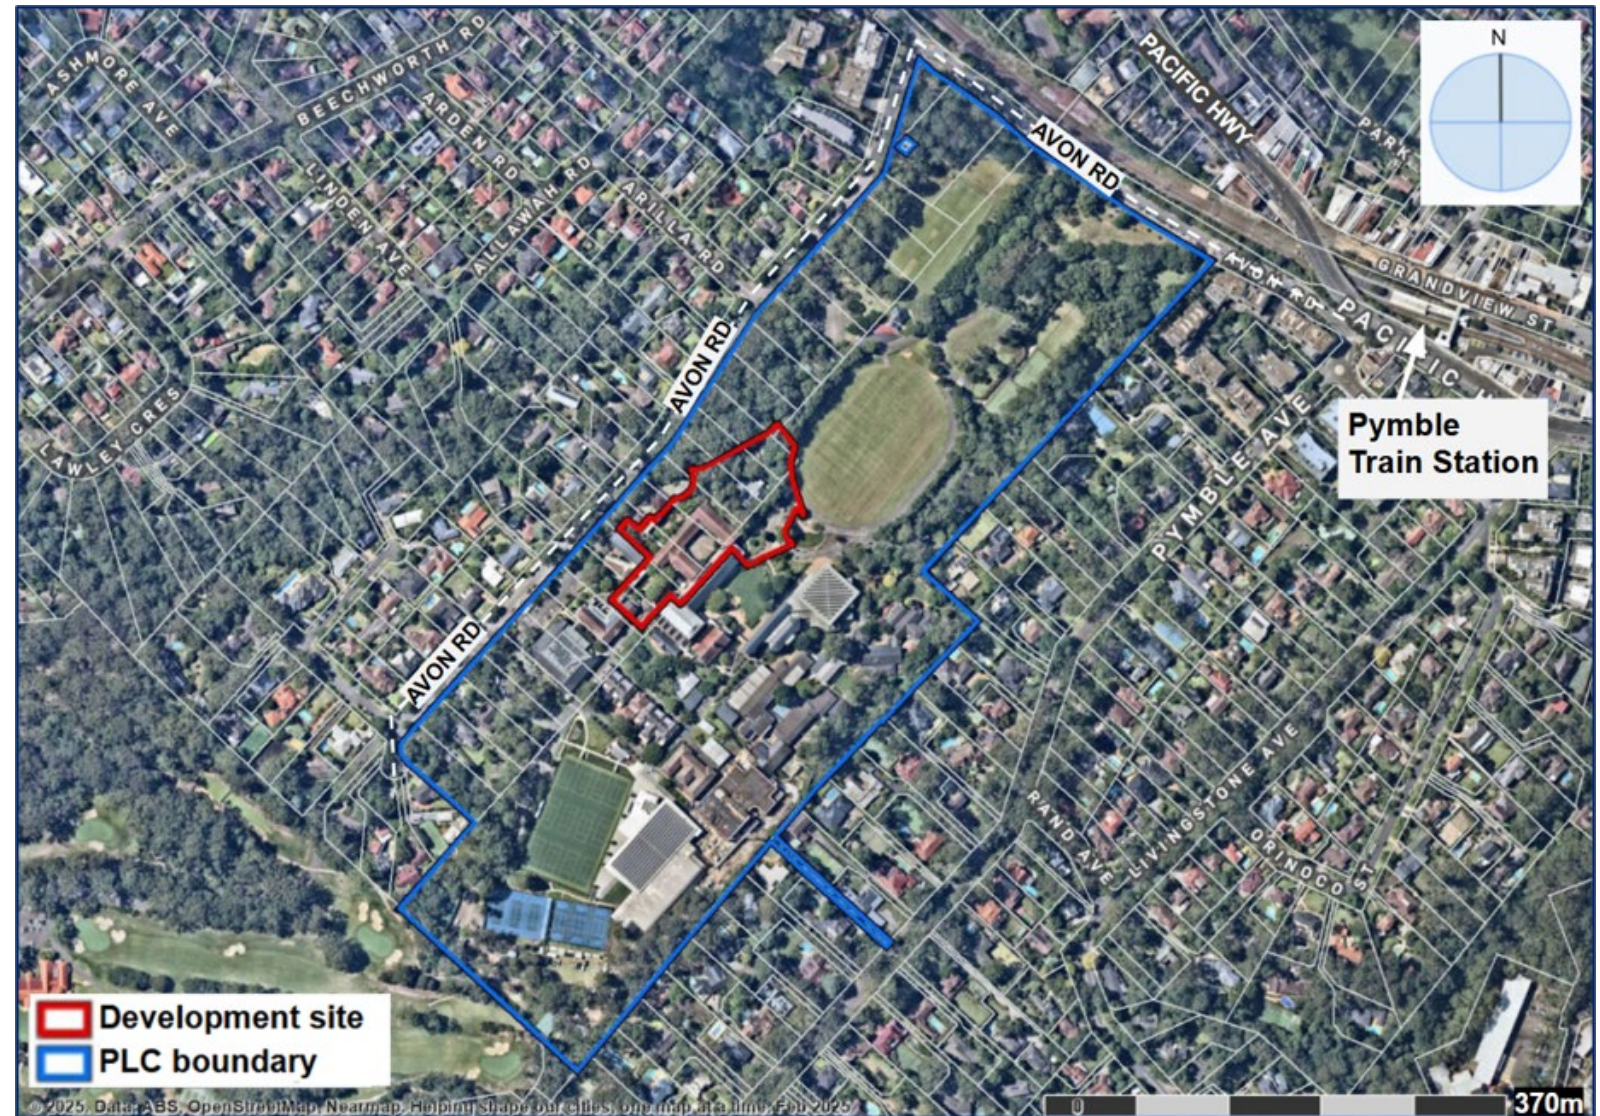
Figure | Local context & development site

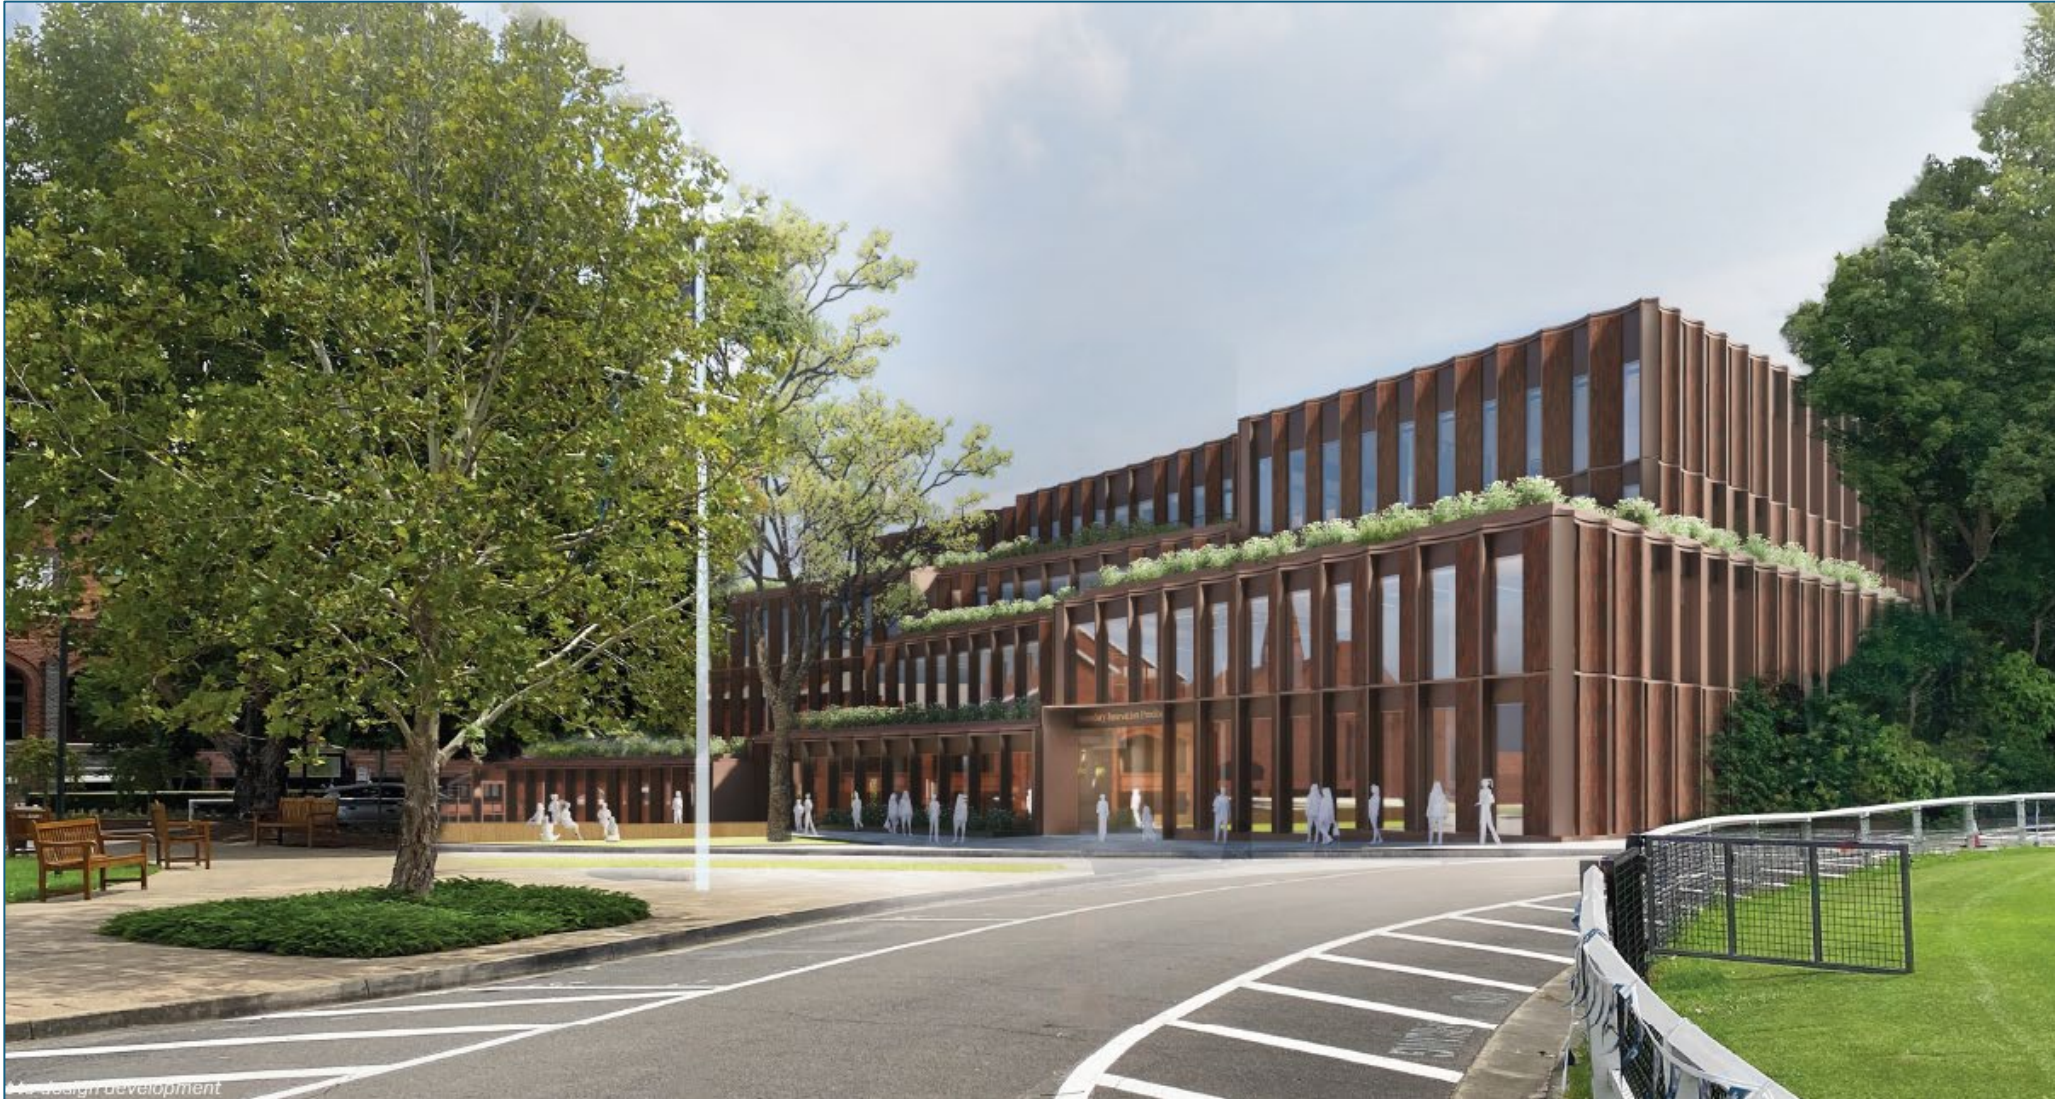
**Figure** | 3d view of the SIP building's south elevation / building entry side

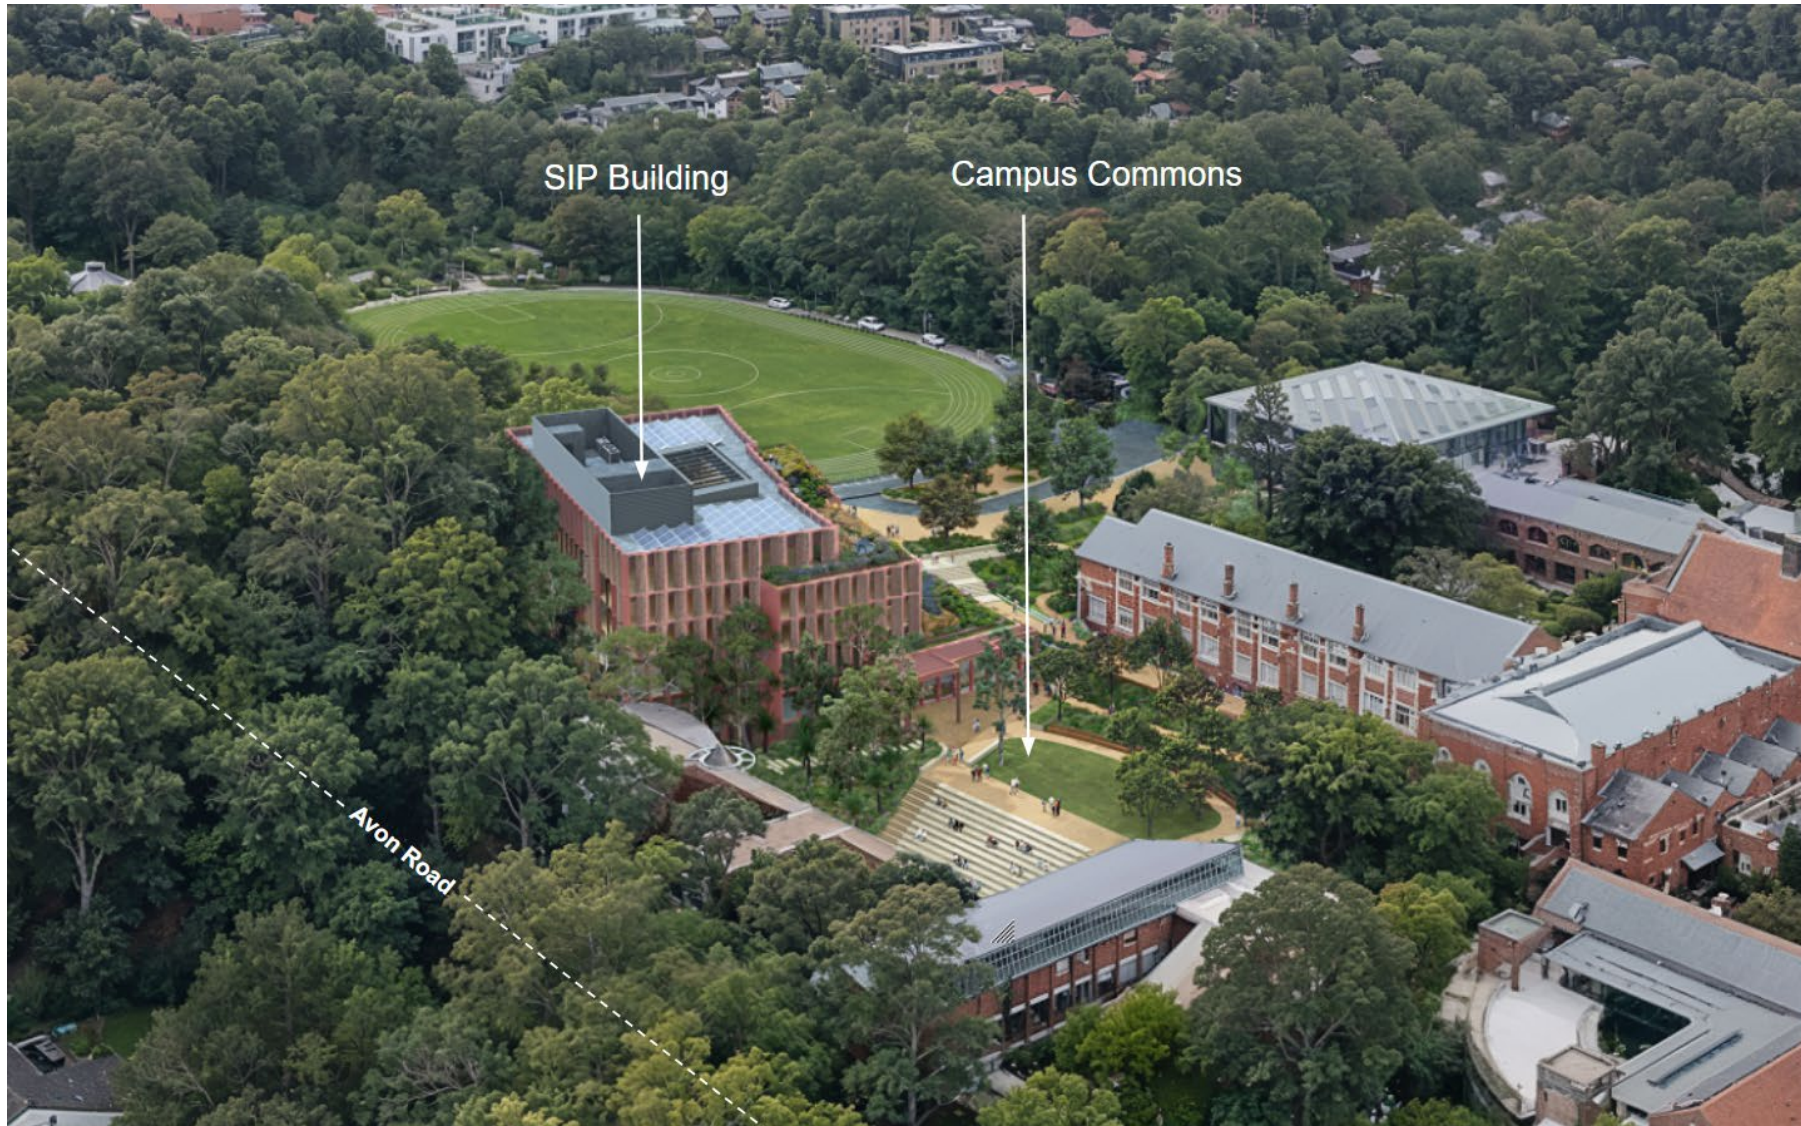
**Figure** | 3d aerial view of the SIP building and Campus Commons

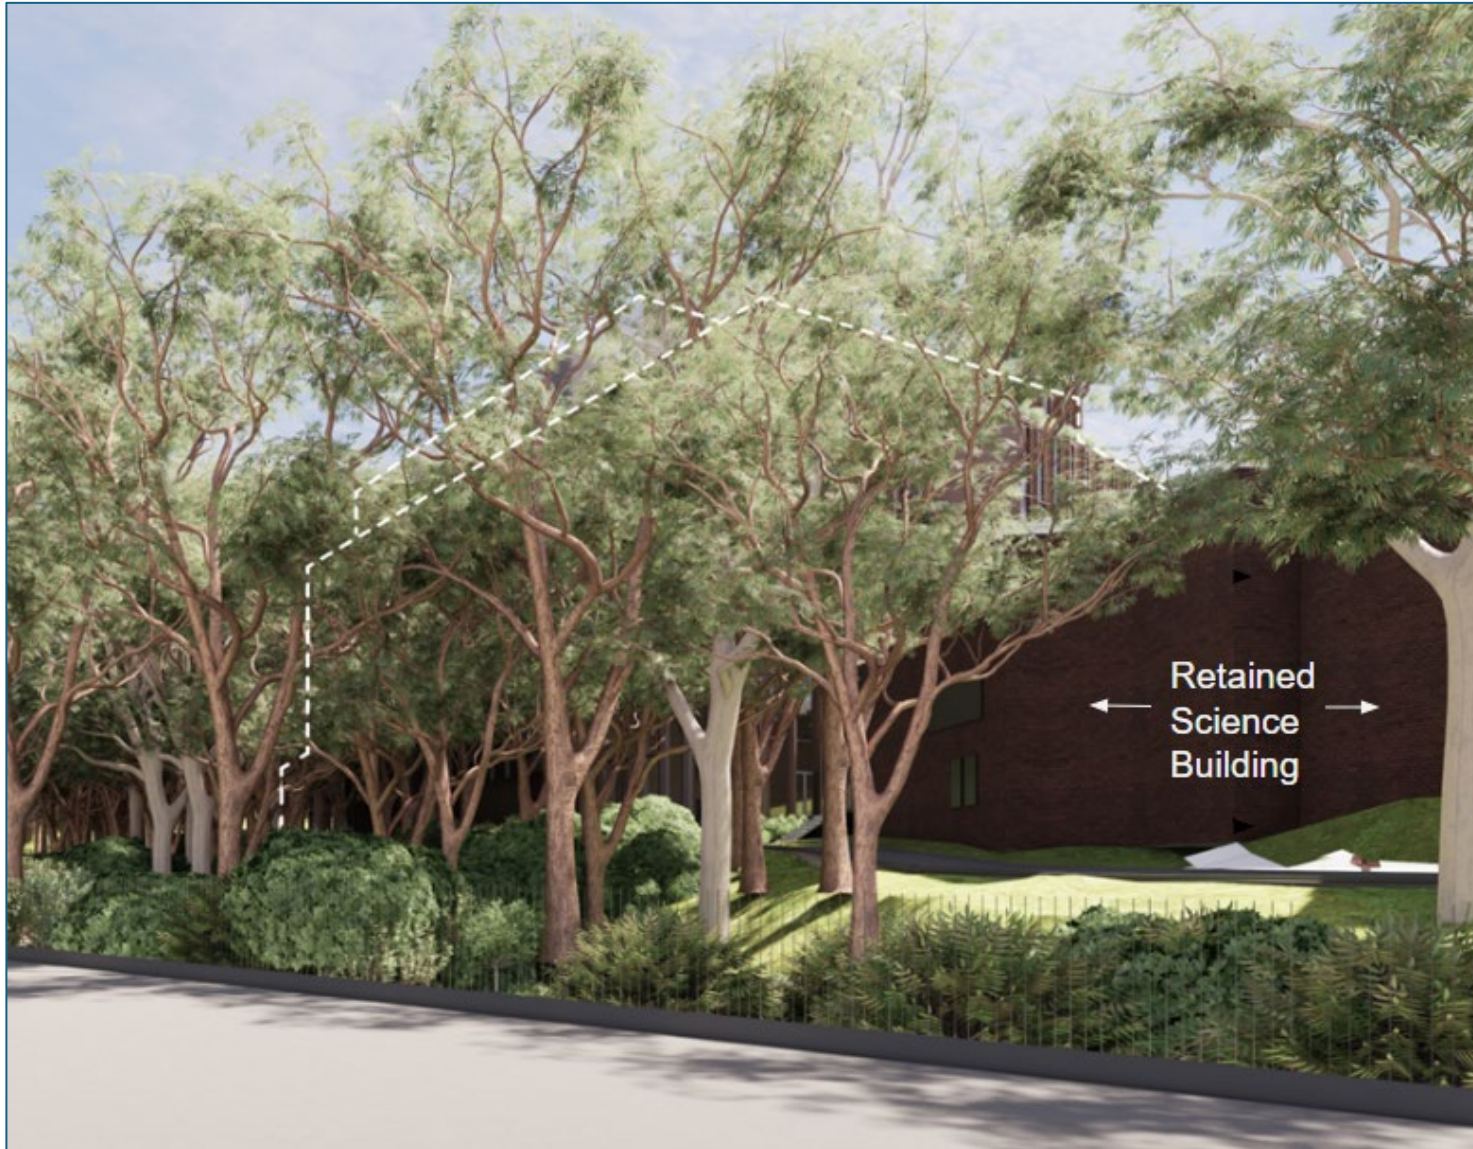
**Figure** | Indicative visualisation looking north-east from Avon Road, modelling the location of the SIP building behind retained trees/vegetation

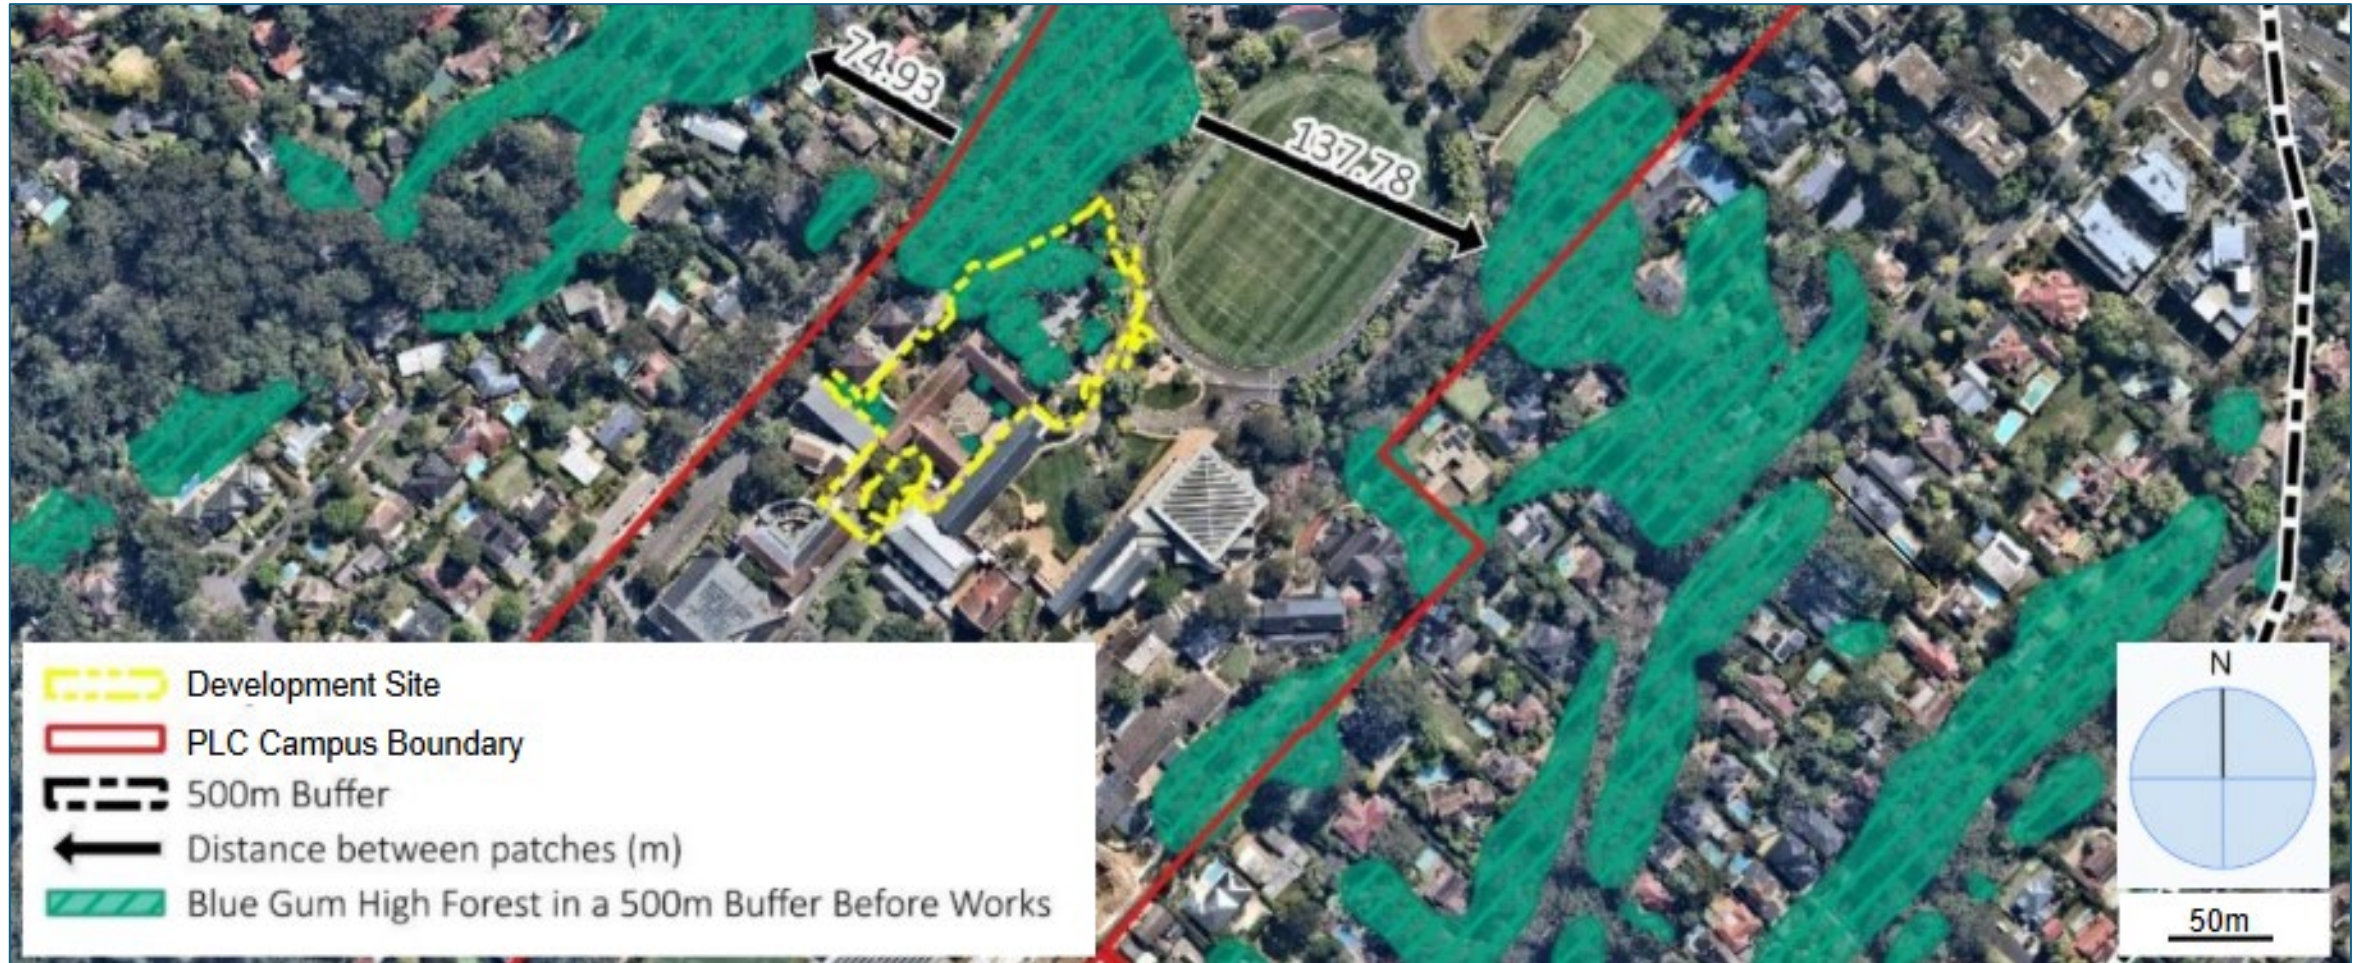
**Figure |** BGHF areas within and surrounding the development site

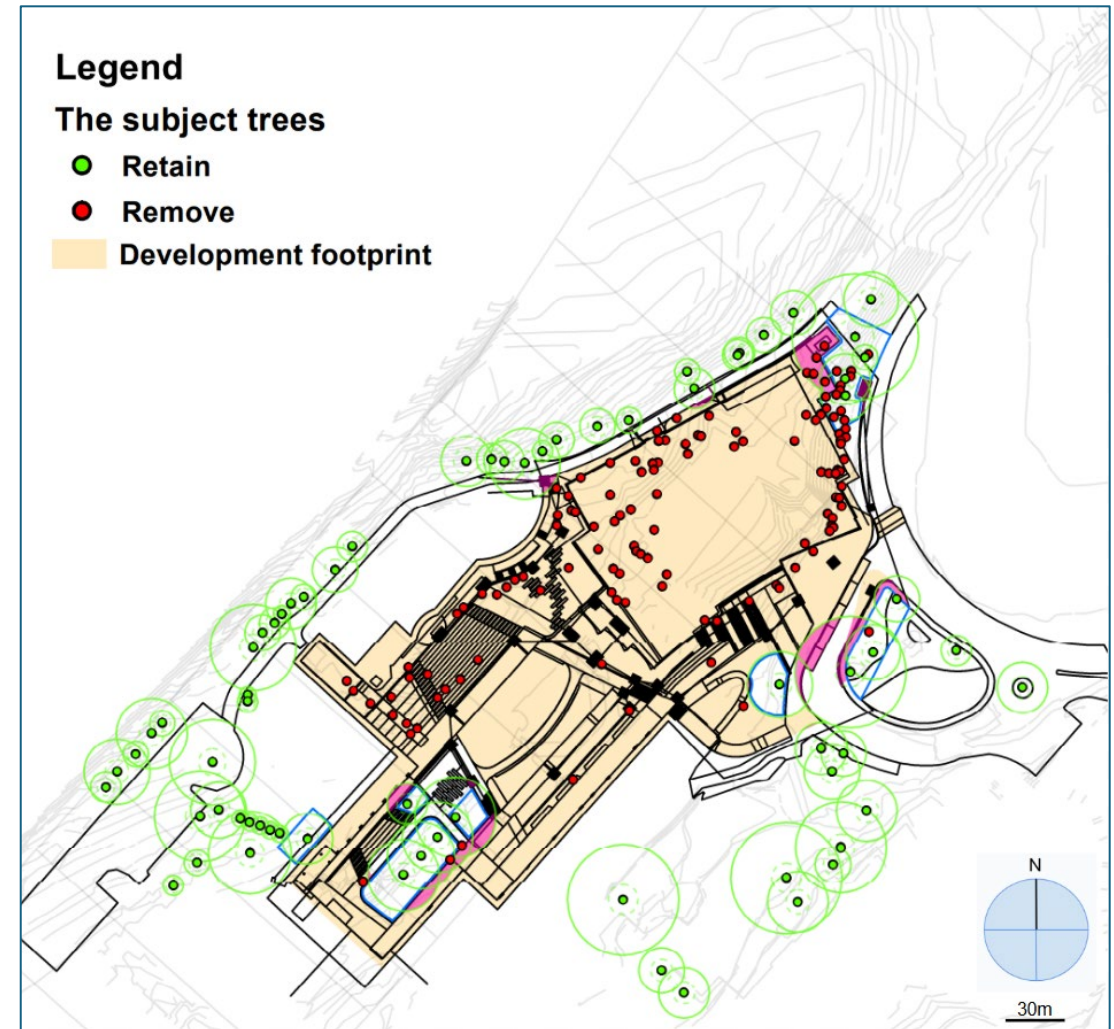
**Figure |** Tree removal / retention plan

- Replacement planting to be consistent with BGHF species
- Appointment of a project arborist (supervision / tree protection)
