Conservation Management Plan

Varroville Estate: 166-176 St Andrews Road, Varroville

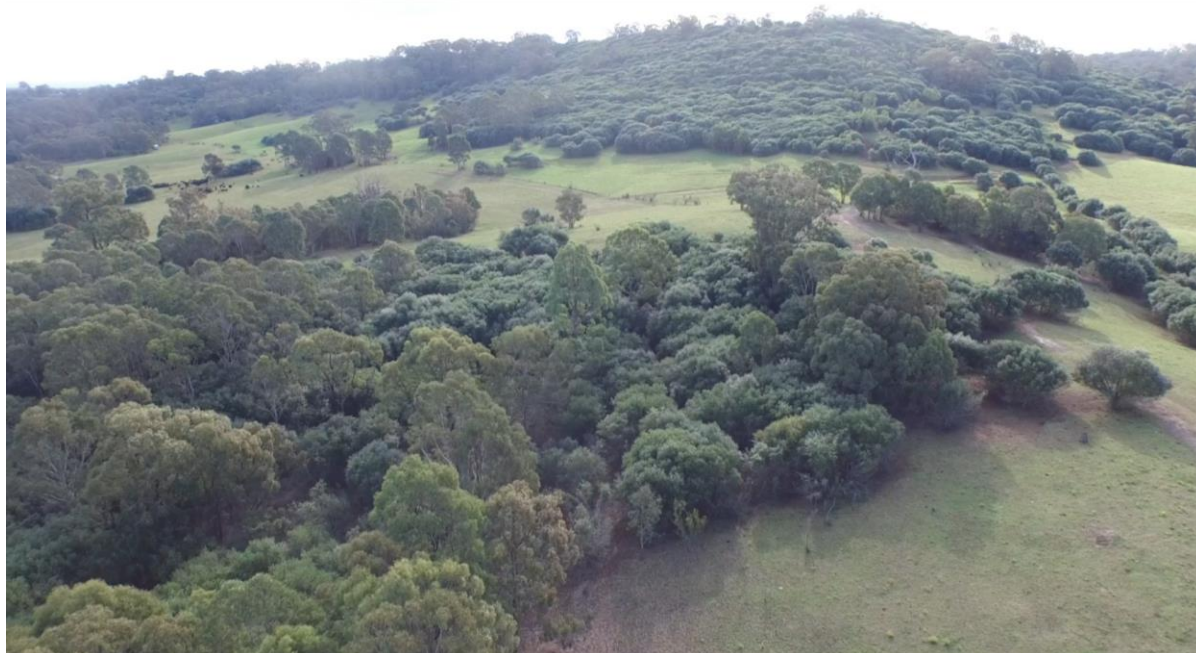
FIGURE 5 – VIEW OF THE DENSELY TREED NORTHERN PROPERTY BOUNDARY AND SHOWING NATIVE VEGETATION

PICTURE 1 – VIEW OF THE DENSELY TREED NORTHERN PROPERTY BOUNDARY

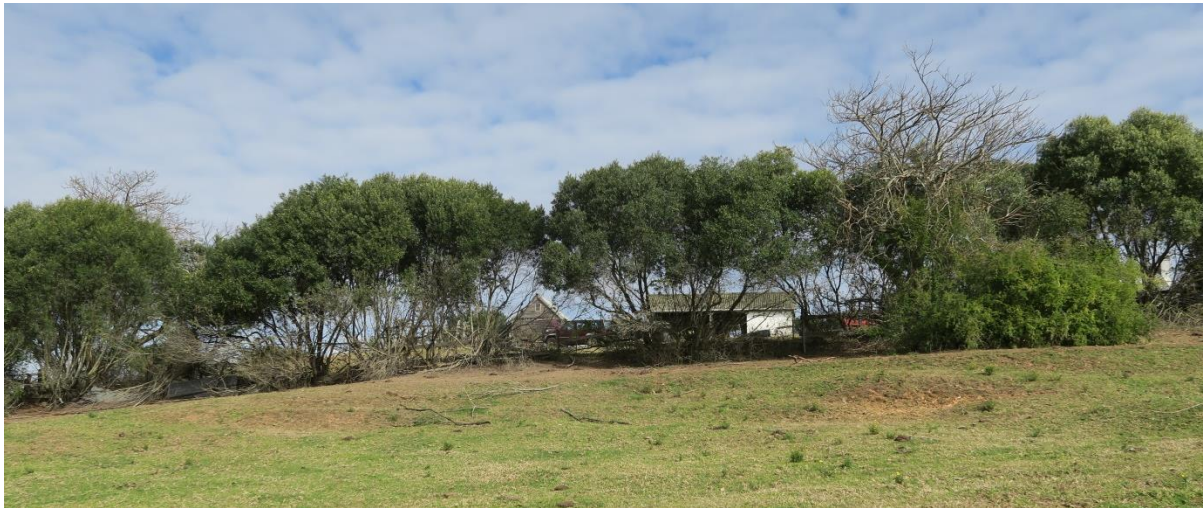
PICTURE 2 – VIEW WEST TO THE OUTBUILDINGS ON THE SUBJECT PROPERTY, WITH THE C.1950S DRIVEWAY PLANTINGS OF AFRICAN OLIVE AND CORAL TREES LINING THE ROAD (WITH THE DAIRY BUILDING BEYOND)

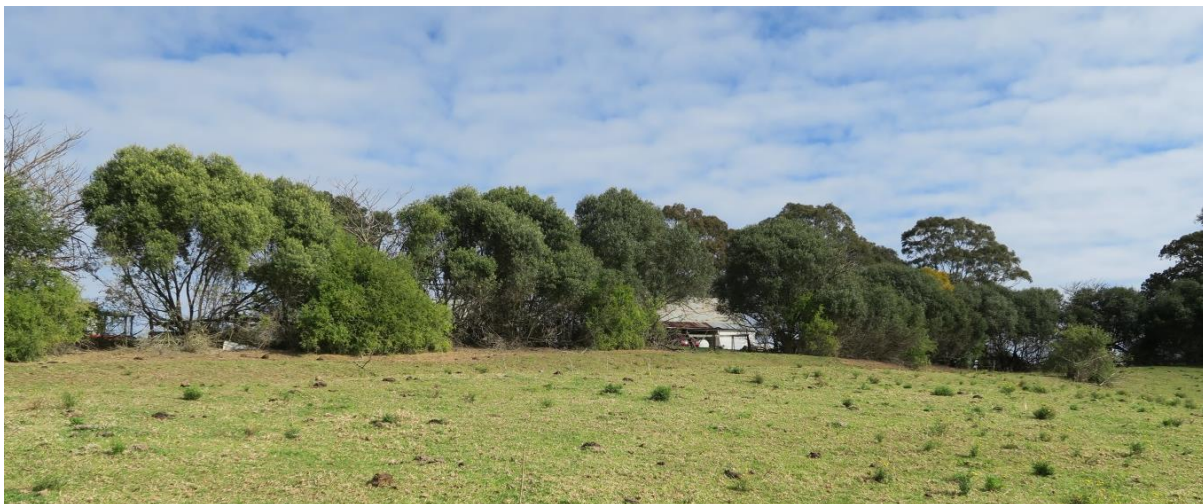
PICTURE 3 – VIEW WEST TO THE OUTBUILDINGS ON THE SUBJECT PROPERTY, WITH THE C.1950S DRIVEWAY PLANTINGS OF AFRICAN OLIVE AND CORAL TREES LINING THE ROAD (WITH THE FORMER COACH HOUSE BEYOND)

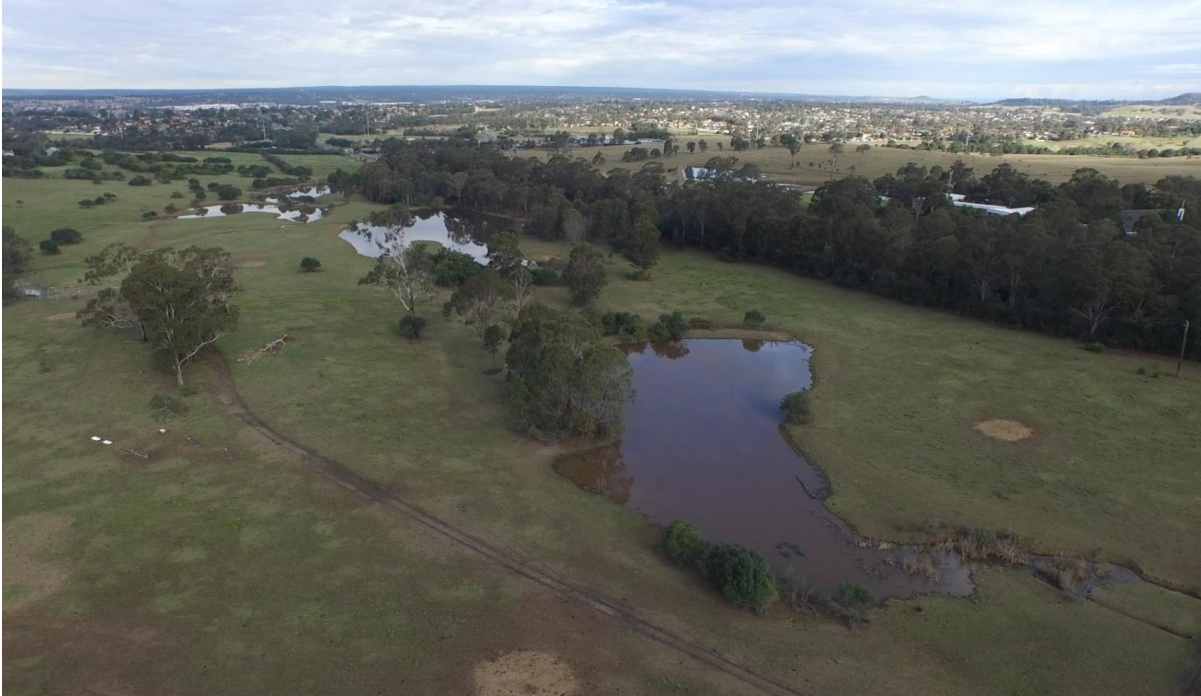
FIGURE 8 – VIEWS AND AERIAL VIEWS OF THE DAMS AND WATERCOURSES

Catchment A, (referring to dams 2-9) incorporates two large dams with functional spillways, with dams 2 and 3 interconnected by the spillway. Dams 2, 3, 6, 7 and 8 are noted as stable. Dam 9 is small and does not hold significant water.¹⁶ In relation to Catchment B (the south eastern watercourses) the report notes that dam 11 (presumably) has been artificially created. Dam 10 is noted as small and has been breached in the main wall but still holds water.¹⁷

PICTURE 4 – VIEW SOUTHWEST ACROSS THE PROPERTY TOWARDS ST ANDREWS ROAD AND SHOWING THE CHAIN OF DAMS ALONG THE WESTERN BOUNDARY (THE WESTERN LAKES, DAMS 5,4,3 AND 2)

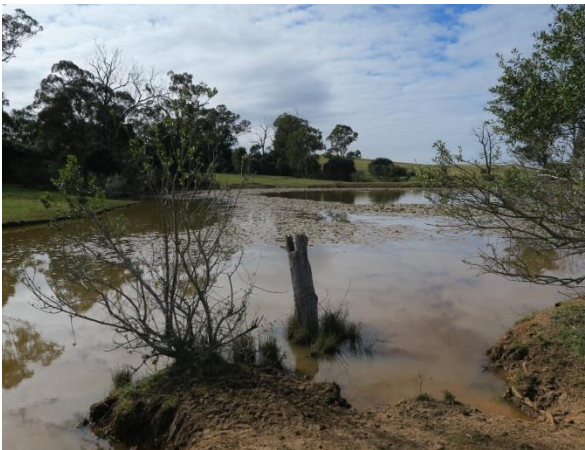
PICTURE 5 – VIEW ACROSS THE LARGE DAM EAST OF THE HOMESTEAD GROUP (DAM 11)

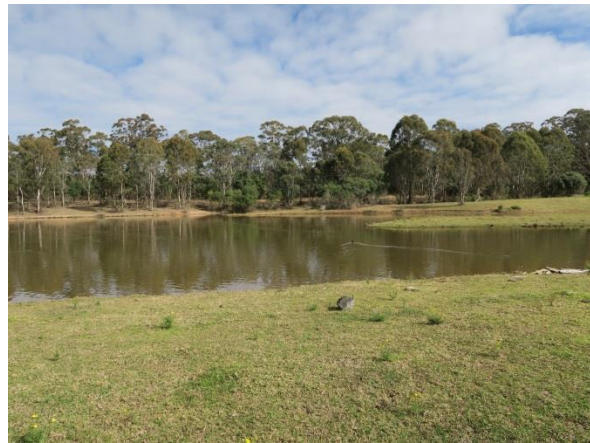
PICTURE 6 – VIEW WEST ACROSS DAM 5, THE DAM SHOWN IN THE FOREGROUND OF PICTURE 4 ABOVE

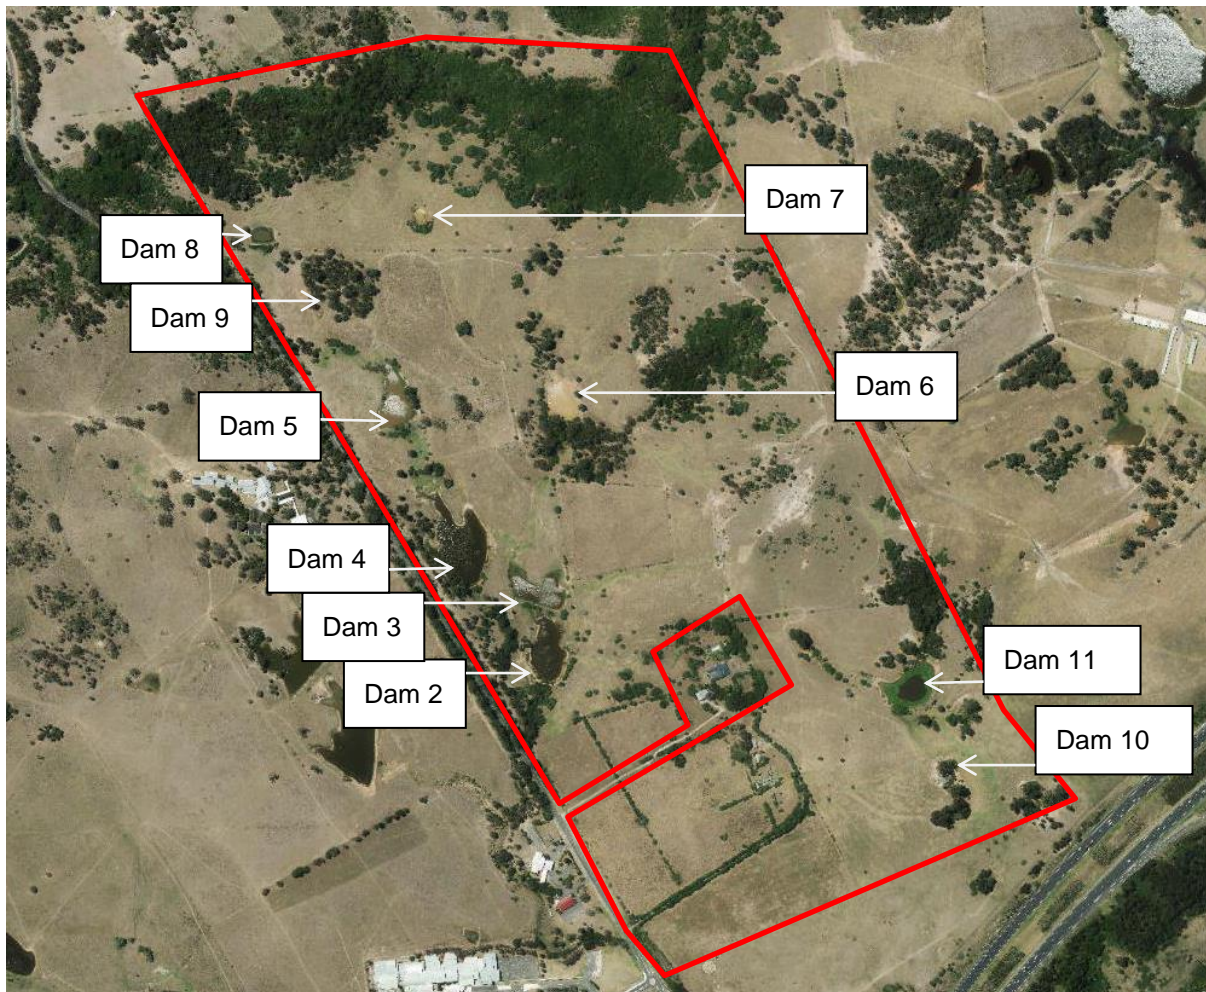
FIGURE 9 – AERIAL VIEW SHOWING THE DAMS

PICTURE 7 – AERIAL VIEW SHOWING LOCATIONS OF THE DAMS, WITH DAMS NUMBERED AS PER THE 2013 WATERCOURSE ASSESSMENT REPORT

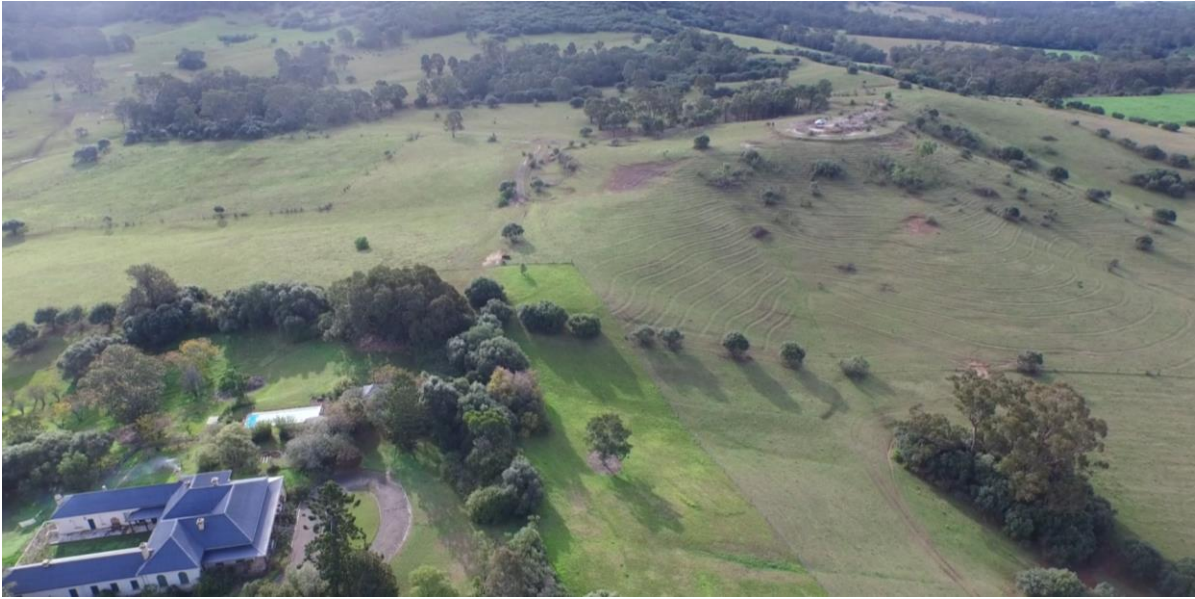
FIGURE 10 – AERIAL VIEWS OF THE SITE SHOWING REMNANT VINEYARD TERRACING

PICTURE 8 – AERIAL VIEW NORTH OVER VARROVILLE HOUSE AND SHOWING TERRACING ON SLOPES OF THE HILL TO THE NORTHEAST. VARROVILLE HOUSE IS EXCLUDED FROM THE SUBJECT SITE

Parts of Varroville were terraced for viticulture from the early days of Townsone grant. Evidence of ground modelling for vineyard terracing is clearly visible in the landscape in the vicinity of the House and outbuildings, to the east and northeast, as shown in the aerials and views at Figure 10 below as well as in historical aerials at Figure 33, Figure 35 and Figure 36. Remnant terracing is extensive and comprises an approximate area of more than 7 hectares, in varying degrees of integrity, and primarily focussed around the hill to the northeast of Varroville House and slopes to the east in front of the house.

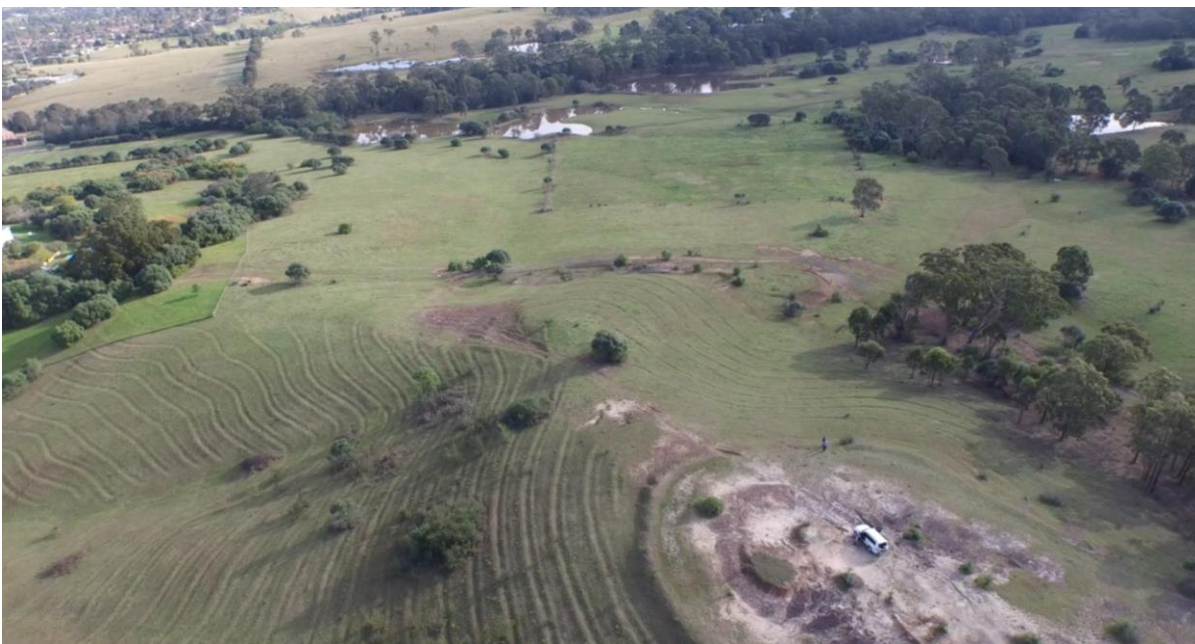
PICTURE 9 – VIEW WEST ACROSS THE SITE TOWARDS THE DAMS AND ST ANDREWS ROAD, AND SHOWING REMNANT TERRACING ON THE SLOPES OF THE HILL

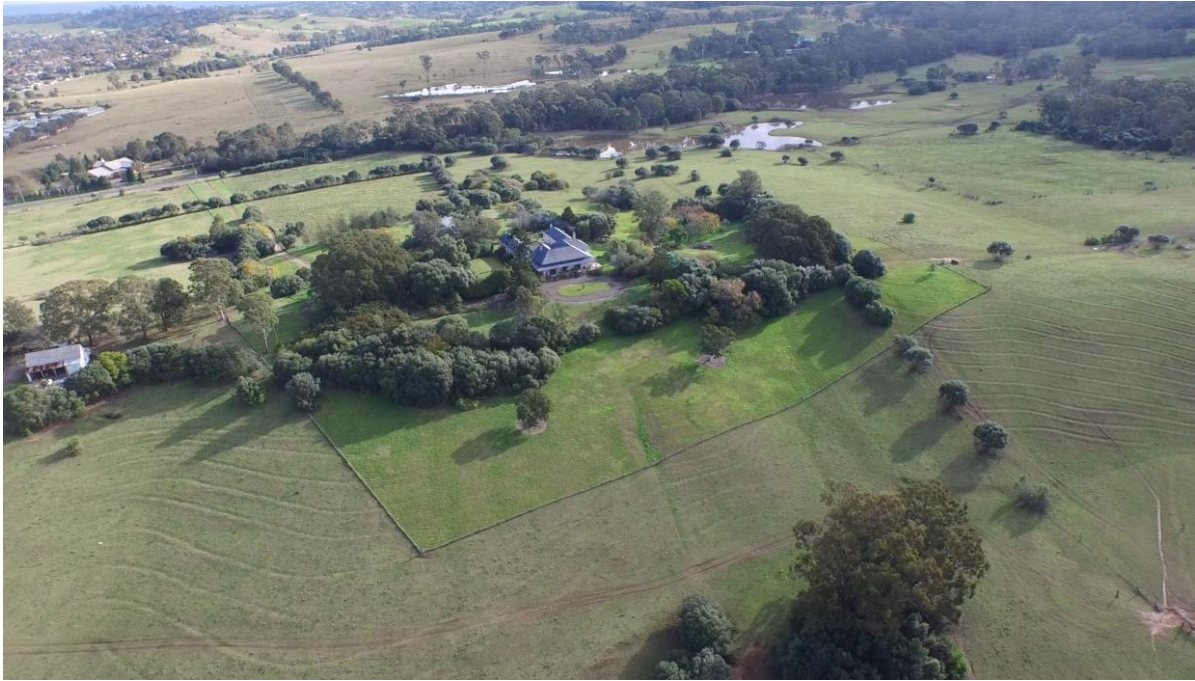
PICTURE 10 – VIEW WEST TOWARDS ST ANDREWS ROAD, SHOWING REMNANT TERRACING IN FRONT OF VARROVILLE HOUSE AND THE COACH HOUSE (AT LEFT)

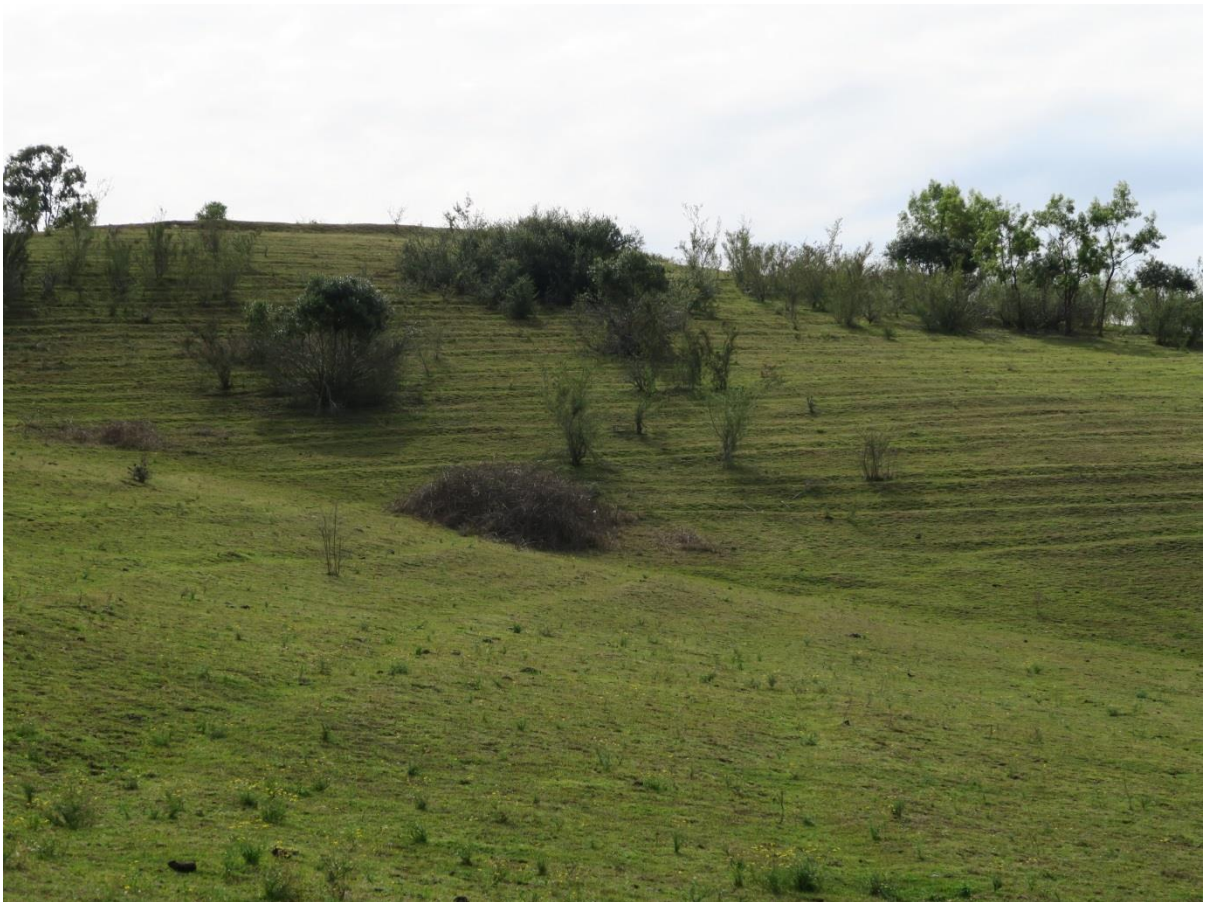
PICTURE 11 – VIEW OF REMNANT TERRACING

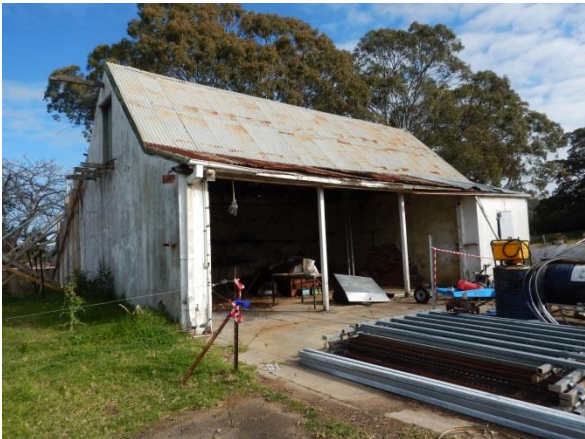
PICTURE 13 – THE PRINCIPAL EASTERN FAÇADE
SOURCE: ARTEFACT HERITAGE

The original form of the building comprised a simple gabled structure with a broken back skillion roof wing at the rear. Views of the building c.1935 (Figure 32) illustrate that the principal eastern façade was enclosed with a wide bay of double timber doors, while the northernmost section of the façade was masonry, with a single door opening to a separate utility room. The northern façade features a double hung window at the ground floor, with a second matching window within the gabled roof and a vent on the rear skillion section of the façade. The southern façade retains remnants of a pulley and timber ledge within the gable end, for storage within the roof/ loft. The original roof was shingled and is retained beneath the galvanised sheeting on the eastern façade.

The building was modified in the early 1950s for use as a machinery shed, incorporating a new verandah to the eastern façade. This incorporated provision of steel and timber framing to facilitate access for trucks. The extended masonry sections are of breeze block construction, with a rendered finish. A new room addition was also constructed at the northern end of the verandah in the latter part of the 20th century.

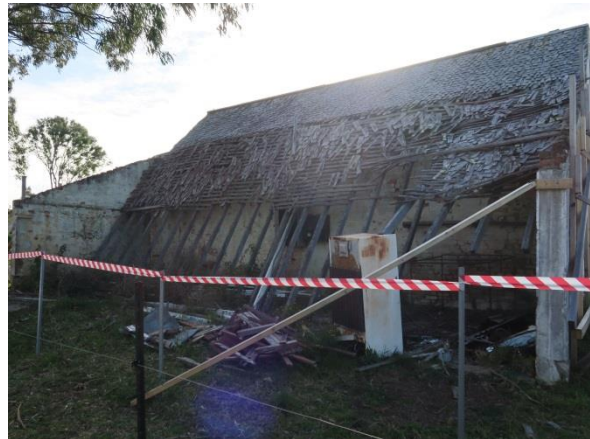
PICTURE 14 – THE REAR OF THE FORMER COACH HOUSE HAS COLLAPSED AND THE TIMBER SHINGLED ROOF IS EXPOSED

The building is currently in extremely poor and dangerous condition, with the rear portion of the western roof structure having collapsed, leaving the original shingle roof exposed. Ground settlement has caused major cracks in the northern, southern and western walls and sections of the brickwork in the northern wall of the main room are failing, with a large area of the inner skin of the double brick wall having collapsed. The wall is also affected by rising damp. The fin walls of the skillion section at the rear indicate movement and there is major cracking along the juncture with the gabled main section of the building. The hard wood roof framing has suffered from dry rot and pest activity.

The structure has presently been cordoned off and is not safe to access.

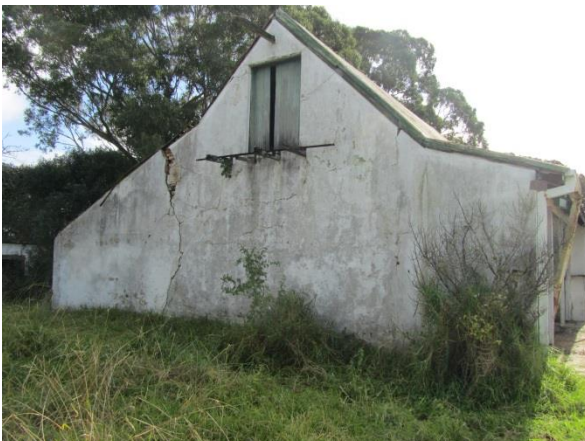
PICTURE 15 – THE SOUTHERN FAÇADE

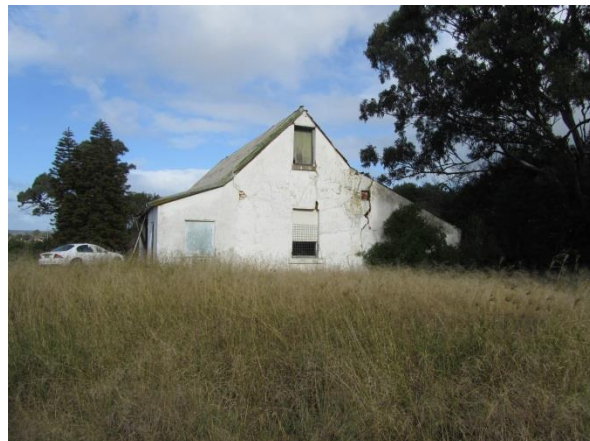
PICTURE 16 – THE NORTHERN FAÇADE

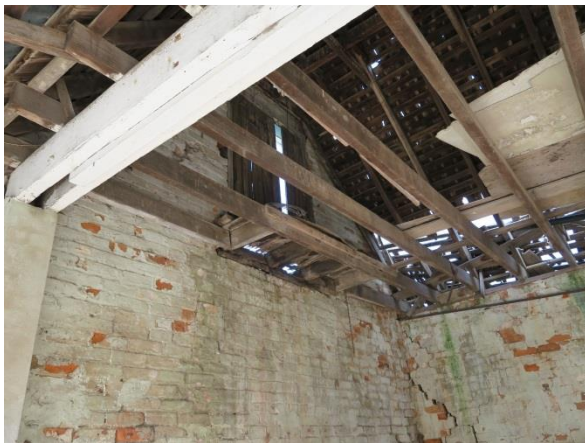
PICTURE 17 – DETAIL OF THE ROOF, STRUCTURE AND SOUTHERN FAÇADE GABLE WINDOW (ENCLOSED)

The interior is largely open plan, divided into east (front) and west (rear) sections. The eastern section features a concrete floor, while the rear section is an earth floor. The timber roof truss is exposed, and the underside of the original timber shingles is able to be viewed. The masonry structure has a painted finish. Views of the interior are provided below at Figure 14

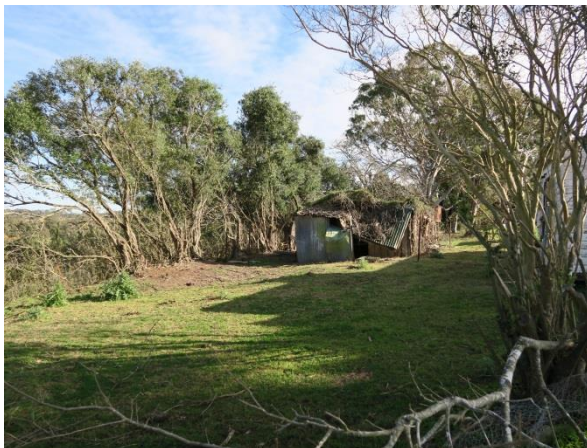
FIGURE 16 – THE TIMBER SLAB HUT

The slab hut is in a ruinous condition. Regrowth scrub is present throughout the area and has completely enclosed the rear of the slab hut, the roof has collapsed inwards and the southern verandah has collapsed. The interior of the hut was not able to be accessed assessment of exterior fabric is limited. The building is constructed of vertical timber slabs and originally featured a low pitched gabled roof with gable vents. It was a residence in the 1950s but more recently was used as a laundry. Views of the slab hut in 2004 (Figure 39) illustrate that the hut had been modified with a concrete floor, and sheet lined interior.

PICTURE 23 – VIEW NORTHWEST TOWARDS THE SLAB HUT, OBSCURED BY REGROWTH VEGETATION

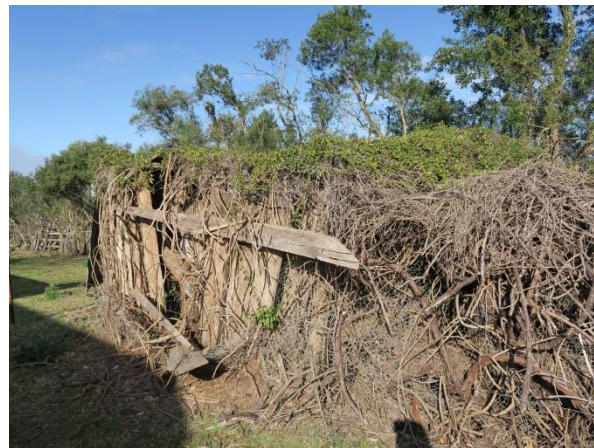
PICTURE 24 – THE EASTERN ELEVATION OF THE SLAB HUT

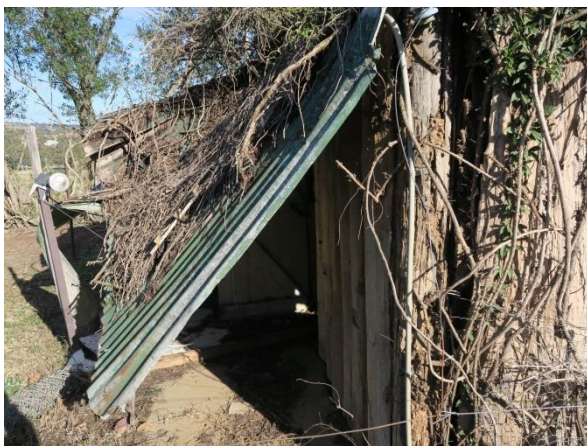
PICTURE 25 – VIEW TOWARDS THE SOUTHERN FAÇADE, SHOWING THE COLLAPSED VERANDAH ROOF

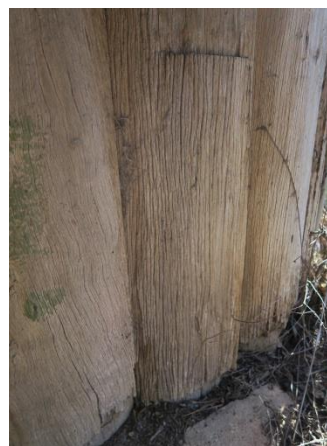
PICTURE 26 – DETAIL OF THE TIMBER SLABS (SOUTHERN FAÇADE)

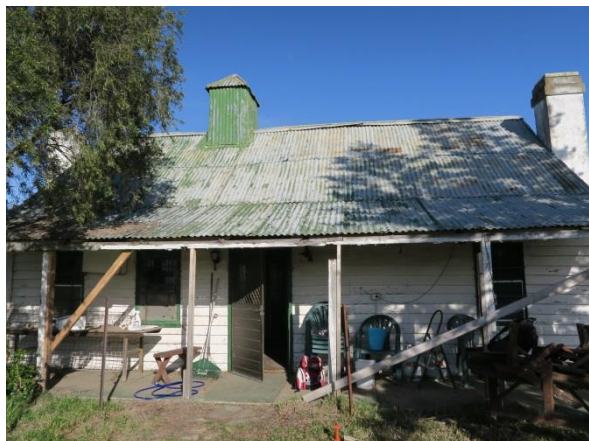
PICTURE 27 – THE PRINCIPAL EASTERN FAÇADE

The cottage originally served as two dwellings with the second doorway adjacent to the central entry (on the north side) infilled sometime after the 1950s. A low pitched skillion roofed extension wraps around the south western corner of the cottage, constructed in the early 1950s, reportedly from a prefabricated migrant hostel.¹⁹ It is understood that the Jackamans substantially reconstructed the cottage, noting that when they purchased Varroville, the cottage had no internal walls, a dirt floor and the southern wall is described as having “disappeared”²⁰ although it is assumed that this likely refers to the external weatherboard rather than the structure itself. Internal joinery, dropped ceilings, timber floors and lightweight walls date to the 1950s reconstruction and the eastern verandah was also reconstructed at this time.

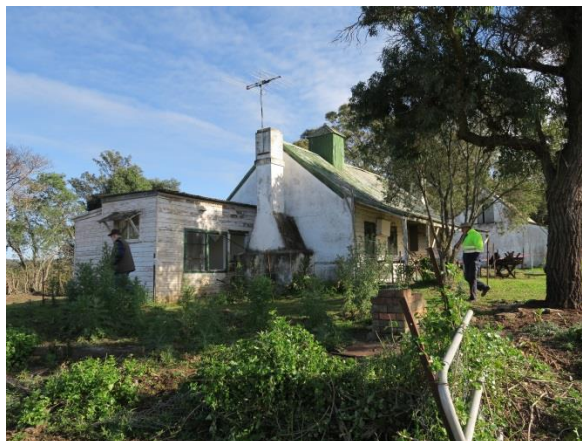
PICTURE 28 – VIEW NORTH WEST TO THE COTTAGE AND SHOWING THE 1950S ADDITION

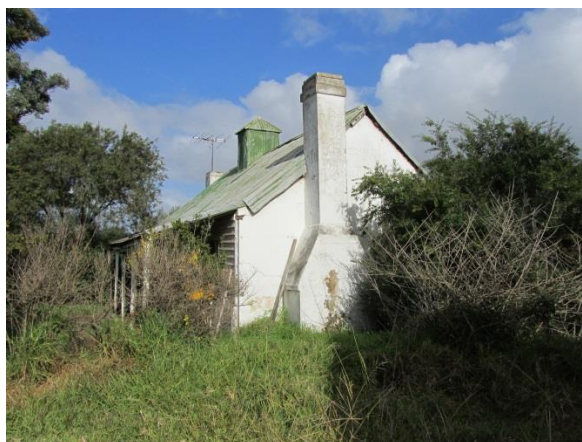
PICTURE 30 – THE NORTHERN MASONRY FAÇADE AND CHIMNEY

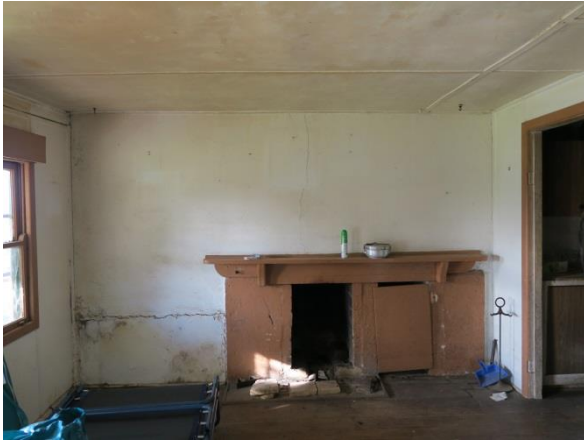
PICTURE 31 – VIEW SOUTH TOWARDS THE LIVING ROOM FIREPLACE. NOTE THAT THE INTERIOR WAS FULLY REFURBISHED IN THE 1950S (R1)

Internally, the main cottage is divided into a main living area, with three bedrooms, bathroom and kitchen. There is one internal masonry wall, which is thought to be original, dividing the two formerly separate residences. The rear southern extension is accessed via the kitchen. The flooring is timber and appears to be salvaged as the profiles are consistent with the likely Victorian period of the cottage. There is a suspended ceiling (c.1950s) obscuring the original timber lined underside of the gabled roof. The bathroom and kitchen are modern (c.1950s).

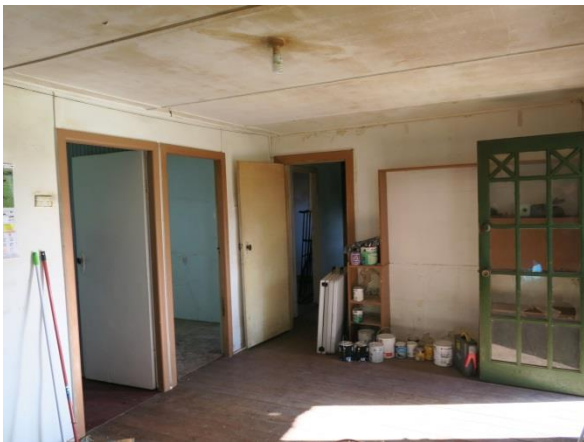
PICTURE 32 – VIEW OF THE BEDROOM/ FORMER LIVING AREA (R2). IT IS NOTED THAT THE FIREPLACE HAS BEEN COVERED WITH MASONITE SHEETING

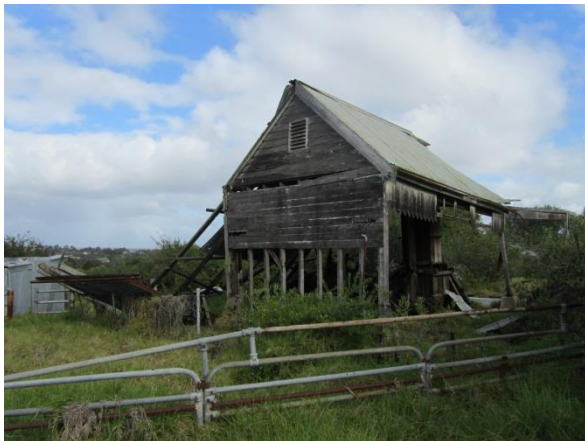
FIGURE 20 – VIEWS OF THE TIMBER BARN

The barn is in a derelict condition, having partially collapsed. The original extent of the building is indicated by the retention of the western timber post of the building frame. Historic aerials suggest that the building attached to a larger shed on its southern side, the ruins of which survive, to the south and southwest of the building.

PICTURE 39 – VIEW SOUTHWEST TO THE TIMBER BARN

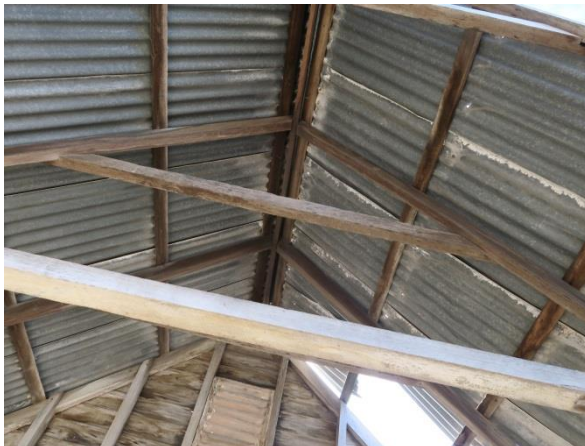
PICTURE 41 – DETAIL OF THE GABLED ROOF AND VENT

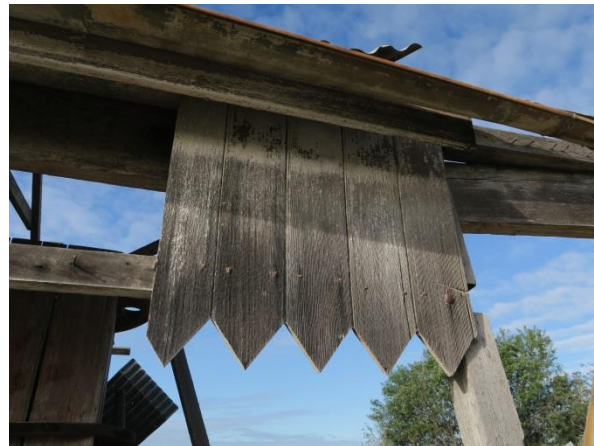
PICTURE 42 – DETAIL OF THE REMNANT POINTED TIMBER VALANCE

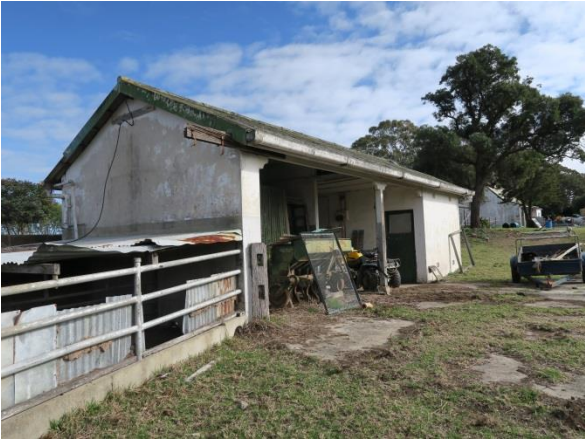
PICTURE 43 – VIEW NORTH TO THE DAIRY SHOWING THE PRINCIPAL EASTERN FAÇADE

structure at the rear houses animal stalls. The building is reportedly built to a standard specification for dairy buildings of the period and was common across NSW.²¹

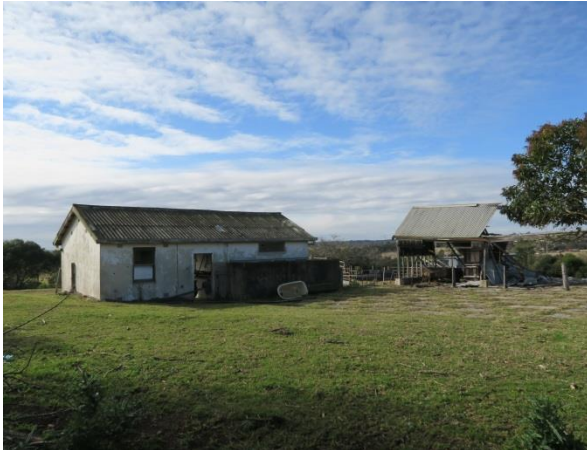
PICTURE 44 – VIEW EAST TO THE REAR OF THE DAIRY

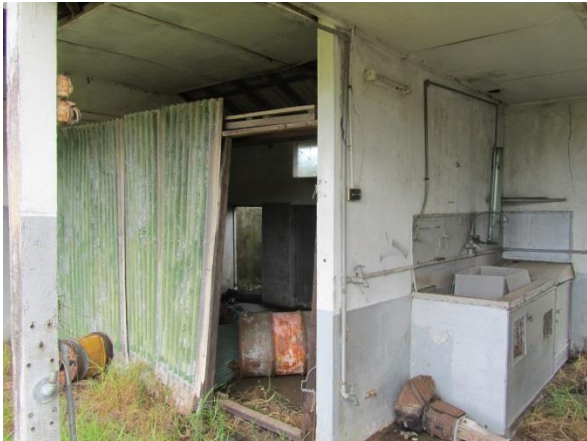
PICTURE 46 – THE INTERIOR OF THE DAIRY

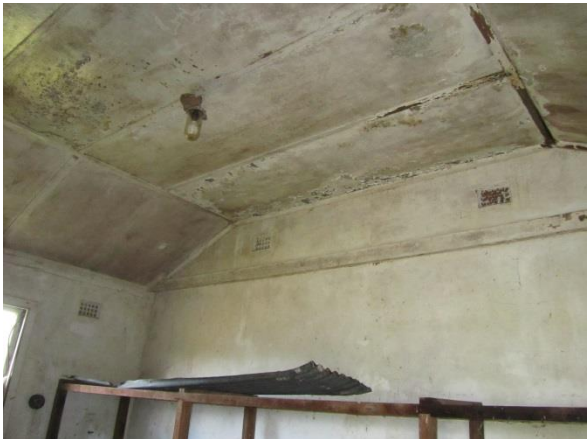
PICTURE 48 – VIEW OF THE VAULTED CEILING

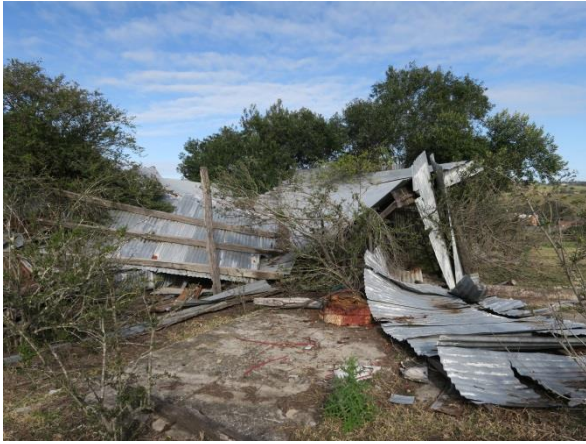
PICTURE 49 – RUIN OF A FORMER SHED BUILDING ASSOCIATED WITH THE TIMBER BARN

There are a number of ancillary corrugated iron sheds and remnant ruinous structures in the vicinity of the timber barn and dairy buildings as well as fences and yard structures including remnants of post and rail fencing. There is evidence of other former structures such as in ground footings, wells and cisterns. To the rear of the cottage there is a later 20th century chicken coop and water tank and the remains of a contemporary brick structure.

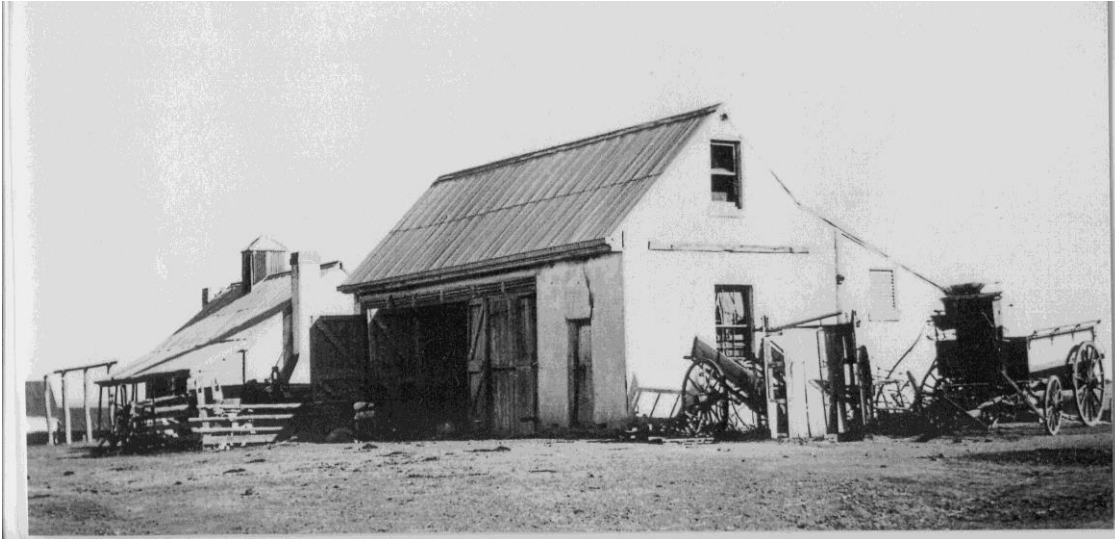
PICTURE 64 – C.1935 VIEW OF THE FORMER COACH HOUSE, WITH THE COTTAGE BEHIND. NOTE THAT THERE IS NO VERANDAH AND THE FAÇADE APPEARS TO BE ENCLOSED BY PAIRS OF TIMBER DOUBLE DOORS

The former coach house was also modified for use as a machinery shed, with works including the addition of the front verandah and removal of the former timber doors and valance shown in the 1935 view at Figure 32. The dairy building was also constructed under the Jackaman ownership, c.1952. It had not yet been constructed when the Campbelltown and Airds Historical society viewed the property in 1952 and is not shown in the historic views at Figure 34 however is apparent on the 1955 aerial along with the associated concrete slab.

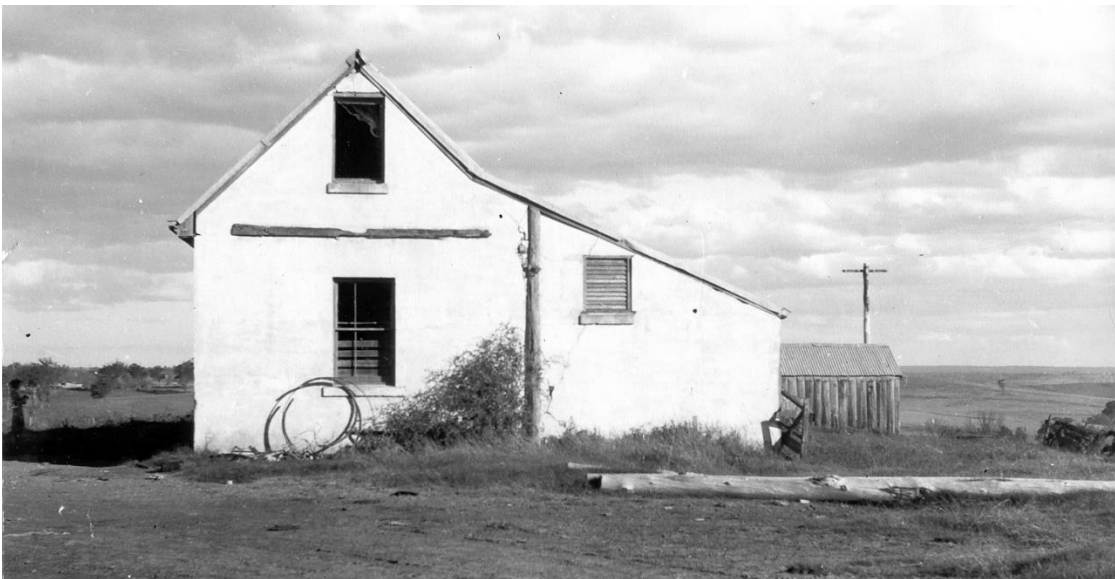
PICTURE 65 – UNDATED VIEW OF THE COACH HOUSE WITH THE SLAB HUT IN THE DISTANCE (RIGHT) (1935-1952)

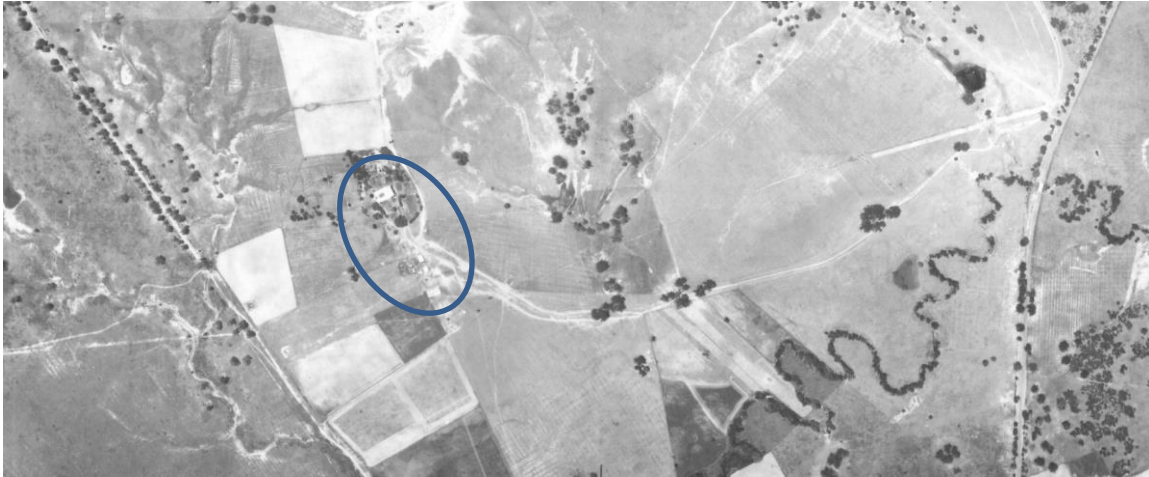
PICTURE 66 – 1947 AERIAL OF THE HOUSE AND ESTATE (PART VIEW) WITH THE HOUSE AND OUTBUILDINGS INDICATED AND SHOWING THE ORIGINAL DRIVEWAY AND SOME DAMS

Aerial photography in 1947, 1955 and 1961 (Figure 33, Figure 35 and Figure 36) shows the subject property to be largely cleared for grazing, with only scattered trees, presumably remnants of the original vegetation community or regrowth thereof. Exotic plantings within the present estate are largely limited to the driveway from St Andrews Road to the group of farm outbuildings which was constructed c1950s presumably to serve the new dairy constructed by the Jackamans c1952. Trees planted along the new drive are just visible in the 1955 air photo and are most likely the extant mix of *Erythrina x sykesii* (coral tree) and *Olea europaea* ssp. *cuspidata* (African olive).

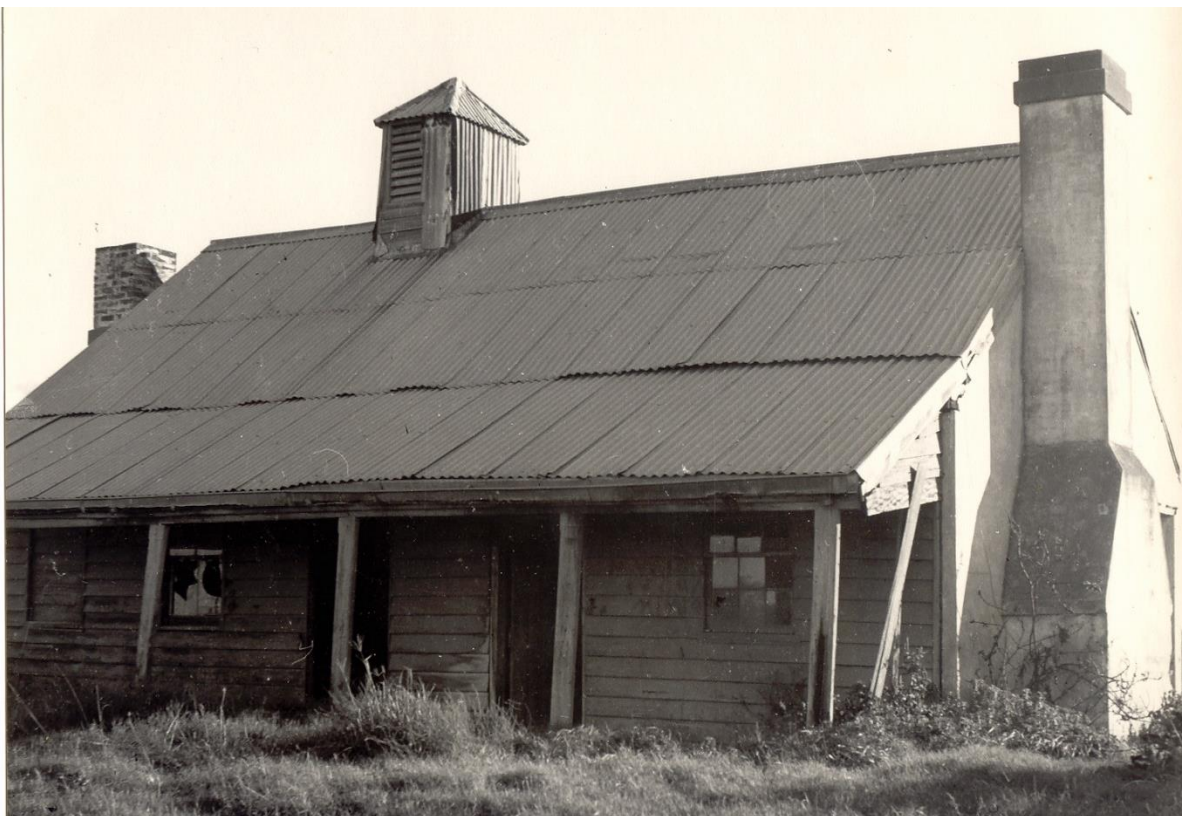
PICTURE 68 – THE 19TH CENTURY COTTAGE

at Figure 34 above illustrate that it formerly was used for two dwellings, the northern most entry having since been infilled. The southernmost window is also shown as infilled and the southern chimney appears to have been reconstructed.

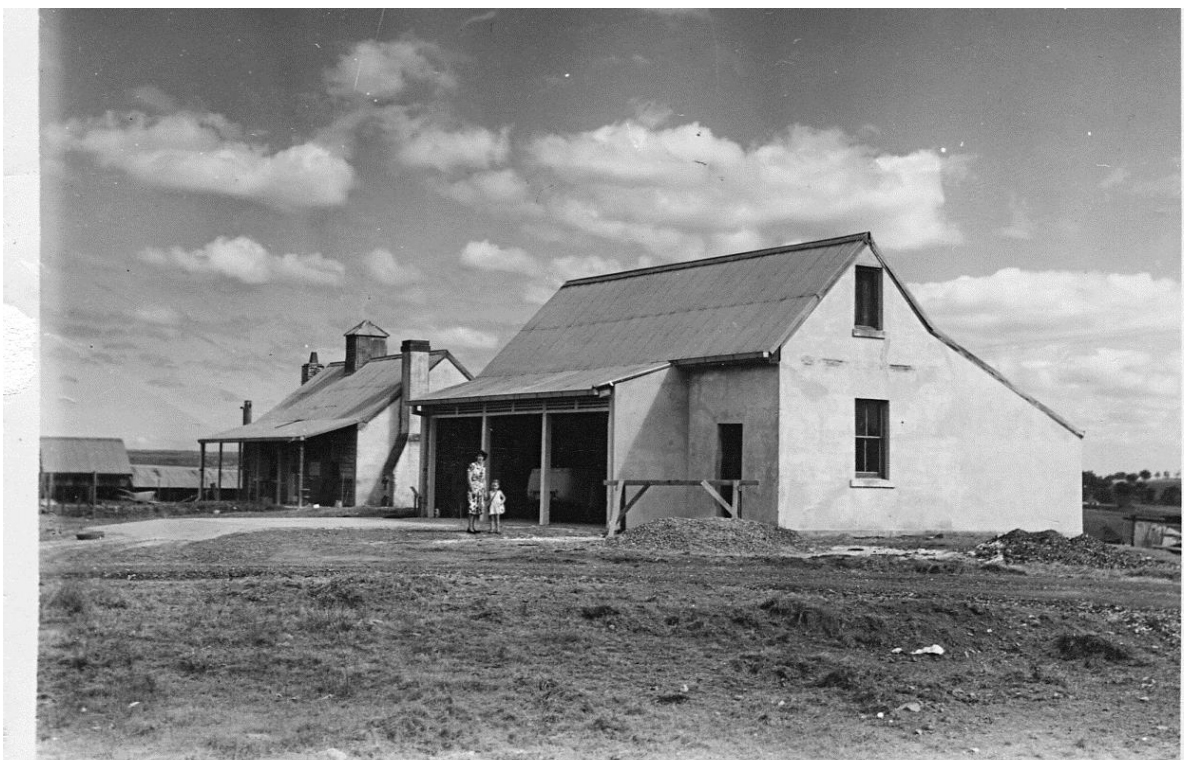
PICTURE 70 – THE FORMER COACH HOUSE AND 19TH CENTURY COTTAGE BEYOND. NOTE THE VERANDAH TO THE COACH HOUSE HAS BEEN ADDED SINCE THE 1935 IMAGE.

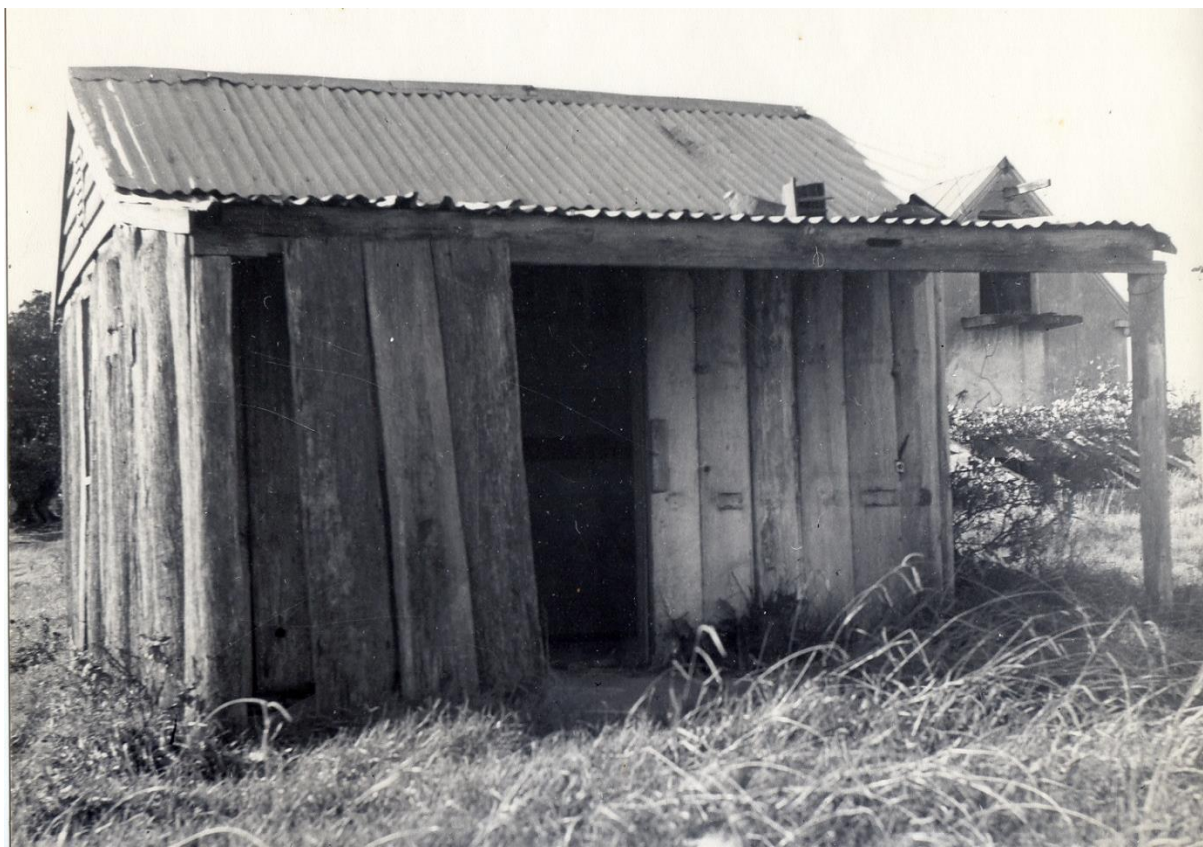
PICTURE 71 – THE TIMBER SLAB HUT WITH THE COACH HOUSE VISIBLE AT THE REAR RIGHT

without characteristic features such as windows or a stone chimney. It is noted that these features may have been previously extant; however the structure is simplistic even in the 1950s views of the site (refer Figure 34). Its present ruinous condition prevents a detailed physical analysis. With consideration for the simplicity of the structure, the use of the property and examination of slab hut typologies, it is considered that this structure was constructed as more of a utilitarian structure, rather than being occupied as Townson's first hut.

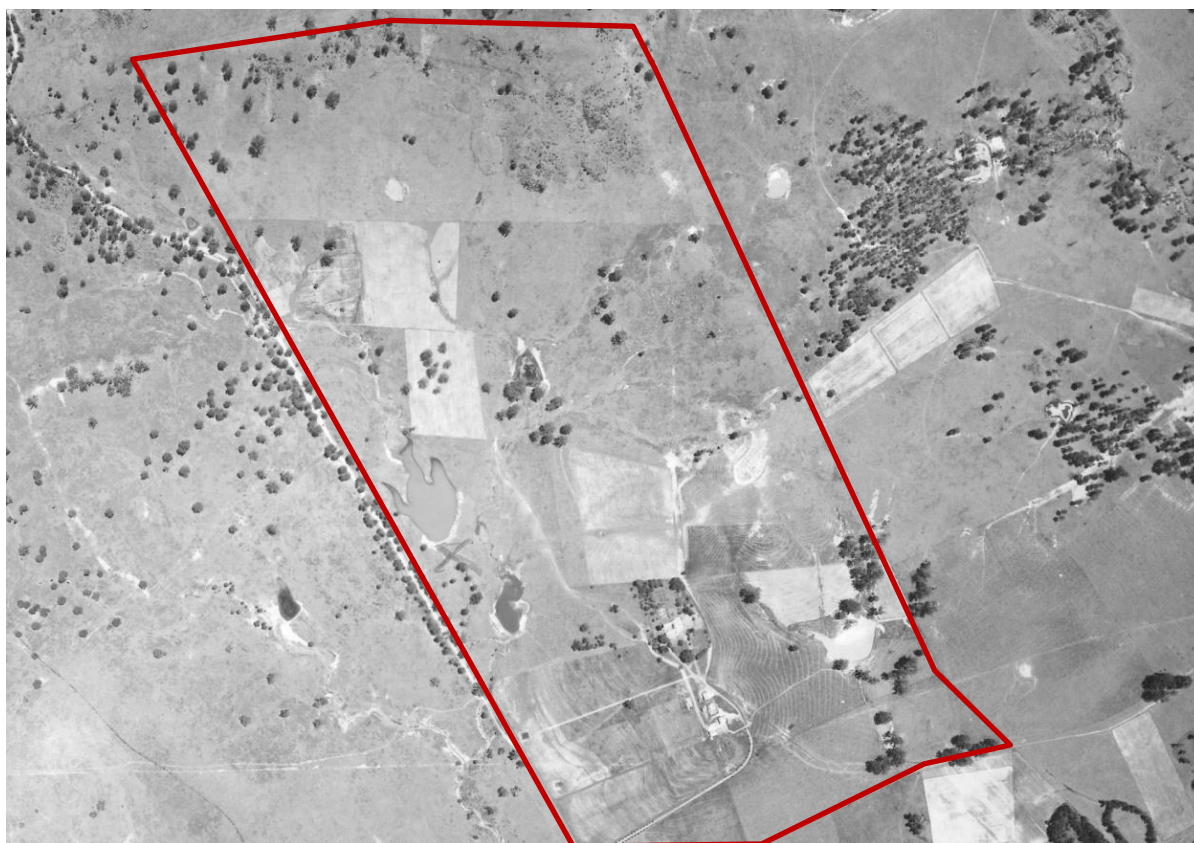
PICTURE 74 – 1955 VIEW SHOWING THE APPROXIMATE SITE AREA

A new driveway to the property from St Andrews Road was also established in 1950s. The 1955 aerial (Figure 35) shows the driveway and the beginnings of the avenue of trees lining the drive at the western end adjacent to St Andrews Road. St Andrews Road was established along what was originally a farm track between Townson and Andrew Thompsons original land grants. The original drive remains apparent in the aerial view.

The aerial illustrates the site as largely cleared land, and shows the remains of vineyard terracing around the main house and outbuildings and extending to St Andrews Road and up to the knoll northeast of the main house. The aerial also shows the dams on the western side of the site which have been attributed to Charles Sturt's occupation of the property in the late 1830s. Analysis of historic aerial views indicates that 5 of the 10 dams were present prior to 1947 (being dams 2, 4, 6, 10 and 11). Dams 3 and 5 may have been constructed between 1956 and 1961 while dams 7-9 on the north side of the site appear to post-date 1955. The 1961 aerial also suggests that works may have been undertaken to the dam wall of dams 2-6 as the edge is much more defined.
