Conservation Management Plan

Varroville Estate: 166-176 St Andrews Road, Varroville

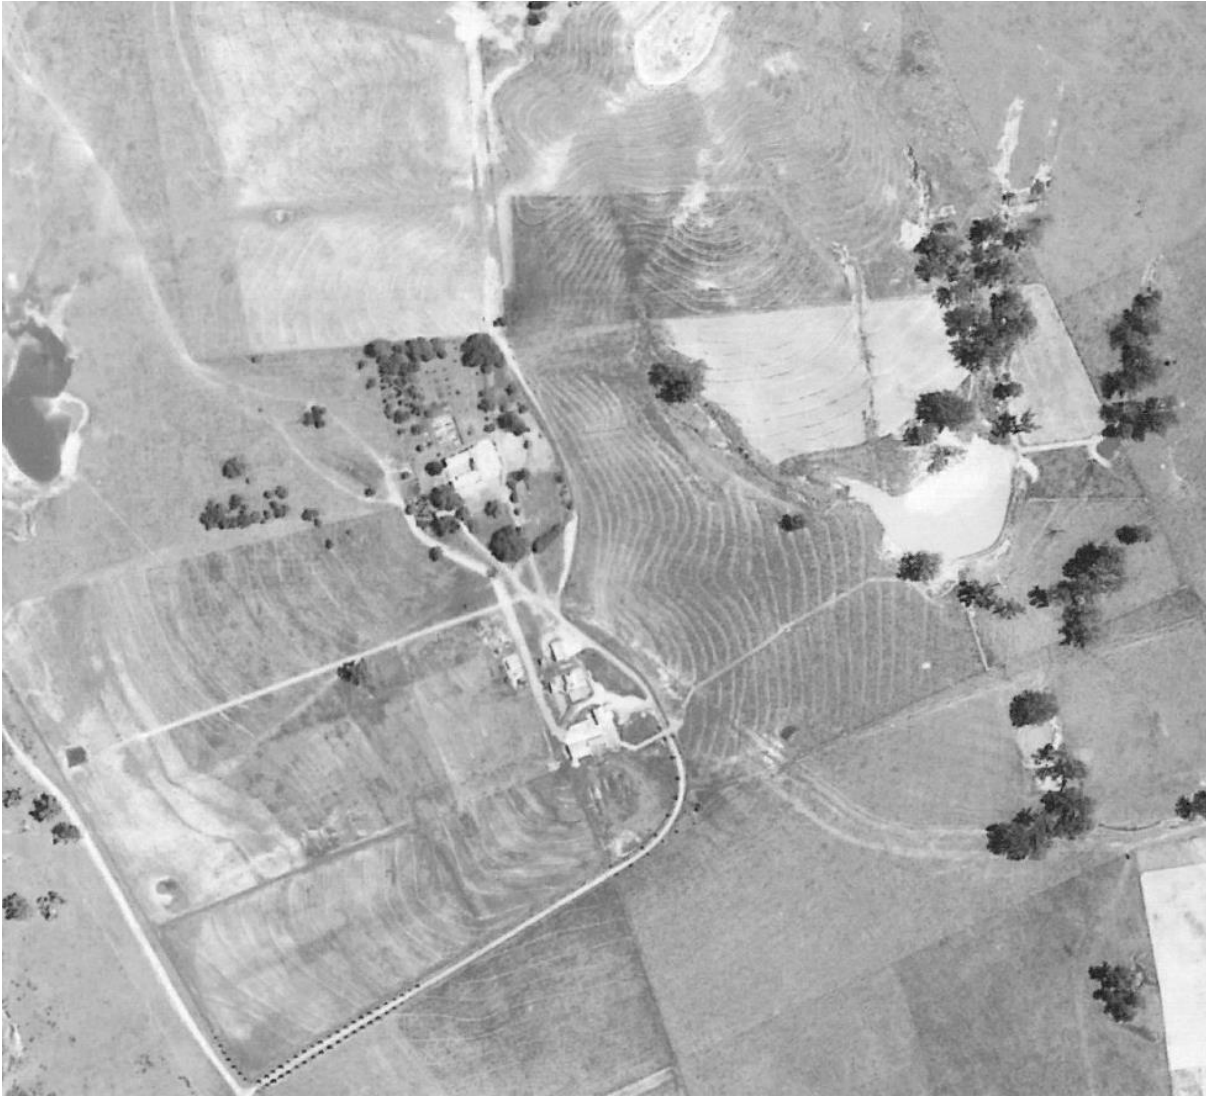
PICTURE 75 – DETAIL OF THE 1955 AERIAL SHOWING THE MAIN HOUSE, THE OUTBUILDINGS, REMNANTS OF THE ORIGINAL DRIVE, THE NEW DRIVE FROM ST ANDREWS ROAD (WITH NEW AVENUE OF TREE PLANTINGS) AND EXTENSIVE EVIDENCE OF CONTOUR TERRACING, EXTENDING TO ST ANDREWS ROAD, AND AROUND THE HILL NORTH OF THE MAIN HOUSE. THE NEWLY CONSTRUCTED DAIRY BUILDING IS ALSO SHOWN

The aerial illustrates the site as largely cleared land, and shows the remains of vineyard terracing around the main house and outbuildings and extending to St Andrews Road and up to the knoll northeast of the main house. The aerial also shows the dams on the western side of the site which have been attributed to Charles Sturt's occupation of the property in the late 1830s. Analysis of historic aerial views indicates that 5 of the 10 dams were present prior to 1947 (being dams 2, 4, 6, 10 and 11). Dams 3 and 5 may have been constructed between 1956 and 1961 while dams 7-9 on the north side of the site appear to post-date 1955. The 1961 aerial also suggests that works may have been undertaken to the dam wall of dams 2-6 as the edge is much more defined.

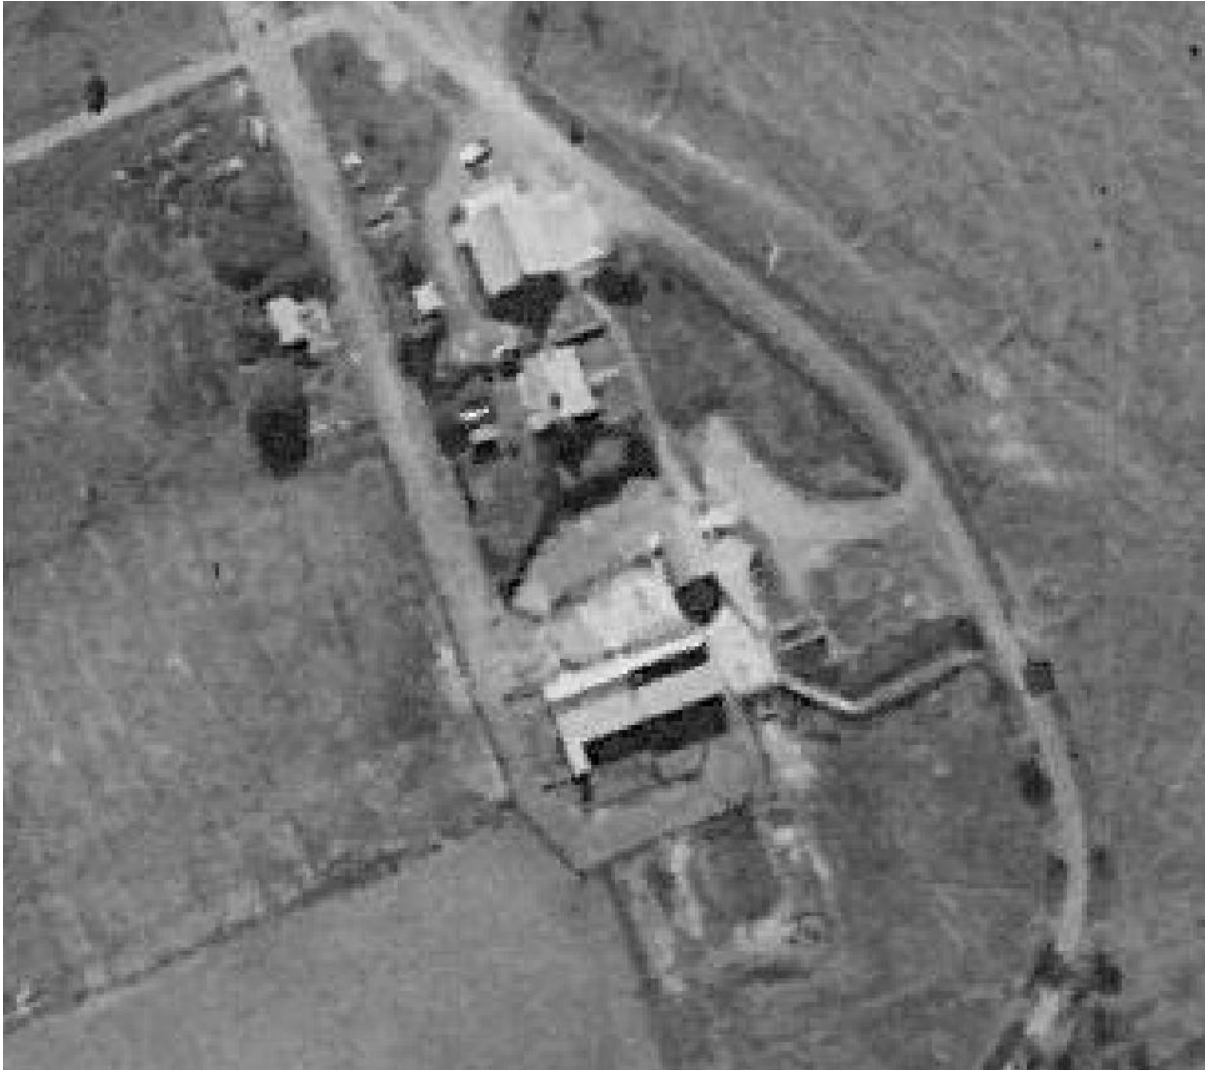
PICTURE 76 – DETAIL OF THE OUTBUILDINGS SHOWING THE RECENTLY CONSTRUCTED DAIRY
SOURCE: LAND AND PROPERTY INFORMATION

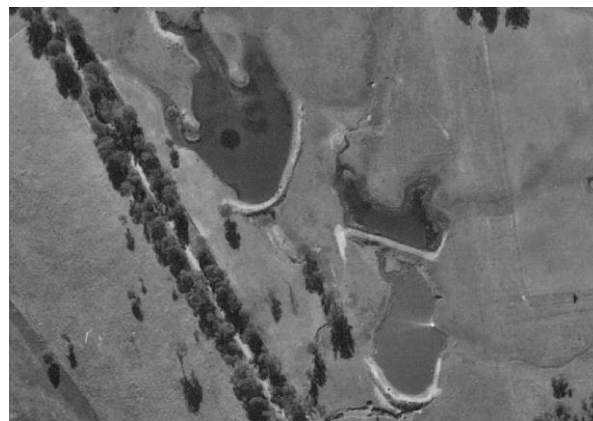
PICTURE 78 – DETAIL OF THE WESTERN LAKES, DAMS 2, 3 AND 4 WHICH ARE SHOWN WITH A MUCH MORE DEFINED EDGE TO THE DAM WALLS
SOURCE: LAND AND PROPERTY INFORMATION

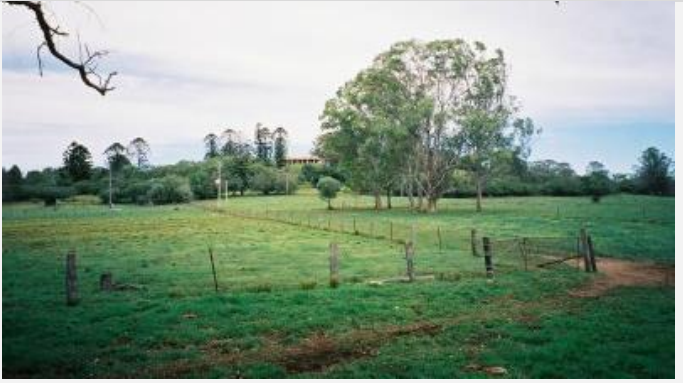
<p>THE WINERY PRECINCT (SOURCE: HERITAGE OFFICE NSW-SHI LISTING FORM).</p>

<p>is a detached timber and brick structure behind the cottage with a hip end gable roof.</p> <ul style="list-style-type: none"> Winery: Double gable, random rubble stone building with stone quoins, lintels and sills. The front has a double opening door and two six paned windows. The rear of the building is two storeys high, to compensate for the slope of the hill. It has three square windows placed just beneath the eaves.

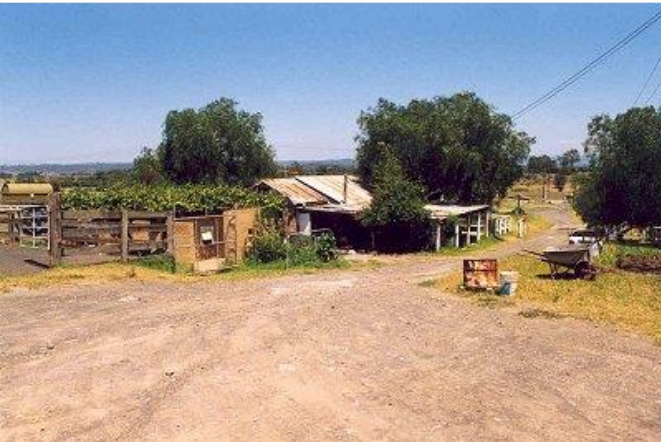
<p>FORMER 1880S DAIRY (SOURCE: HERITAGE OFFICE NSW-SHI LISTING FORM).</p>   <p>WESTERN FAÇADE OF THE DAIRY (CMP, 2001)</p>

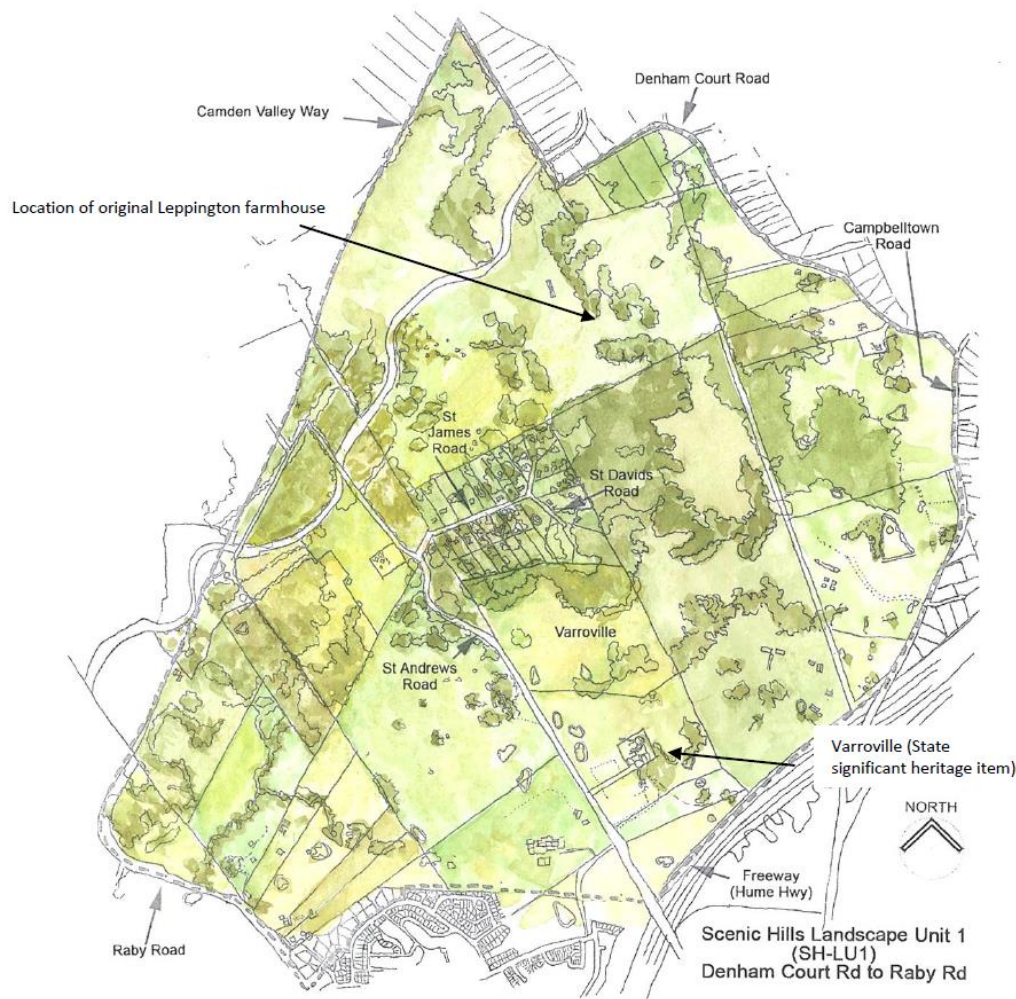
FIGURE 43 – ILLUSTRATION OF LANDSCAPE UNIT 1 COMPRISING VARROVILLE

The scenic values of the site have been assessed by Paul Davies and Geoffrey Britton in 2011 as part of the *Visual analysis of Campbelltown's Scenic Hills and East Edge Scenic Protection Lands*, October 2011. The visual qualities of the Scenic Hills in which the subject property is located have been assessed¹²⁸ and 'Varroville' and the subject property are included in Scenic Hills Landscape Unit 1 (SH LU 1), which is characterised by retained pastoral character on the lower slopes and foothills, patches of remnant indigenous woodland or regrowth thereof, extensive areas of land infested with *Olea europaea* ssp. *cuspidata* (African olive), with a small scattering of modestly scaled buildings along St Andrews Road and St Davids Road.

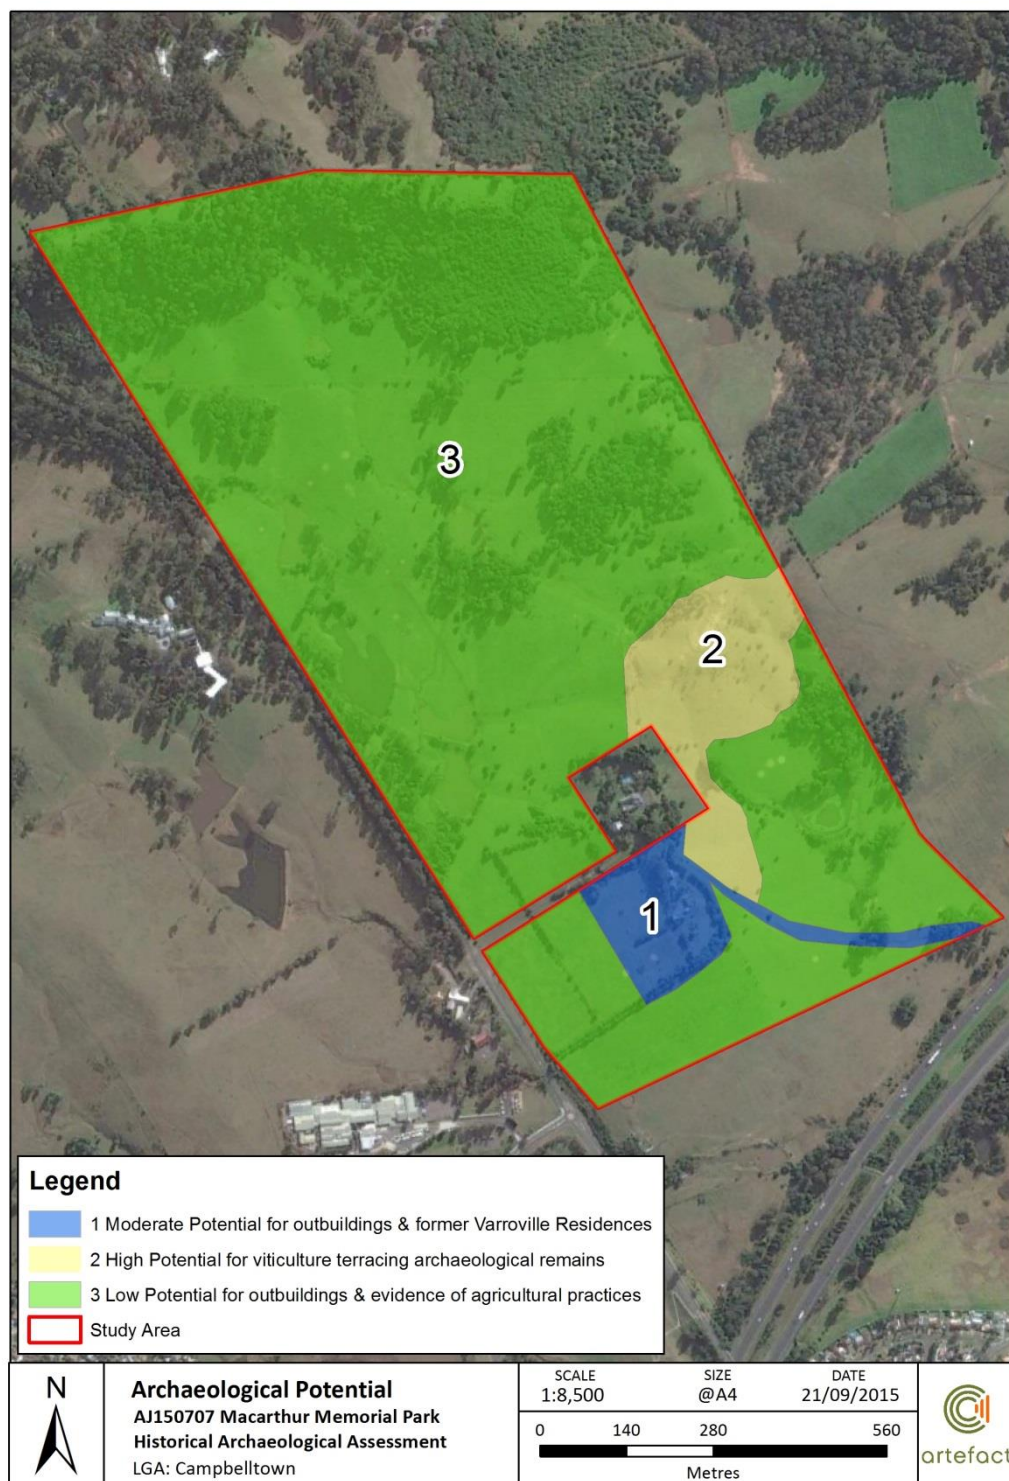
FIGURE 46 – ARCHAEOLOGICAL POTENTIAL OF THE STUDY AREA

The historical archaeological assessment found that:

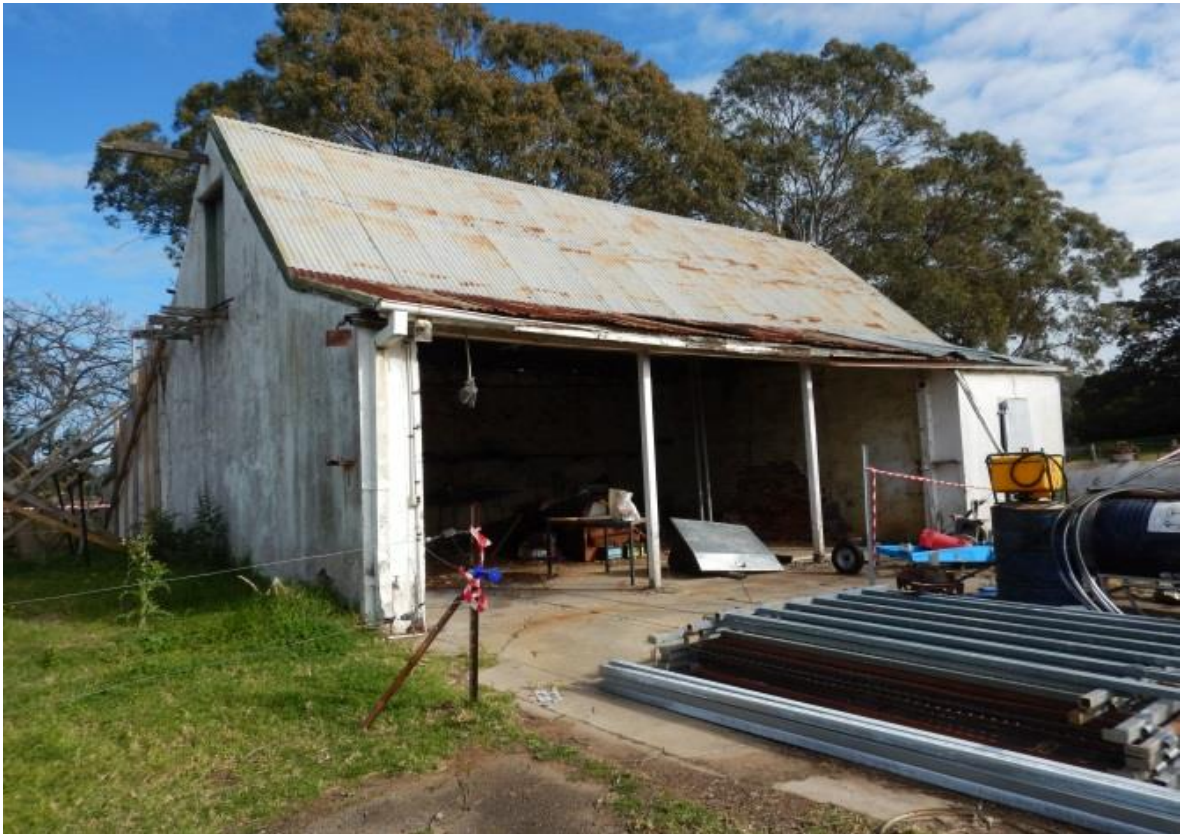
Image caption	Former Coach House (principal eastern façade)				
Image year	2015	Image by	Fiona Binns	Image copyright holder	Urbis Pty Ltd

There is no conclusive evidence that confirms the date of construction of the former coach house; however, stylistically it is likely to be a late colonial/early Victorian construction (c.1830-1860). Its extant materials are suggestive of this time period. However, the former coach house has been modified in the c1950s for use as machinery shed. This included works to the principal eastern façade and likely was also when the concrete floor was added. It is presently in poor condition.

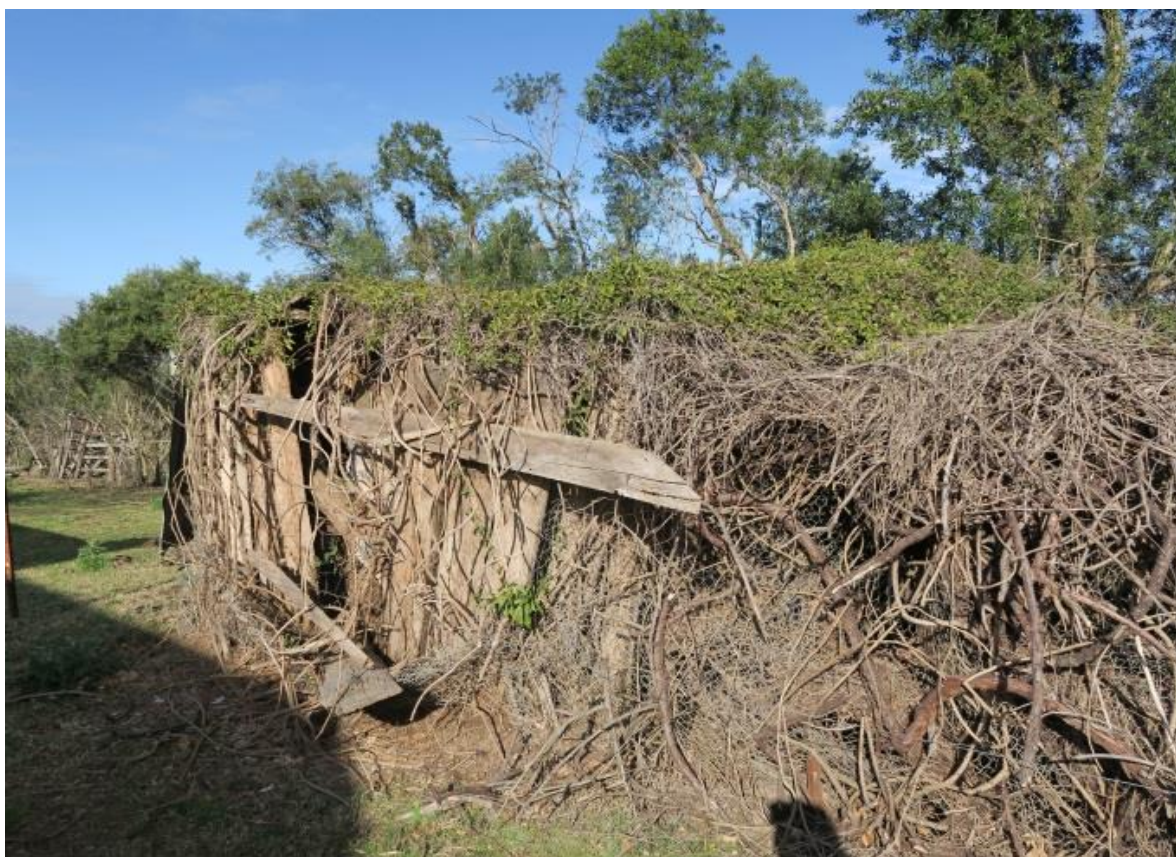
Image caption	Timber Slab Hut				
Image year	2015	Image by	Fiona Binns	Image copyright holder	Urbis Pty Ltd

Whilst it is said that Townson lived in uncomfortable conditions on his grant while developing the farm and homestead, and it has been speculated that he may have lived in the slab hut, which would infer a construction date of c.1810, there is no conclusive historical evidence that confirms the date of construction for the slab hut at Varroville. A comparison with other slab hut buildings shows that it is stylistically likely to be an early 1800s development and is immediately comparable to other examples in its construction techniques, however the typology and method of construction does not change considerably.

without characteristic features such as windows or a stone chimney. It is noted that these features may have been previously extant; however the structure is simplistic even in the 1950s views of the site (refer Figure 34). Its present ruinous condition prevents a detailed physical analysis. With consideration for the simplicity of the structure, the use of the property and examination of slab hut typologies, it is considered that this structure was constructed as more of a utilitarian structure, rather than being occupied as Townson's first hut.

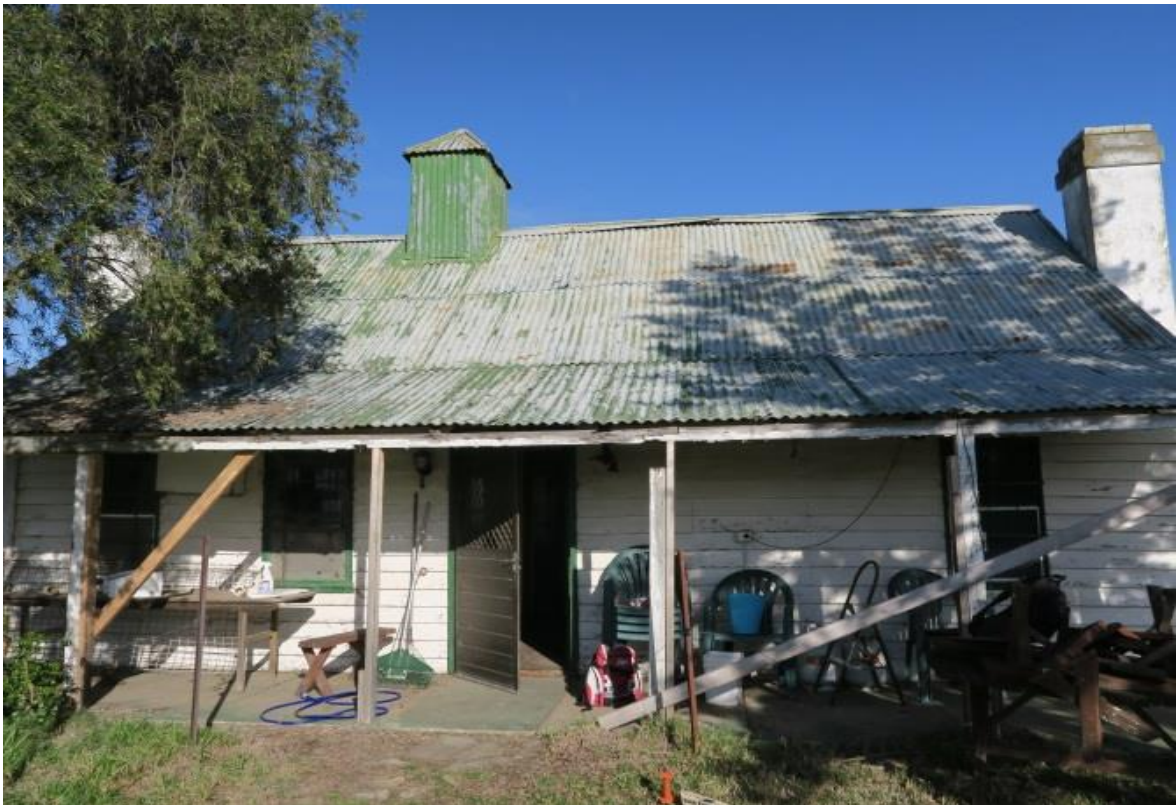
Image caption	The Cottage (principal eastern façade)				
Image year	2015	Image by	Fiona Binns	Image copyright holder	Urbis Pty Ltd

The remnant cottage at Varroville is a significant structure of the Varroville farm complex, which contributes to its overall significance. The extant cottage at Varroville is of simple construction and incorporates timber, weatherboard and masonry and features gable ends with masonry brick chimneys. It is presently in fair condition although derelict.

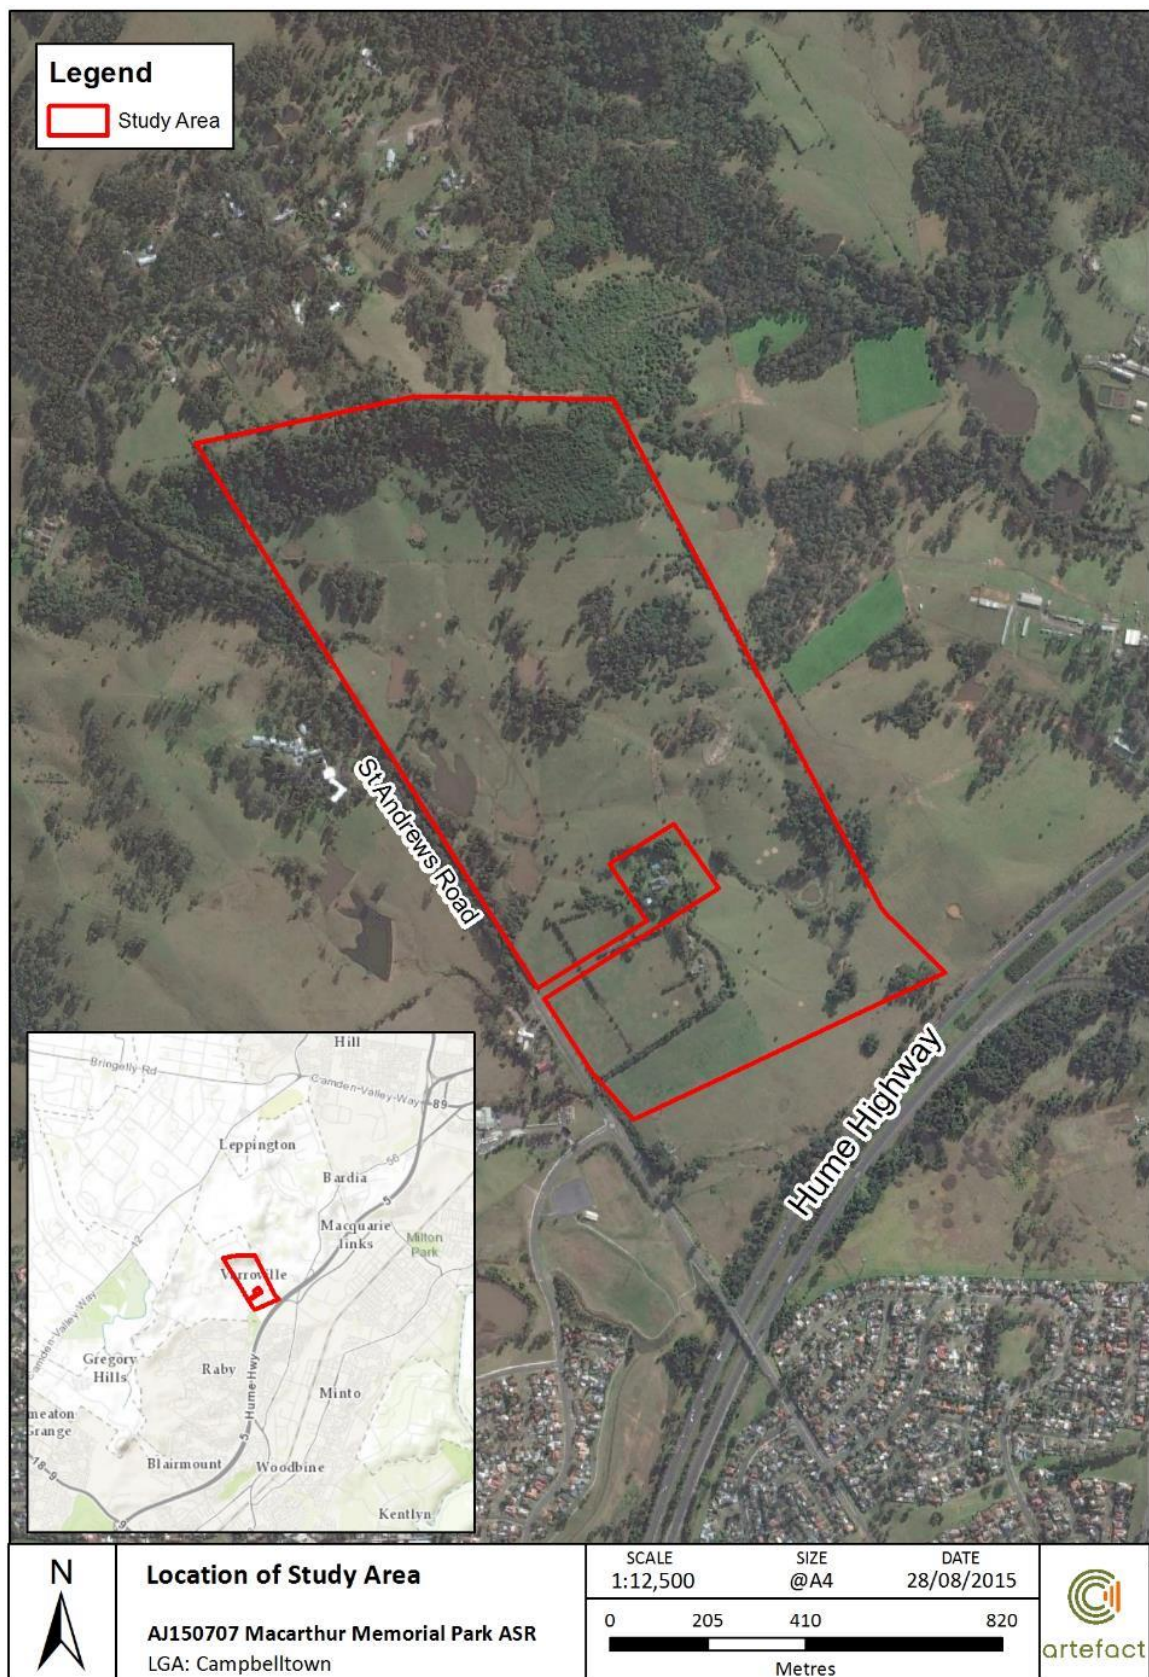
Figure 2: Study area outlined in red.¹

The study area (Figure 2) is located within a rural setting at 166-176 St Andrews Road, Varroville. The Hume Highway lies to the south of the study area, rural and residential properties are located along the northern and eastern boundaries. St Andrews Road bounds the study area to the west.

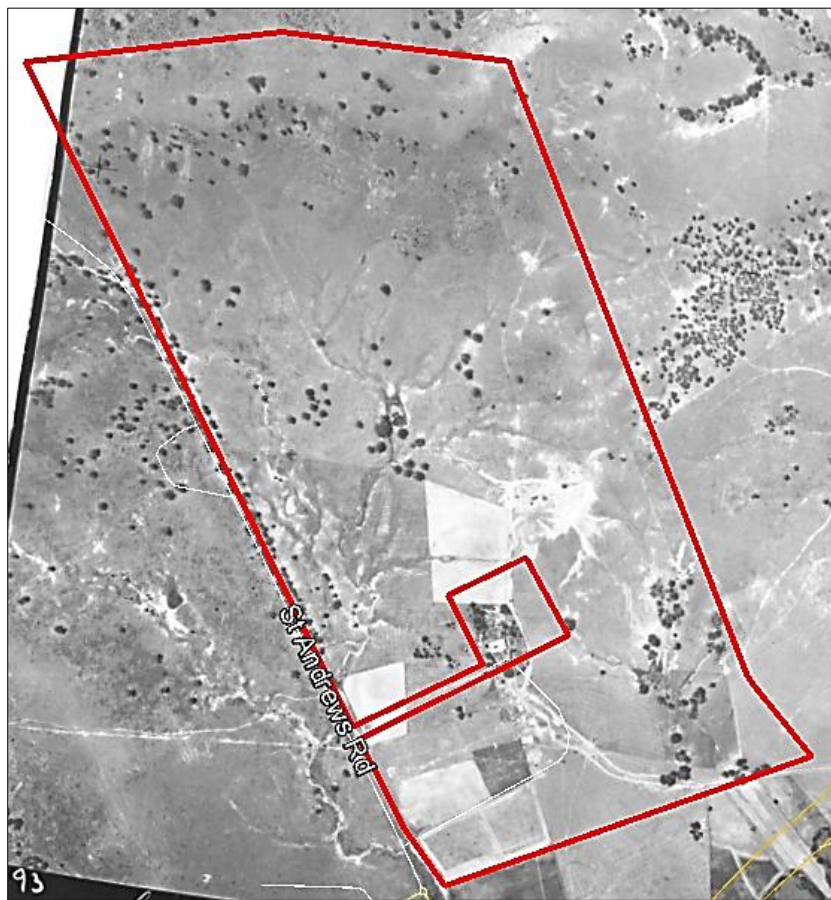
Figure 9: 1947 aerial photograph overlayed with study area boundary as indicated by red line.

The southern portion of the study area consists of a terraced landscape including furrows down the hill slope to the east of the estate (Figure 21). The paddocks adjacent to the outbuildings (Figure 22) have not been subject to a significant degree of disturbance, as evidenced by the historical aerial photographs (Figures 9 and 10).

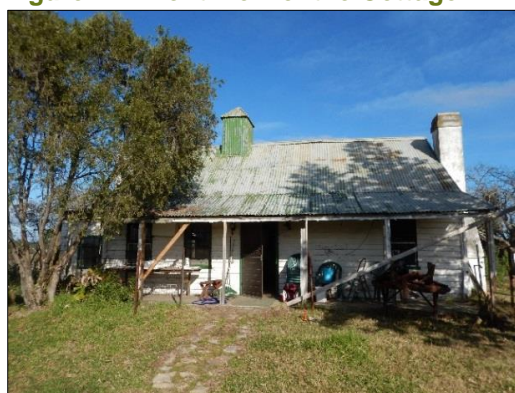
Figure 12: Front view of the Cottage.

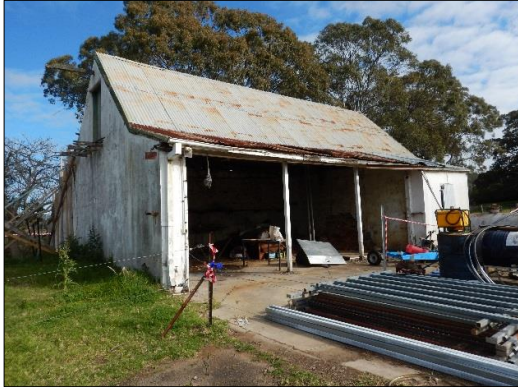
There are concrete foundations present as part of a garden path to the residential cottages and concrete foundations have been added to the coach house. The outbuildings include, a cottage (Figure 12), a coach house (Figure 13), a slab hut (Figure 15), a dairy (Figure 17), a chicken coop (Figure 18), and a wool press area with remnants of the wool manufacturing equipment present on site (Figure 19). The area around the outbuildings appears to have been impacted to a higher extent than the rest of the study area. Regrowth scrub is present throughout the area and has completely enclosed the rear of the slab hut (Figure 16).

Figure 13: Front view of coach house.

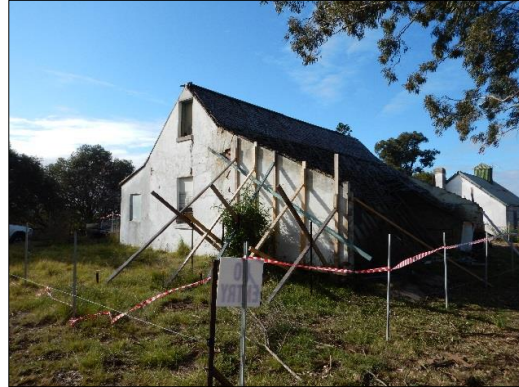
Figure 14: Rear perspective of coach house.

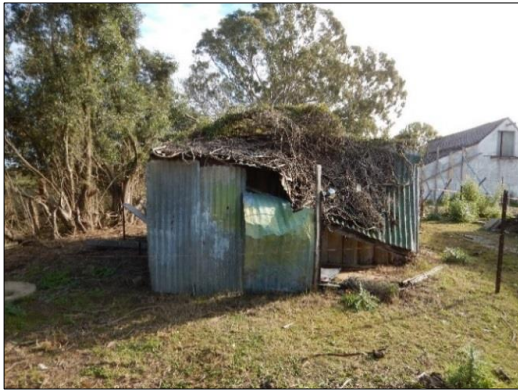
Figure 15: Front view of slab hut.

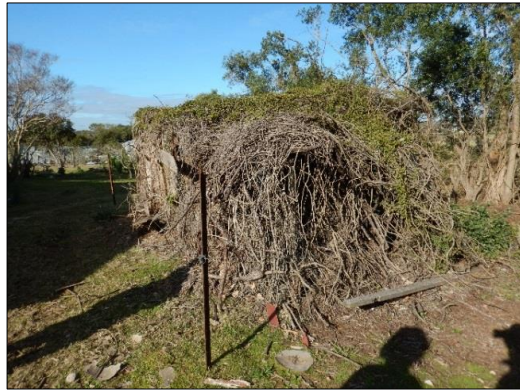
Figure 16: Rear view of 19th century slab hut.

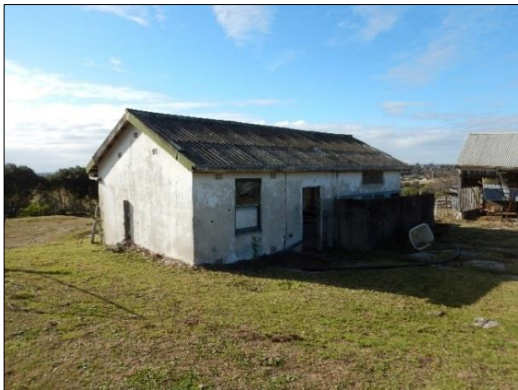
Figure 17: Rear view of the dairy.

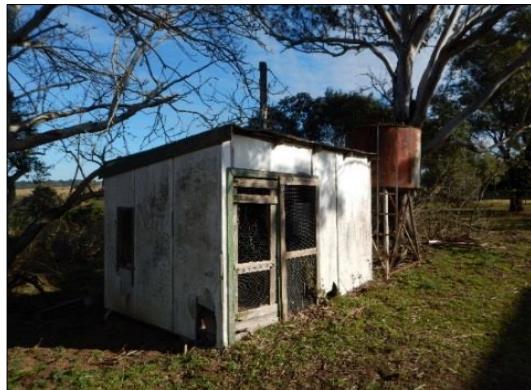
Figure 18: Front view of chicken coop.

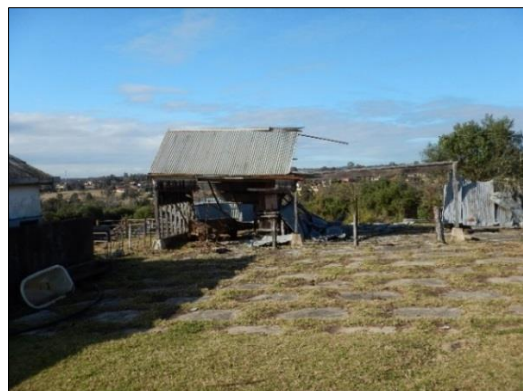
Figure 19: Westerly view of wool shed.

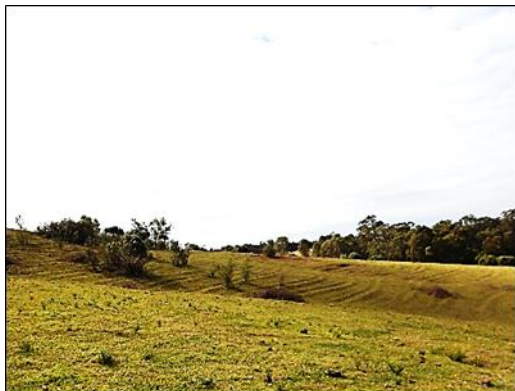
Figure 21: North-west perspective of terracing on hillside.

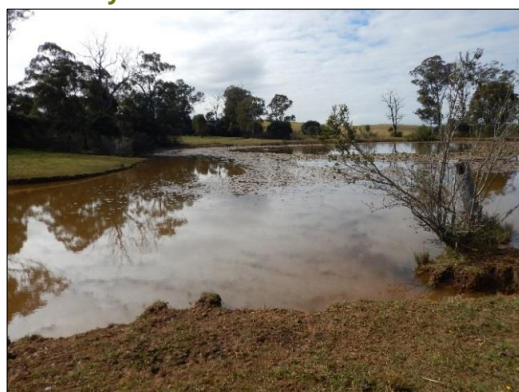
Several dams were identified on the property (Figure 23 and Figure 24). The dimensions of the dams vary widely. Presence of dams in the study area indicate that such water sources would have been part of a water management system used for livestock and agriculture.

Figure 23: View of dam in southern section of the study area.

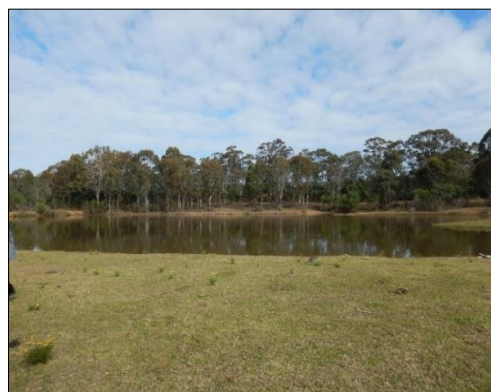
Figure 24: View of dam on the western side of Varroville estate.

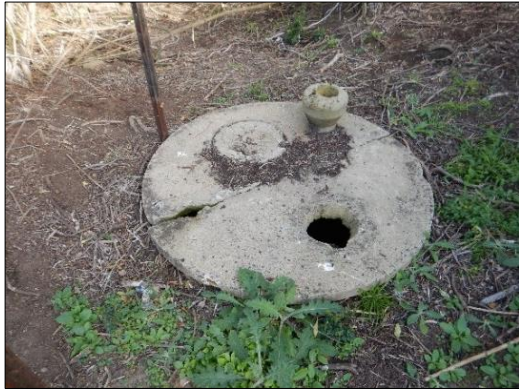
Two cistern/wells were identified in the study area around the outbuildings. One cistern/well is situated at the northern end of the slab hut (Figure 25) and one is located to the rear of the dairy (Figure 26).

Figure 25: Well located adjacent to the slab hut.

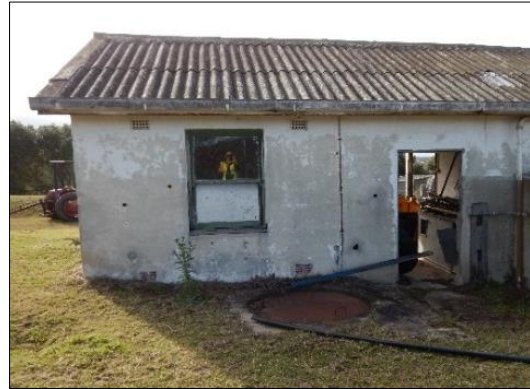
Figure 26: Cistern located at the rear of the dairy.

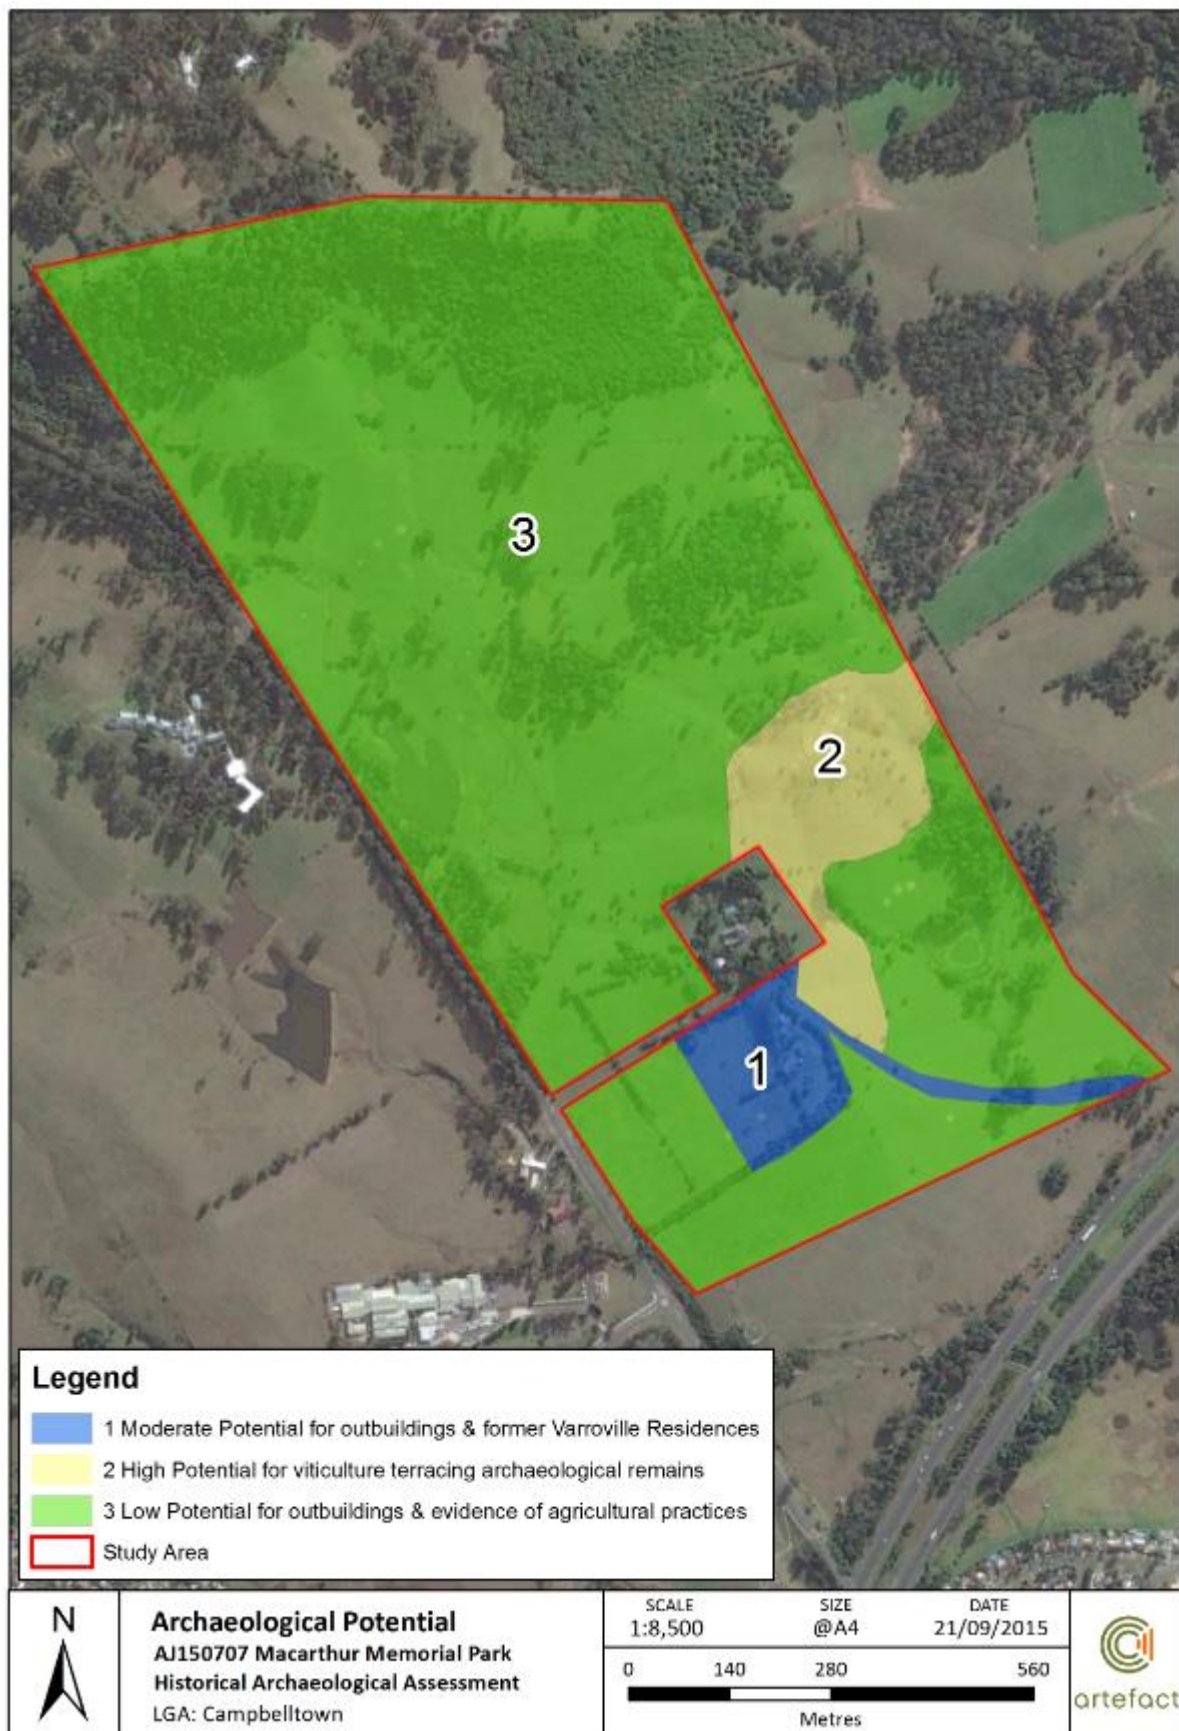
Figure 27: Archaeological potential of the study area.

This archaeological potential of the study area is summarised in Table 1 and illustrated in Figure 27.

Location	Phase	Possible Archaeological remains	Potential
Southwest of study area (Area 1)	1-4	Outbuildings <ul style="list-style-type: none"> • tree boles and evidence of burning from land clearance; • post holes associated with paddocks and stockyard fencing; • structural elements such as post holes associated with former structures such as coops, stalls, stockyard and stables; • structural elements such as post holes, brick or stone footings, hearths associated with the former cottage, outbuildings or similar structures; • wells/cisterns; • underfloor deposits with artefacts; • yard surfaces and deposits with artefacts; • rubbish pits containing artefacts and other archaeological material; • deposits and backfill containing artefacts within cisterns/wells; • evidence of small scale farm industry such as smithying and coopering; • drainage channels, brick, stone, ceramic or terracotta; • surfacing of former garden paths; • road base, drainage and artefacts associated with the carriage way; and • soils containing palynological evidence. 	Moderate

Southeast of study area (Area 2)	1-3	Vineyard and terracing <ul style="list-style-type: none"> • post and stake holes; • furrows and terracing; and • terracotta pipes and irrigation lines. 	High
Rest of Study area (Area 3)	1-4	Estate paddocks and dams <ul style="list-style-type: none"> • evidence of land clearance such as tree boles and areas of burning; • post holes associated with paddocks and boundary fencing; • soil deposits containing plough marks and agricultural furrows; and • archaeological remains associated with water management and dams such as artefacts, clay banks, other structural evidence. 	Low

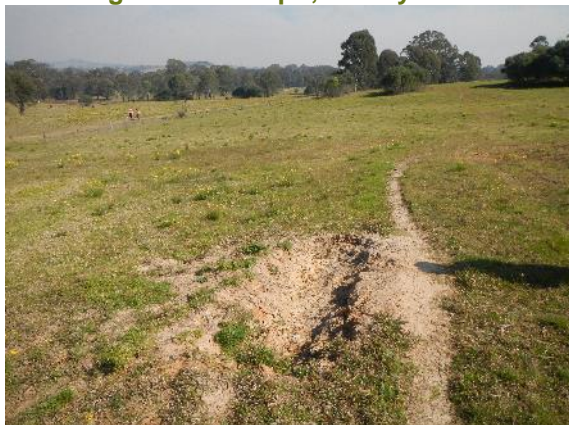
Plate 5: geotechnical pit, survey unit 1

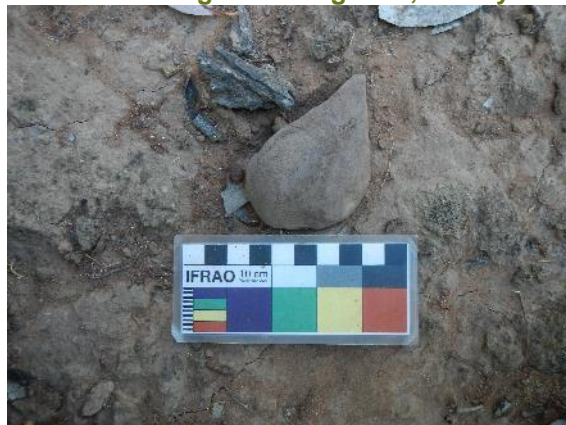
Plate 6: Basalt ground fragment, survey unit 1

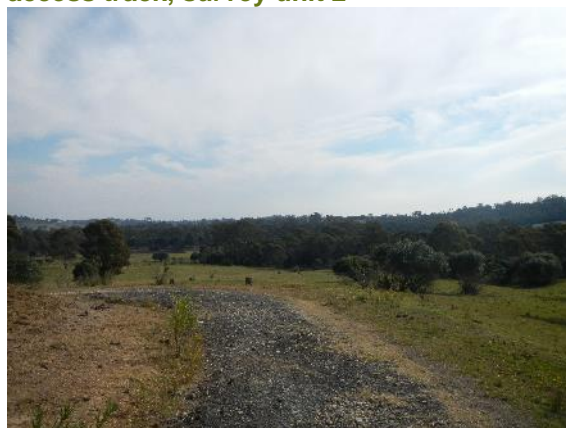
Survey unit 2 is located to the south east of survey unit 1. This survey unit includes the lower slopes of the escarpment as well as the north to south trending ridgeline along the eastern boundary of the study area. Landforms in this survey unit are characterised as slope and crest. The majority of the survey unit is covered by dense grasses which limited visibility (Plate 7). Visibility is limited to exposures created by vehicle access tracks which run along the northern boundary of the survey unit and the eastern ridge line (Plate 8). A drainage line runs north east to south west through the central portion of the survey unit (Plate 9). Disturbance was noted by the construction of a dam along the western boundary of the survey unit. The access track along the eastern ridge line has been stabilised in some places with introduced fill materials (Plate 10).

Plate 10: Introduced fill located on ridge line access track, survey unit 2

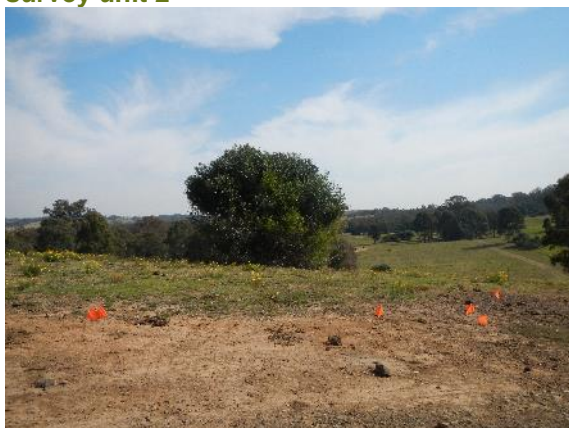
There were four previously recorded sites and four newly recorded sites located in survey unit 2. These all consisted of stone artefacts and were located within areas of exposure on vehicle tracks. Artefacts identified at Varroville Artefact Scatter 2 were found to be eroding out of a vehicle track (Plate 11). These sites will be discussed in more detail in Section 6.3.

Plate 11: Varroville Artefact Scatter 2, view east orange flags indicate artefact locations, survey unit 2

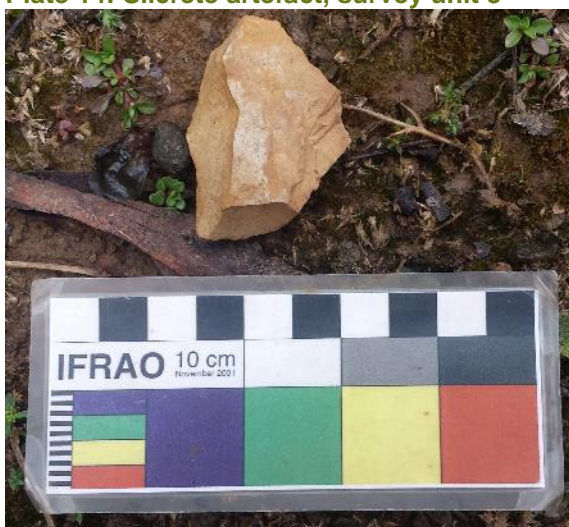
Plate 14: Silcrete artefact, survey unit 3

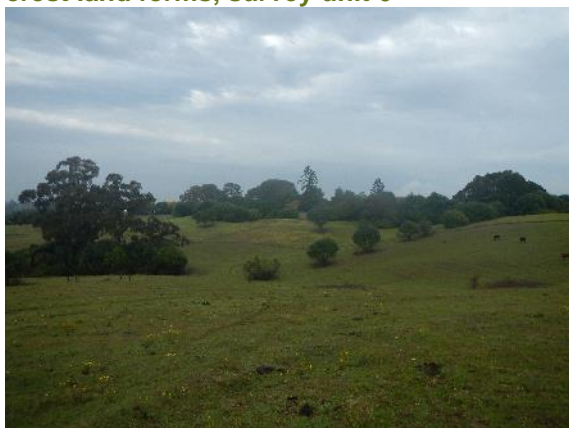
Plate 21: View south west across slope and crest land forms, survey unit 6

Survey unit 6 encompasses the southern extent of the eastern ridgeline as well as slope and flat landforms. The survey unit consists of cleared fields. Dense grass covers the majority of the area with some stands of mature and new growth eucalypts. A drainage channels runs south through the eastern portion of the survey unit which has been dammed in several places. Thick vegetation surrounds the drainage line and dams. It was not possible to inspect all of the mature native trees as they were surrounded by impenetrable weeds. A possible scarred tree was identified by Glenda Chalker during survey. On further inspection the scar did not appear to demonstrate any cultural features such as cutting marks and was found to be irregular in shape suggesting that it is a natural occurrence rather than cultural (Long 2015).

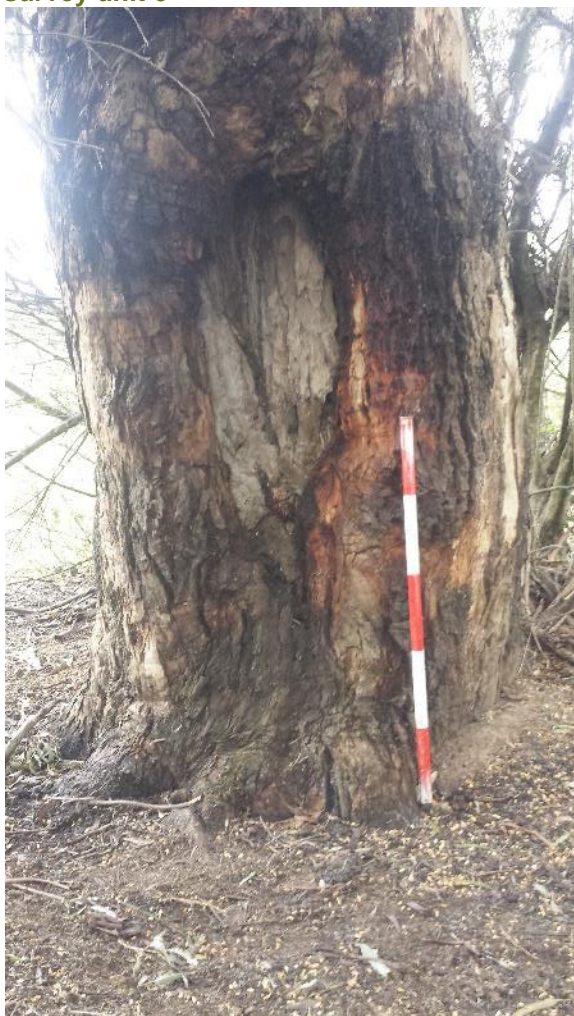
Plate 23: Detail of scar assessed as natural, survey unit 6

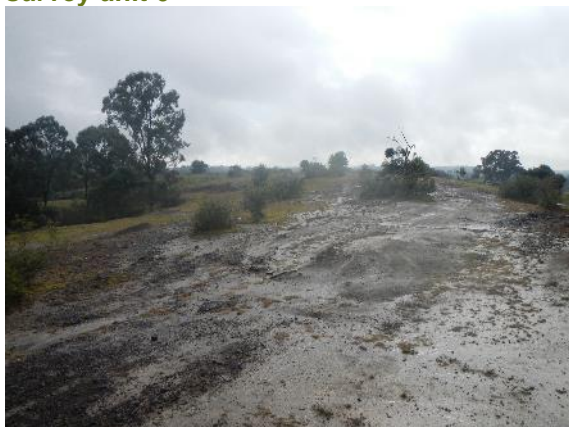
Visibility was generally low throughout the survey unit. Visibility was impeded by dense vegetation and heavy rains on the second day of survey that resulted in mud obscuring exposures. Exposures occurred on vehicle tracks and in areas of erosion on the crest of the ridgeline and slopes. Disturbance was noted along the southern slope of the eastern ridgeline where terracing associated with vineyards has occurred. Furrows were apparent across the study area and the drainage line appears to have been highly modified with the construction of various dams.

Plate 25: Wet conditions impeding visibility, survey unit 6

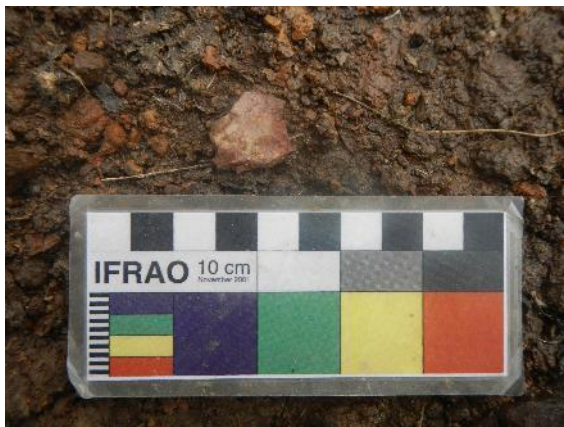
Plate 26: Silcrete artefact, survey unit 6

There was one previously recorded site and two newly recorded sites located within survey unit 6. All of the sites consist of stone artefacts and are located within exposures. These sites will be discussed in more detail in Section 6.3.

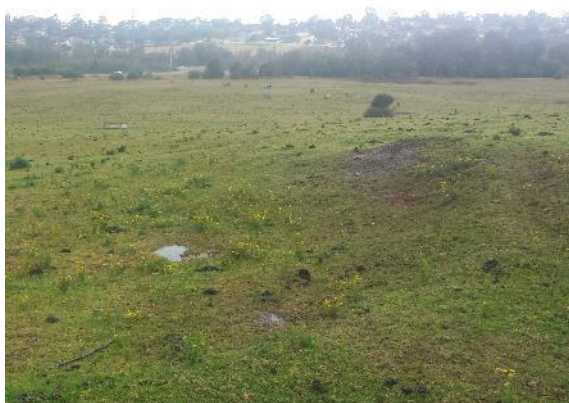
Plate 29: Ground disturbances associated with agricultural activities, survey unit 7

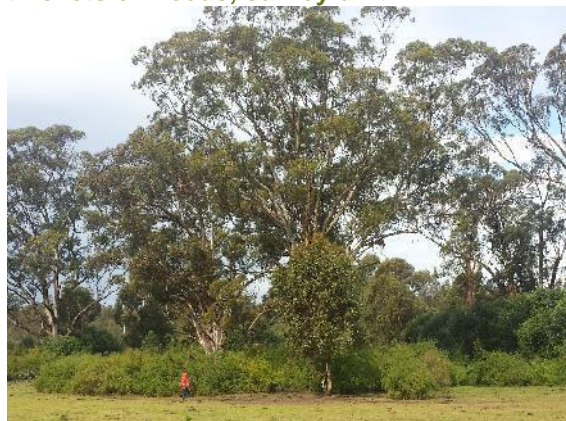
Plate 28: Mature vegetation surrounded by thickets of weeds, survey unit 7
