Conservation Management Plan

Varroville Estate: 166-176 St Andrews Road, Varroville

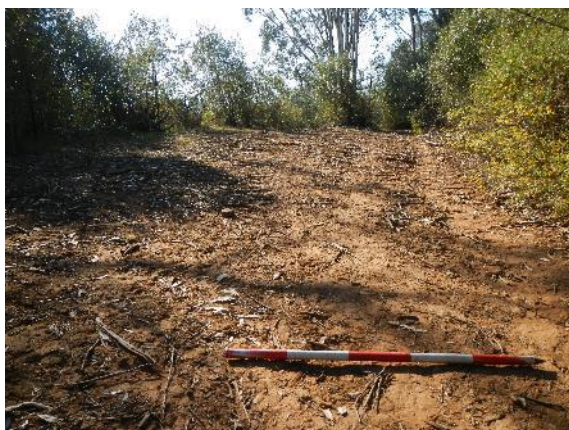
Plate 31: View east across VAS1, scale: 1 m

The current assessment identified the original artefacts recorded as well as an additional six artefacts (n=10). The site generally appeared to be relatively undisturbed and intact (Plate 31). Visibility was high within the exposure except for areas of dense leaf litter (Plate 32). It is possible that more artefacts could be located in these areas.

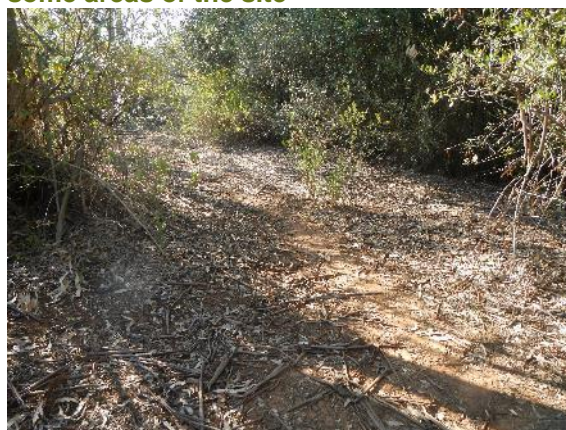
Plate 32: Visibility impeded by leaf litter in some areas of the site

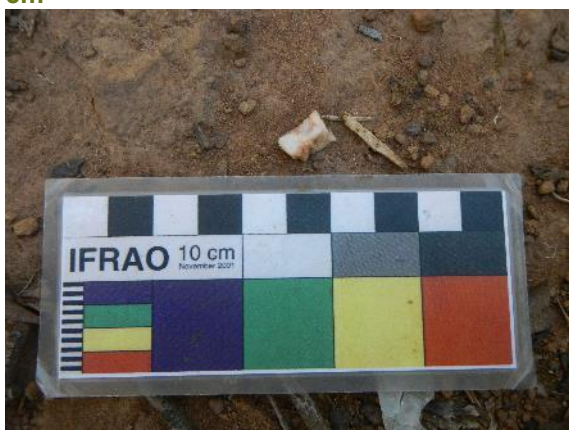
Plate 33: Quartz angular fragment, scale: 10 cm

All of the artefacts were identified within an unformed vehicle track with some artefacts eroding from out of the ground surface. Silcrete was the dominant raw material identified (n= 9, 90%) with one quartz artefact also recorded (10%, see Plate 33). The assemblage consists of broken flake fragments (n=4, 40%), two cores (20%), two complete flakes (20%), one angular fragment (10%) and one pink silcrete blade (10%, see Plate 34).

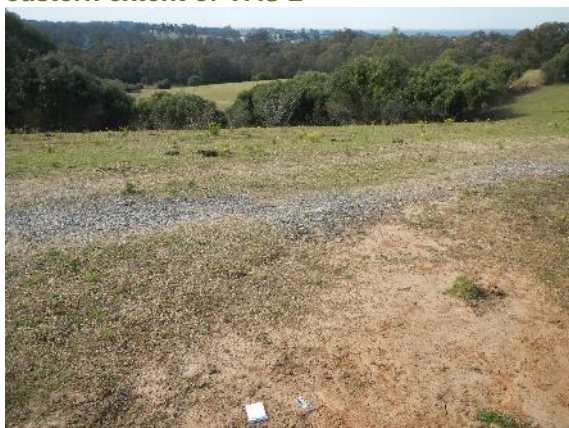
The current assessment relocated the original artefacts recorded at VAS2 as well as an additional 39 artefacts (n=50). The site was found to be in a similar condition to when it was first recorded. Visibility was generally high throughout the exposure. Visibility was lower along the eastern extent where a layer of foreign gravels has been deposited along the track (Plate 35). Aside from the introduced gravels disturbance was generally very low across the site. The western portion of the site consists of a level grassed area of PAD (Plate 36). Artefacts were found to be eroding out of the surface of the vehicle track therefore it is likely that this undisturbed area could contain subsurface archaeological deposits (Plate 37).

Plate 35: Introduced grey gravels along the eastern extent of VAS 2

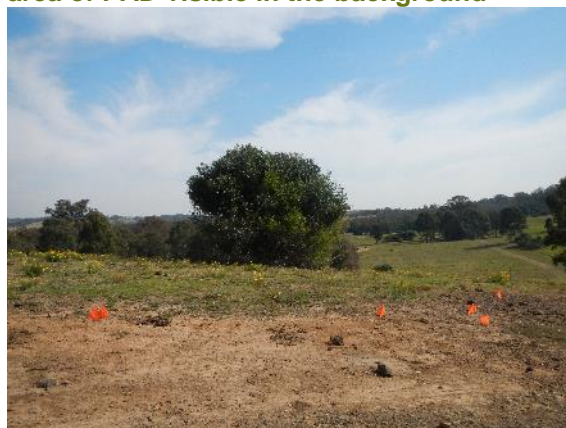
Plate 36: Flags indicate artefact locations, area of PAD visible in the background

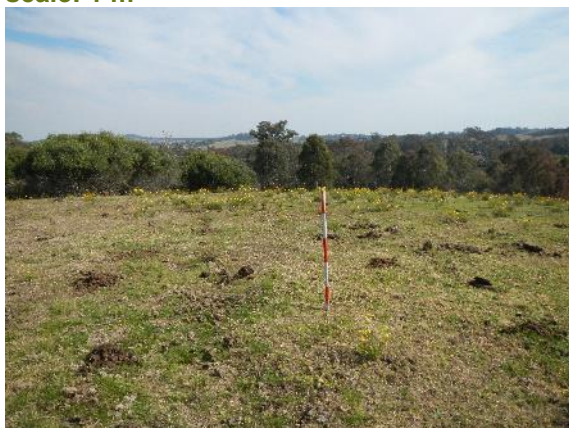
Plate 37: Flat grassed area extending west from the main concentration of artefacts, scale: 1 m

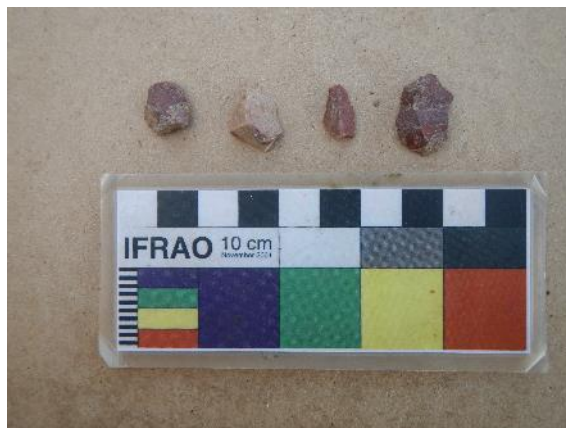
Plate 38: Red and pink silcrete artefacts, VAS 2, scale: 10 cm

The assemblage consists predominantly of silcrete artefacts (n=41, 82%, see Plate 38). Other raw materials identified include quartz (n= 8, 16%) and one chert piece (2%). Artefact types identified include complete flakes (n= 20, 40%), flake fragments (n=11, 20%), angular fragments (n= 17, 34%), a core (2%) and one blade (2%).

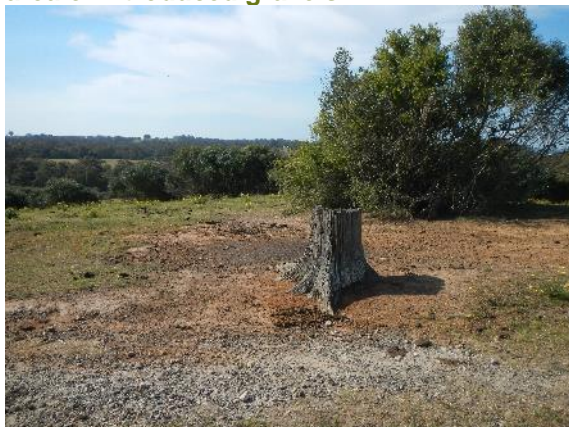
was generally high except for areas covered with introduced gravels (Plate 39). Disturbance levels were generally low aside from the area covered by gravel.

Plate 39: Exposure containing artefacts, note area of introduced gravels

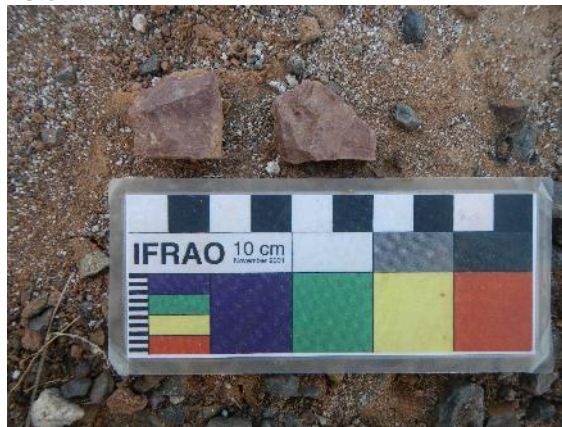
Plate 40: Red silcrete artefacts, VAS3, scale: 10 cm

The assemblage consists of silcrete flaked artefacts (Plate 40). Artefact types identified include complete flakes (n= 5, 50%), cores (n= 3, 30%), and broken flakes (n= 2, 20%).

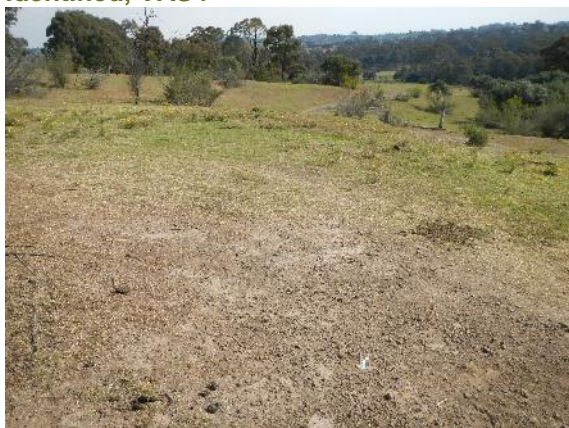
Plate 41: Exposure in which artefact was identified, VAS4

The current assessment did not relocate the original artefacts identified at VAS4 however one additional artefact was identified (n=6). Visibility was high across the exposure and the site appeared to be in a similar condition to the original recording. Minimal disturbance caused by erosion was noted across the exposure. It is likely that the artefacts have eroded from subsurface deposits.

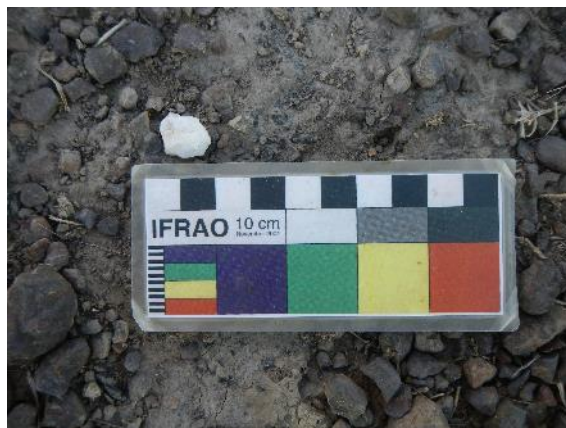
**Plate 42: Quartz artefact, VAS4, scale: 10 cm**

Of the artefacts recorded quartz was the predominant raw material (n=4, 67%), two silcrete artefacts were also recorded (33%). The assemblage consists of complete flakes (n= 3, 50%) and flake fragments (n= 3, 50%).

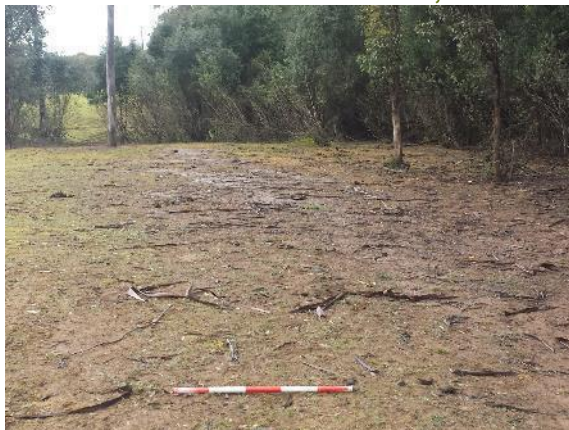
Plate 43: View south across VAS5, scale 1 m

The current assessment found VAS5 to be in an intact and good condition (Plate 43). Visibility was affected by the wet weather conditions at the time of survey. This resulted in lower visibility across the exposure than when the site was originally recorded. The site is located within an access track associated with a power line that runs along the western boundary of the study area. The exposure in which the artefacts are located appears to have been affected by erosion with artefacts identified embedded in the ground.

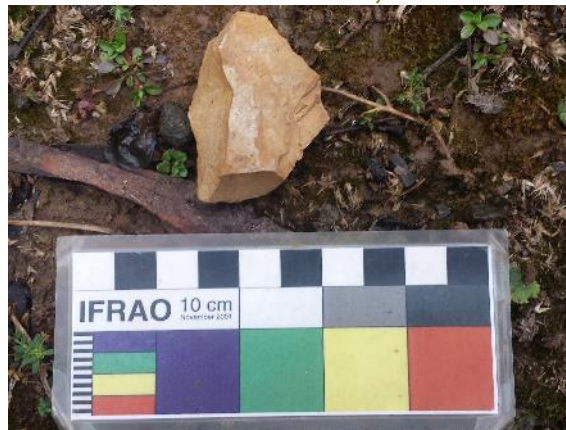
Plate 44: Yellow silcrete core, scale: 10 cm

The assemblage at VAS5 consists of 13 artefacts. Raw materials present include silcrete (n= 11, 86%, see Plate 44), quartz (n= 1, 7%) and IMT (n= 1, 7%). The assemblage consists predominantly of flake fragments (n= 8, 62%), with two complete flakes (15%) and one unifacial core (8%) also identified. Of the artefacts identified two silcrete artefacts were found to be embedded in the ground surface and so the reduction type was not identified. Retouch was noted on one of the complete flakes which appeared to have been backed.

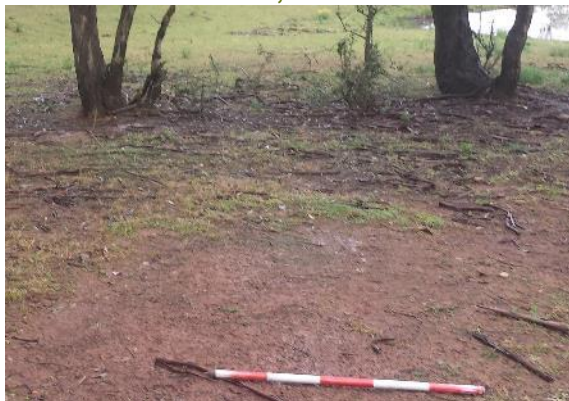
Plate 45: Area of exposure at recorded coordinates for VAS6, scale: 1 m

The current assessment did not identify the previously recorded artefacts at VAS6. Grass has overgrown much of the exposures in which the artefacts were recorded reducing visibility and exposure across the site (Plate 45). There were no obvious disturbances noted and the site appeared to be relatively intact and in good condition. The crest landform on which VAS6 and VAS5 are located appears to also be in a good condition with very little disturbances noted. It is likely that the crest would contain subsurface archaeological deposits (Plate 46). For this reason these sites have been included within the same extent mapped in Figure 6.

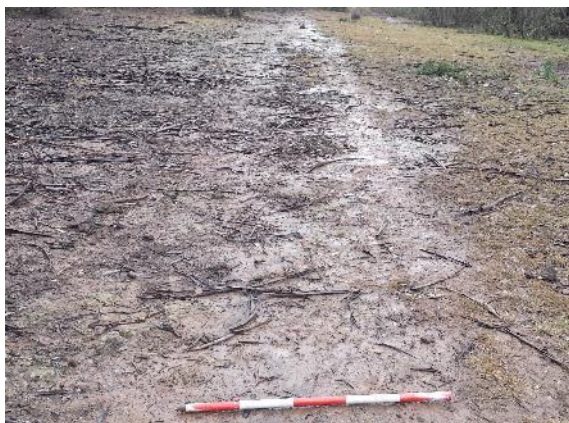
Plate 47: Vehicle track in which artefacts at VAS7 are located, scale: 1 m

The current assessment did not relocate the artefacts originally recorded at VAS7 however an additional five artefacts were identified within the vicinity of the recorded coordinates (n= 13). The artefacts were all recorded within an exposure caused by a vehicle access track (Plate 47). Given the wet conditions during the assessment visibility was reduced. Dense leaf litter in some areas also reduced the visibility within the exposures.

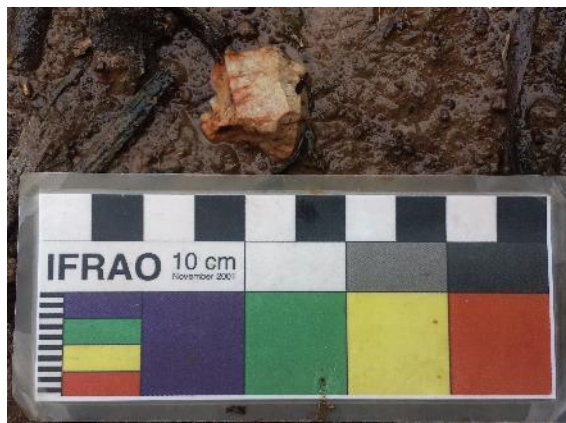
Plate 48: silcrete flake, scale: 10 cm

The assemblage consists of predominantly silcrete artefacts (n= 10, 77%). Quartz (n=1, 7%), IMT (n=1, 7%) and glass (n= 1, 7%) were also noted. Reduction types identified included broken flake fragments (n= 10, 77%), complete flakes (n= 2, 15%, see Plate 48) and one core (7%).

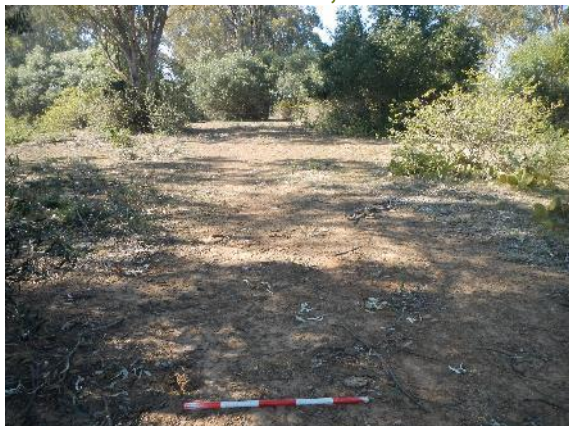
Plate 49: Location of VIF1, scale: 1 m

VIF1 was not relocated during the current survey. Upon inspection the slope in which the recorded coordinates place the find was heavily eroded (Plate 49). It is likely that the artefact has since been

washed away from its recorded location. Another artefact (VIF7) was recorded within 10 metres of VIF1.

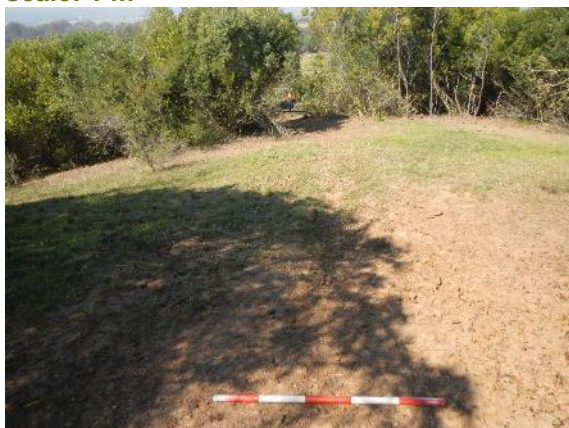
Plate 50: Location of coordinates for VIF2, scale: 1 m

The artefact at VIF2 was not relocated. The location of the recorded coordinates appeared to be heavily eroded with deep channels evidencing the erosive nature of the slope (Plate 50).

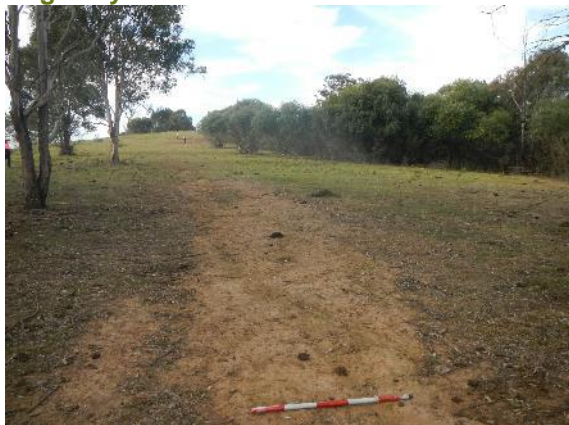
The isolated find was not relocated during the current assessment. The slope on which VIF3 was originally recorded appeared to be highly eroded and it is likely that the artefact has since been washed further down the slope (Plate 51). Newly recorded artefact scatter VAS8 was recorded down slope from VIF3. However it does not appear that VIF3 was recorded with the scatter.

Plate 51: Eroded track where VIF3 was originally recorded. Scale: 1 m

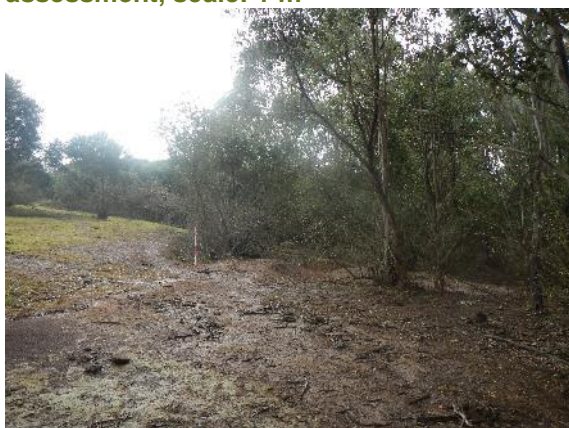
The artefact at VIF4 was not relocated during the current assessment. The area in which the recorded coordinates were located has been heavily trampled by cattle (Plate 52). The area was also waterlogged due to the wet weather conditions at the time of survey.

Plate 52: Recorded location of VIF4, very waterlogged and trampled at time of assessment, scale: 1 m

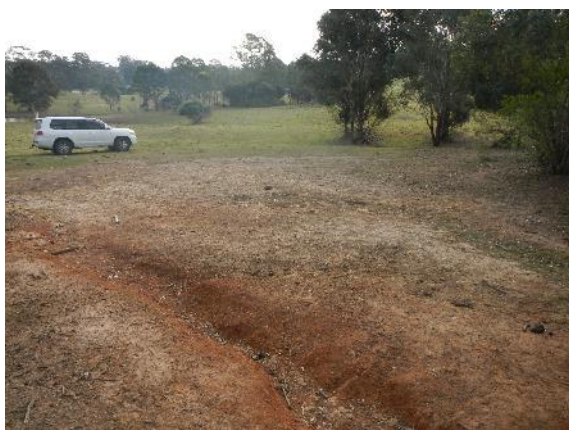
Plate 53: View west across VAS8

VAS8 is located within an exposure associated with an unsealed vehicle access track. The site is located on a lower slope 50 metres west of VIF3 and 190 metres south west of VAS2. An incised drainage line is located 50 metres south of the site. VAS8 featured excellent visibility at the time of recording. The exposure in which the artefacts are located appears to be highly eroded and artefacts were noted eroding out of the ground surface (Plate 53). Other than erosion the site appeared to be relatively undisturbed. Stands of new growth Cumberland Woodland are located to the north and south of the site.

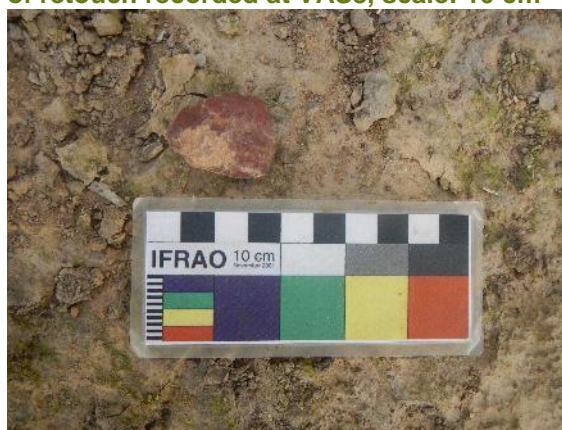
Plate 54: Silcrete complete flake with evidence of retouch recorded at VAS8, scale: 10 cm

The assemblage consists of six stone artefacts. Silcrete is the predominant raw material (n= 5, 84%) with chert also recorded (n=1, 16%). Reduction types present included complete flakes (n=2, 33%), and flake fragments (n= 4, 67%). Of the artefacts recorded two showed evidence of retouch (see Plate 54).

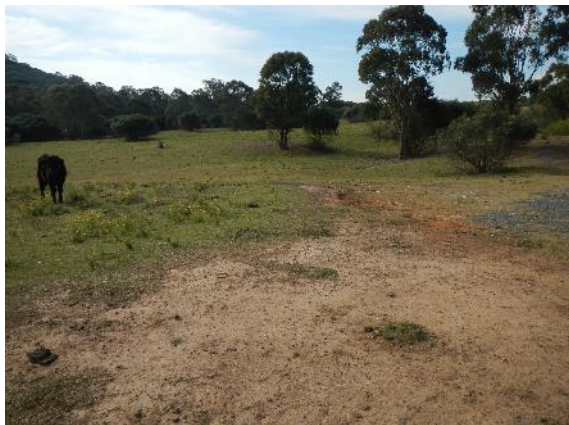
Plate 55: View of VAS9 to the North

VAS9 was recorded within an area of exposure located on a sloping crest landform. The exposed area appears to be associated with an unsealed vehicle access track (Plate 55). The scatter consists of a silcrete complete flake and a quartz angular fragment (Plate 56). The exposure featured high visibility and very little evidence of disturbance. The area surrounding the exposure was covered by dense short grass.

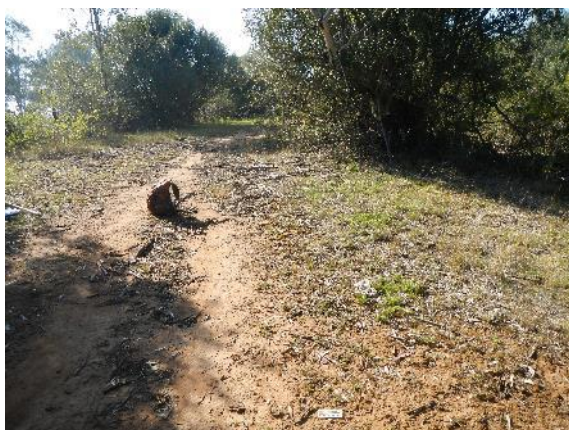
Plate 57: View east across VAS10

VAS10 is located on the northern escarpment approximately 50 metres east of VAS1. The site was recorded within a similar context as VAS1 and is likely associated with the other artefact scatters located along this ridgeline. The artefacts were identified within an unsealed narrow access track (Plate 57). Visibility and exposure was high within the access track however vegetation and leaf litter inhibited visibility in the areas surrounding the track. The site is bounded by the property fence and dense bushes to the north and the steep slope of the escarpment to the south. The artefacts recorded consisted of a silcrete complete flake and a silcrete multi-directional core (Plate 58).

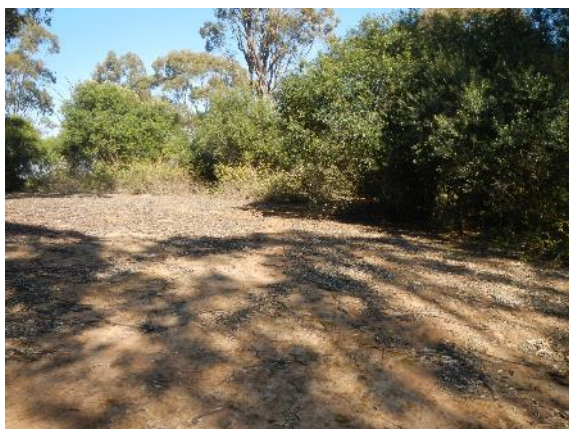
Plate 59: Clearing in which VAS11 is located

VAS11 consists of three artefacts located within a large clearing approximately 75 metres west of VAS1 (Plate 59). The exposure in which the artefacts were identified featured excellent visibility impeded in some areas by dense leaf litter. The clearing is surrounded by native remnant Cumberland Woodland vegetation as well as introduced olive trees and weeds. The assemblage

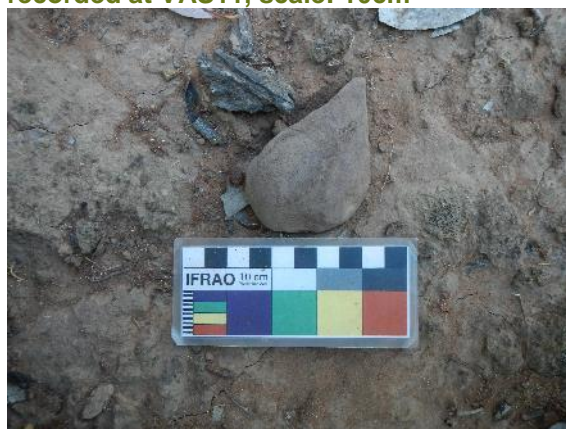
consists of a basalt hammer stone fragment, a chert complete flake and a silcrete angular fragment. The hammer stone fragment featured a ground surface and evidence of pitting (Plate 60).

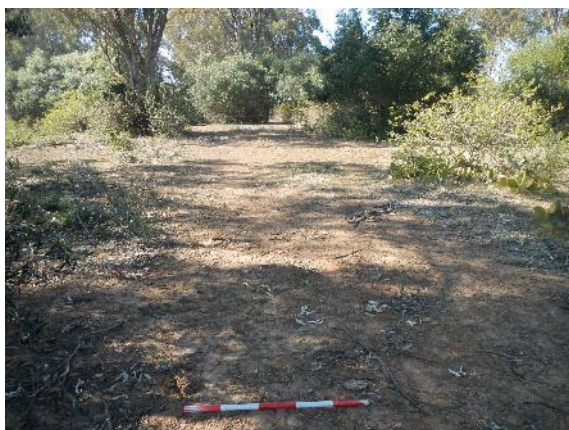
VAS12 is located in the north western corner of the study area on the ridgeline of the northern escarpment. The artefacts were recorded in an exposure next to an ants nest. The area in which the artefacts are located is generally flat with a steep slope located to the south (Plate 61). The assemblage consists of a chert proximal flake fragment, a chert complete flake and a silcrete complete flake (Plate 62). The site is located approximately 300 metres west of VAS11 and approximately 80 metres west of VIF9.

Plate 61: View south across VAS12, scale: 1 m **Plate 62: Silcrete complete flake recorded at VAS12, scale: 10 cm**

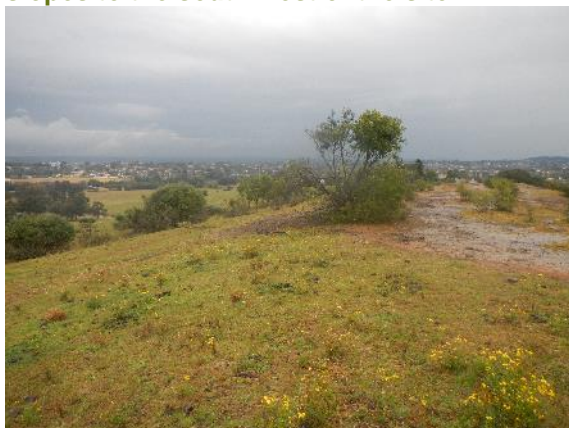
VAS13 consists of 10 artefacts recorded within an exposure on the southern crest of the eastern ridgeline. The ridge line slopes steeply to the south east and north west of the exposure (Plate 63). The exposure appears to have been heavily disturbed (Plate 64). Basal clay is visible on the ground

Plate 63: View south across VAS13, steep slopes to the south west of the site

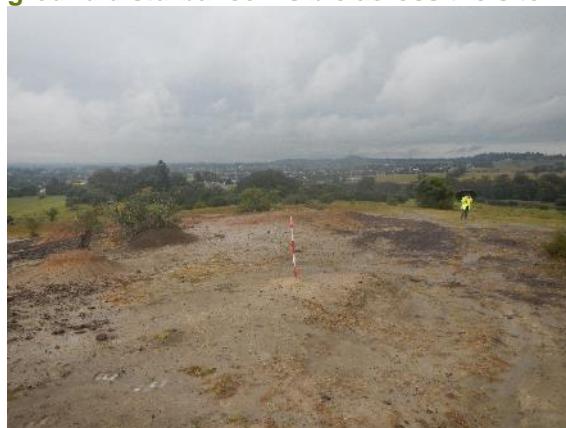
surface and much of the A horizon appears to have been stripped. Mounding is apparent throughout much of the site and evidence of trampling by cattle was noted. Due to the wet weather conditions at the time of survey the site was very waterlogged and this impeded visibility to a large extent. In dry conditions the visibility would generally be excellent throughout the site.

Plate 64: View east across VAS13, evidence of ground disturbance visible across the site

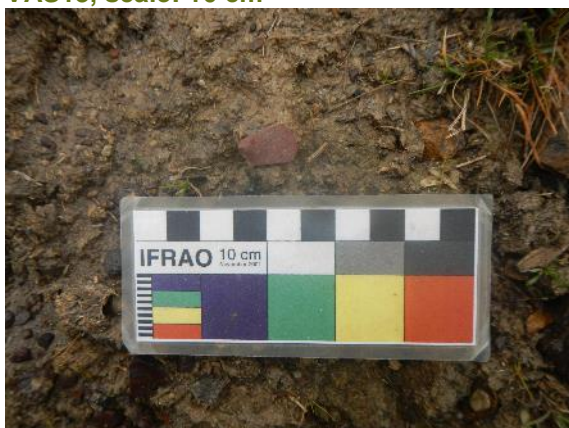
The artefacts recorded predominantly consisted of silcrete (n=7, 7%) with some quartz also present (n=3, 30%). The most frequent reduction type recorded was angular fragment (n= 6, 60%) with four complete flakes also recorded (40% see Plate 65 and Plate 66).

Plate 65: Silcrete complete flake recorded at VAS13, scale: 10 cm

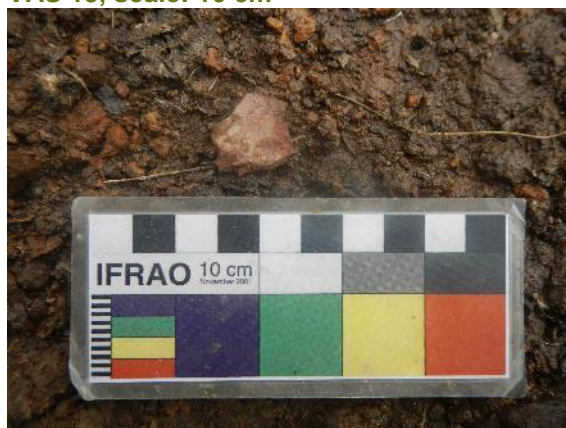
Plate 66: Silcrete complete flake recorded at VAS 13, scale: 10 cm

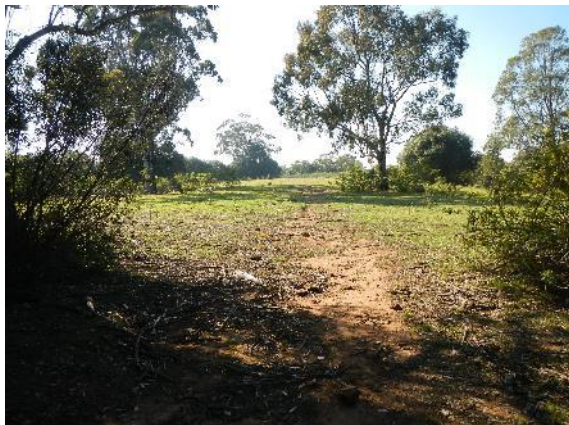
VIF5 is a quartz angular fragment recorded near the northern boundary of the study area within an access track (Plate 67 to Plate 68).

Plate 67: Location of VIF5 view to the east

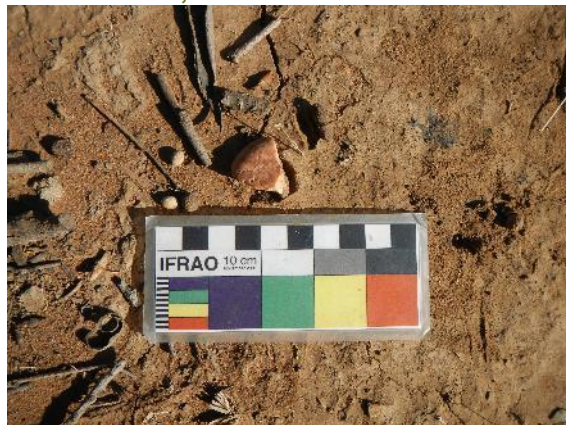
Plate 68: VIF5, scale: 10 cm

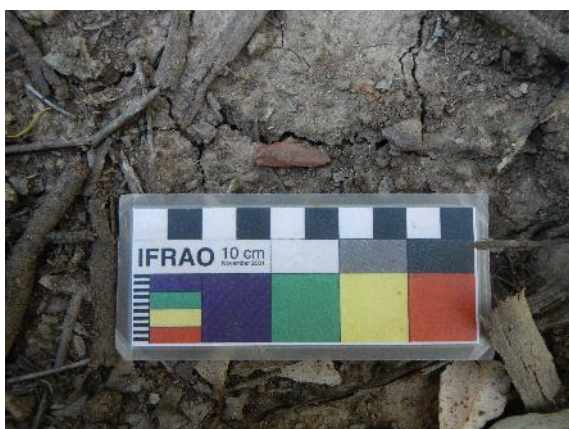
Site VIF6 consists of a red silcrete blade (Plate 69). The artefact is located in between VAS1 and VAS12 within the same ridgeline access track exposure (Plate 70). The artefact shows evidence of backing.

Plate 69: VIF6, scale 10 cm

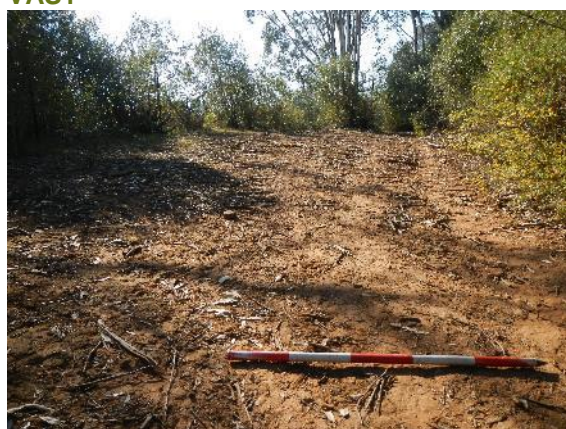
Plate 70: Location of VIF6, view east towards VAS1

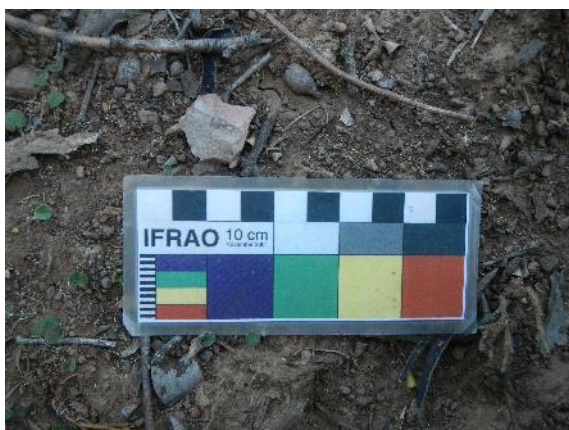
Site VIF7 is located approximately 60 metres west of VAS11 and 10 metres east of VIF1. The site consists of a single silcrete complete flake (Plate 71). The artefact is located within the same ridgeline landform context and vehicle access track exposure as VAS1, VAS10, VAS11, VAS12, VIF1 and VIF6 (Plate 72).

Plate 71: VIF7, scale: 10 cm

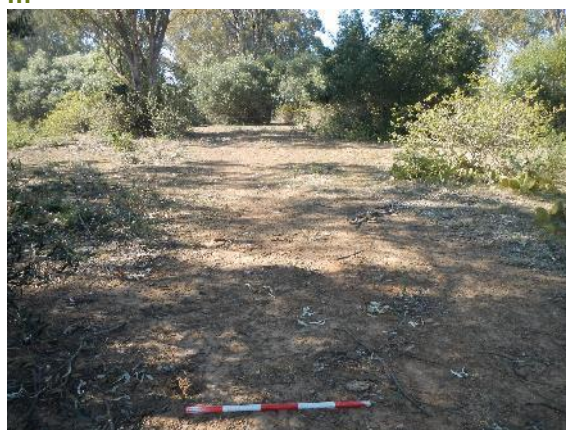
Plate 72: Location of VIF7 view east, scale: 1 m

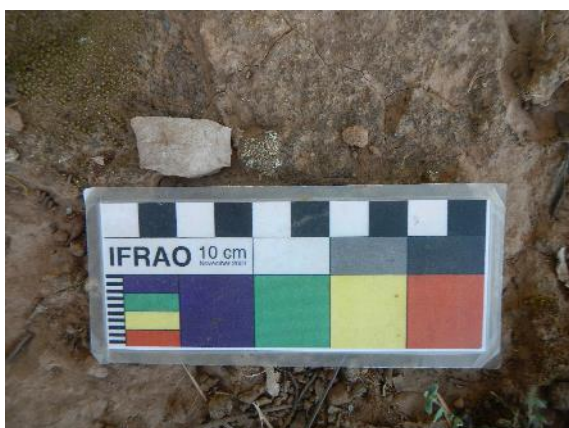
VIF8 consists of a single silcrete proximal flake fragment (Plate 73). The artefact was recorded within an exposure on the northern escarpment towards the edge of the ridge line before it descends steeply to the south (Plate 74).

Plate 73: VIF8, scale: 10 cm

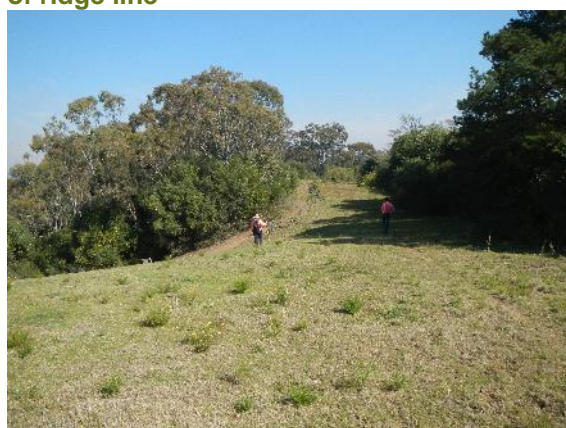
Plate 74: View towards VIF8 located near edge of ridge line

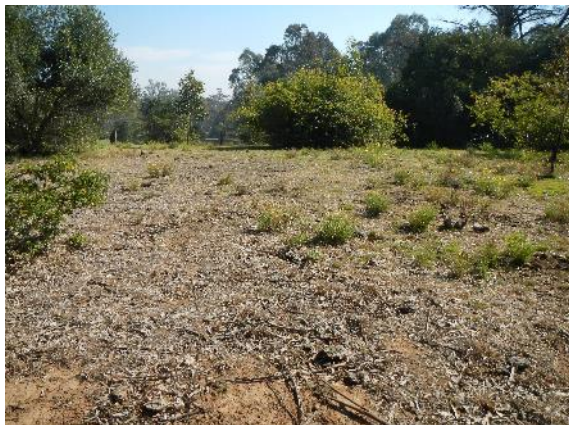
VIF9 is located approximately 20 metres west of VIF 8 (Plate 75 to Plate 76). The site consists of a single quartz complete flake. Like VIF8, VIF9 is located towards the southern edge of the escarpment.

Plate 75: View east across VIF9

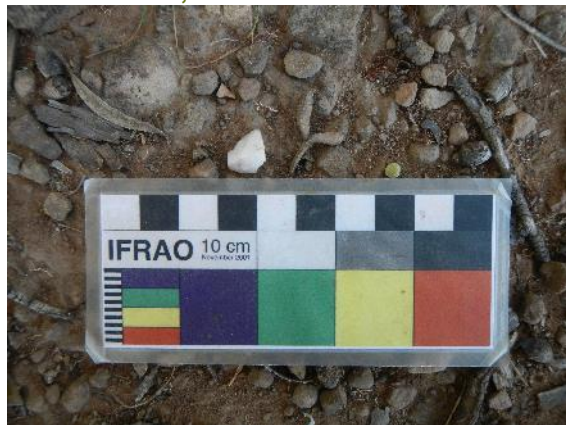
Plate 76: VIF9, scale: 10 cm

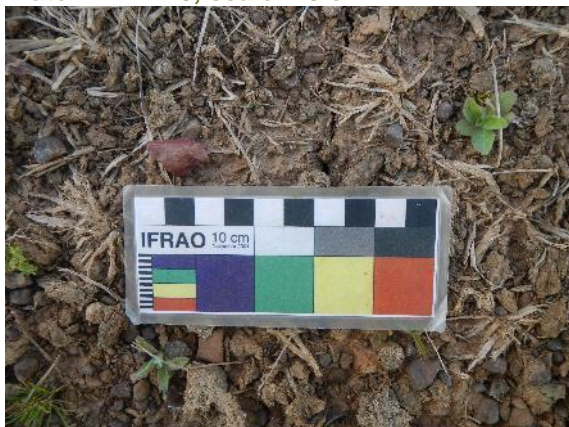
Site VIF10 consists of single red silcrete angular fragment (Plate 77). The artefact was recorded within a vehicle access track along the eastern ridgeline. The site is located approximately 40 metres south of VAS3.

Plate 77: VIF10, scale: 10 cm

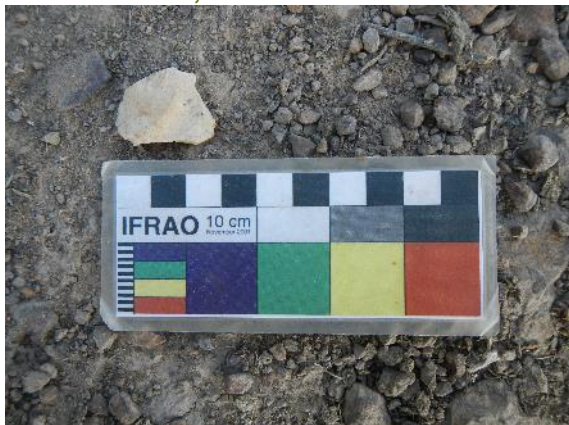
Site VIF11 consists of a single yellow indurated mudstone tuff complete flake (Plate 78). The site is located within an exposure on the eastern ridgeline approximately 45 metres south of VAS4 (Plate 79).

Plate 78: VIF11, scale 10 cm

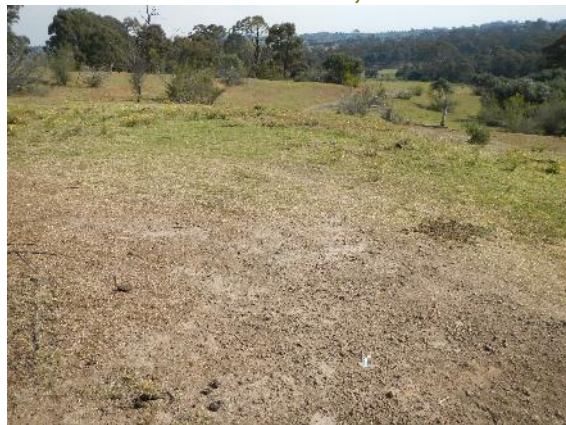
Plate 79: Location of VIF 11, view to the west

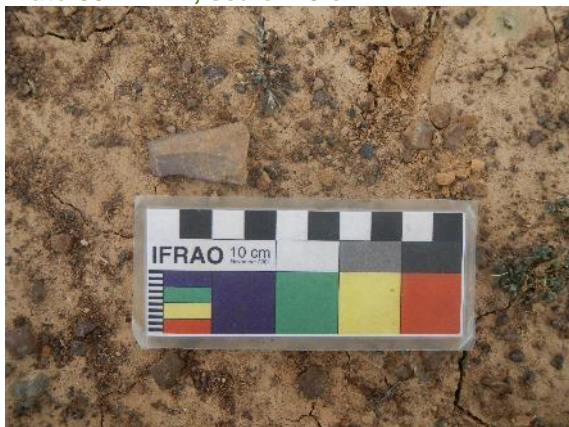
Site VIF 12 consists of a grey silcrete proximal flake fragment (Plate 80). The artefact was located within an exposure associated with a cattle feeding trough (Plate 81). The area was very disturbed due to animal activity.

Plate 80: VIF12, scale: 10 cm

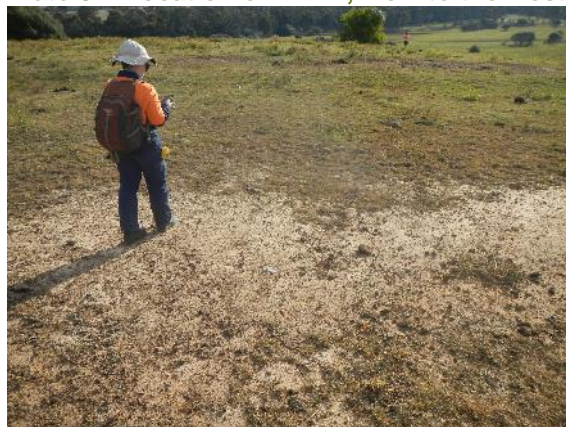
Plate 81: Location of VIF12, view to the west

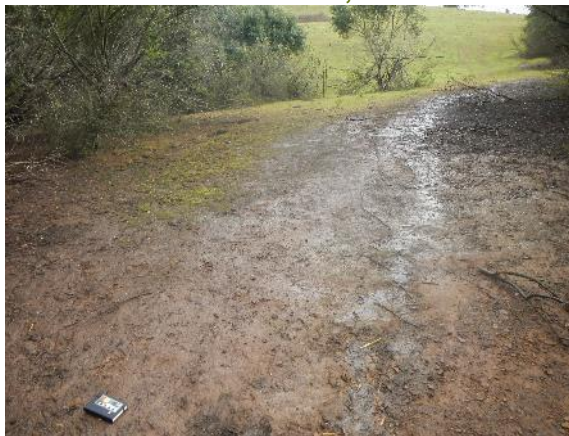
VIF13 was identified within a cattle track along the eastern boundary of the study area (Plate 82). The site is located down slope from the eastern ridge line. The site consists of a single quartz complete flake (Plate 83).

Plate 82: Location of VIF13, view to the north

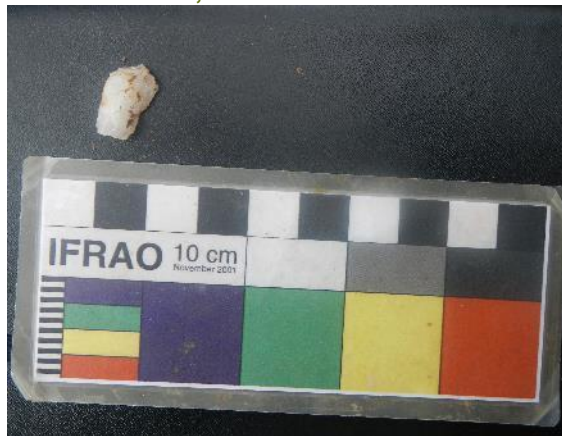
Plate 83: VIF13, scale: 10 cm

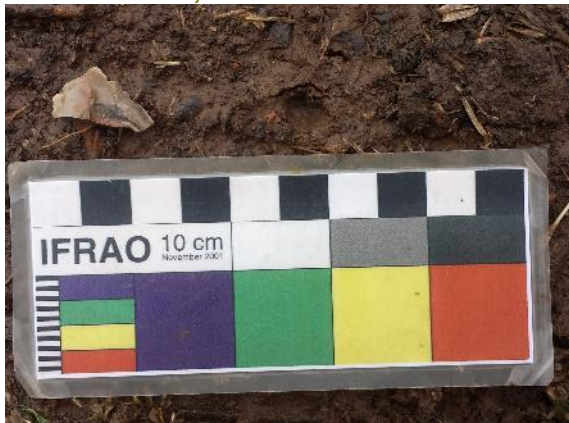
VIF14 consists of a single banded chert complete flake (Plate 84). The site is located on a crest near the Varroville House outbuildings. The artefact was identified within a disturbed area of exposure (Plate 85).

Plate 84: VIF14, scale: 10 cm

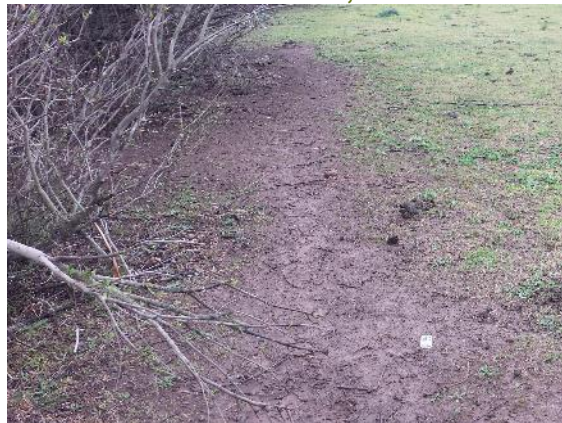
Plate 85: Location of VIF14, view to the west

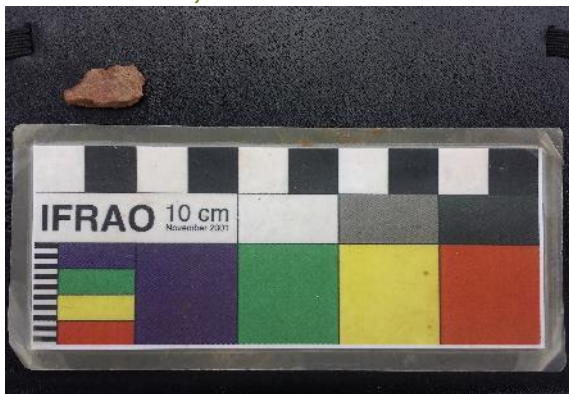
VIF15 consists of single silcrete angular fragment (Plate 86). The artefact was identified within an exposure associated with a dam located near the western boundary of the study area.

Plate 86: VIF15, scale: 10 cm

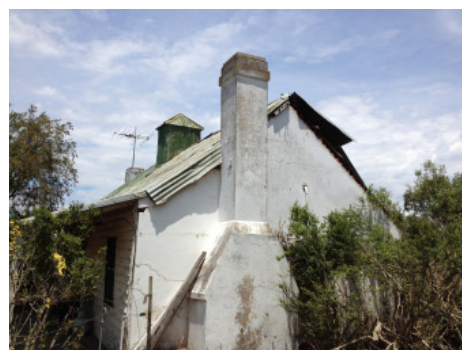
Figure 2.1

View of the northern elevation of the Cottage, the portion of roof sheeting that has become dislodged can be seen off the ridge.

- Securely prop the timber verandah structure and make it safe.
- Do not remove existing fabric, unless it is unsafe to retain. If fabric does require removal, salvage and store securely inside the Cottage building for future reference and possible reinstatement at a later stage. Take care to store the shingles dry.

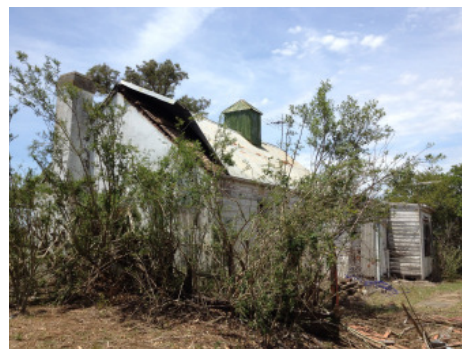
Figure 2.2

Looking towards the western roof of the Cottage. Timber shingles have been revealed below the peeled back corrugated iron.

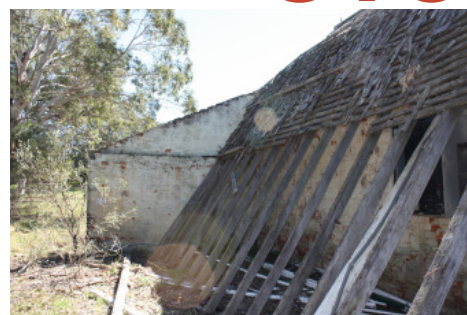
FIGURE 16 – THE TIMBER SLAB HUT

2.5.2 THE TIMBER SLAB HUT

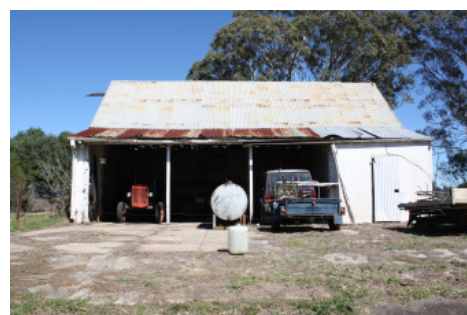
Figure 3.3

Eastern elevation of the Shingle Roofed Shed with the dilapidated condition of the posts and beams supporting the edge of the roof.

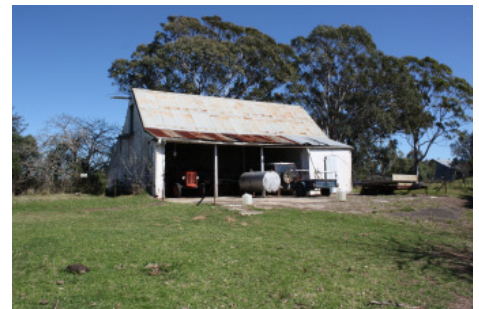
Figure 2.1 below identifies the subject structures and the proximity of the surrounding vegetation. The condition of the primarily buildings range from poor to dilapidated and with some in an advanced state of collapse.

Figure 2.2
Eastern elevation of the Shingle roofed shed (1).

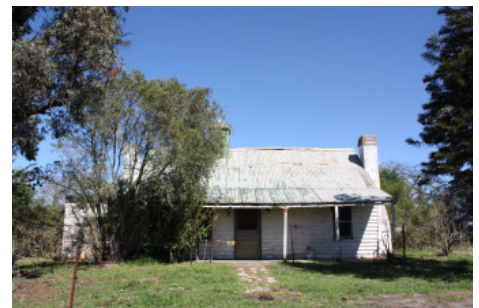
Figure 2.3
Eastern elevation of the Cottage (2). Mature pine species partially visible to the right of the image.

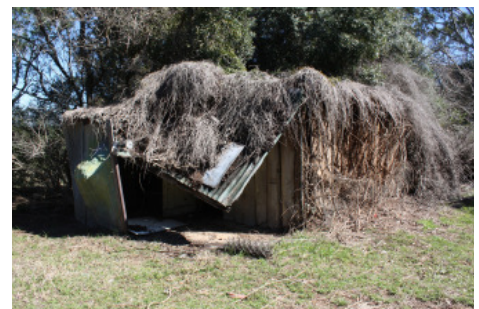
Figure 2.4
Slab shed (3).

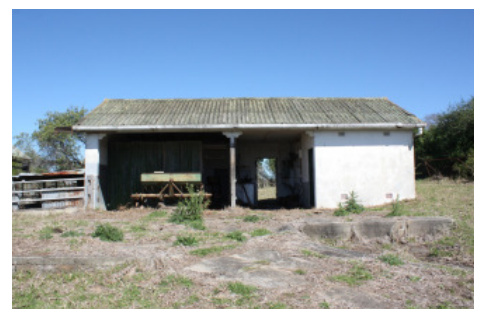
Figure 2.5
Machinery shed (4).

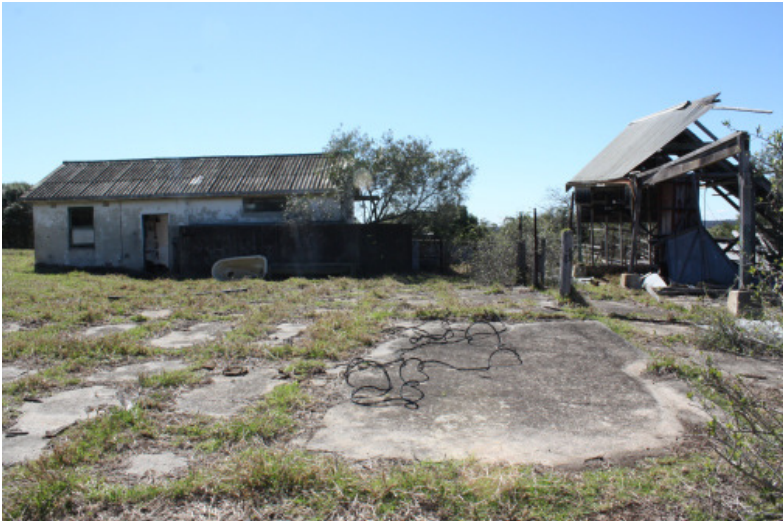
Figure 2.6
Rear of the Machinery Shed (4) with the collapsed timbers shed in area (6) to the right. Areas of concrete hardstand in the foreground may suggest an earlier shed that has now been removed.

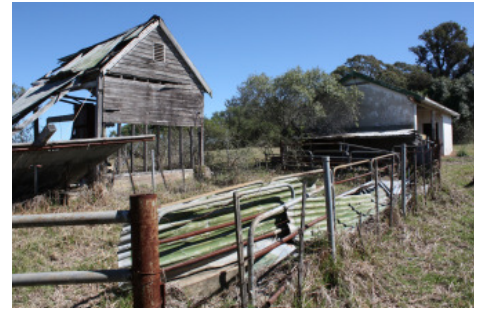
Figure 2.7
Fencing to area (5) to the south of the Machine Shed.

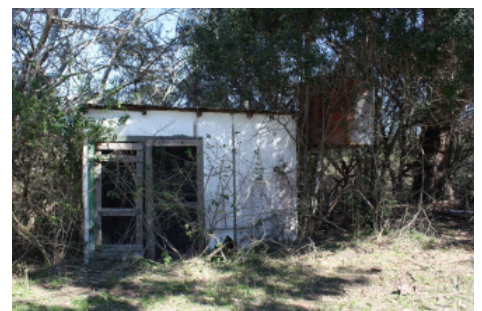
Figure 2.10
Fibro shed and Water tank (7). The water tank is partially obscured in the undergrowth.

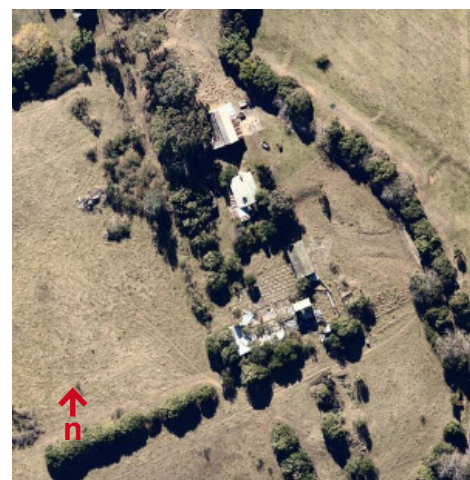
Figure 3.1
Aerial view of the site showing the pattern of vegetation around the historic outbuildings.
