SCT Operations Pty Ltd

ULA4958

ASSESSMENT OF ROCK FALLS IN MONA CREEK CLIFF PROTECTION AREA

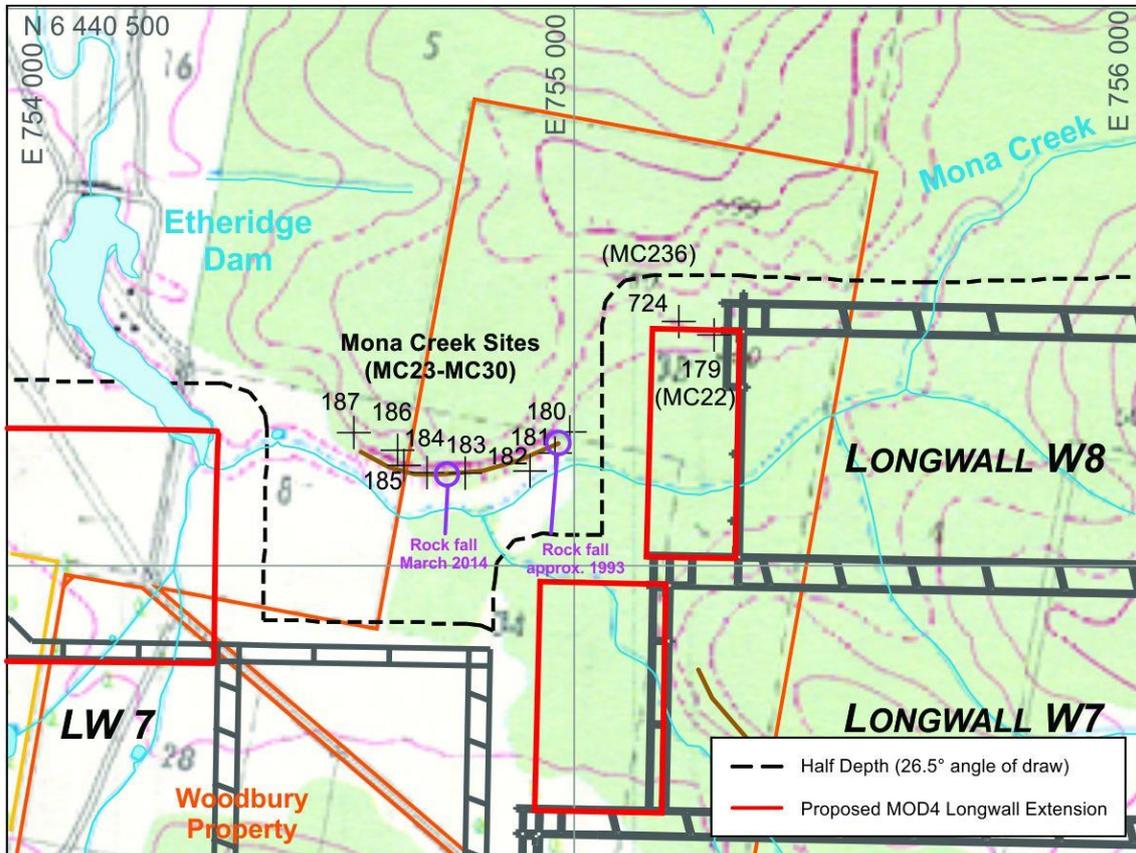
Figure 1: Site Plan

Figure 1 shows the location of the Mona Creek Rock Shelter sites relative to the MOD4 mining areas and the half depth protection barriers.

The depth to the mining horizon in this area is approximately 165m. All the rock shelter sites (MC23-MC30 or Ulan ID #170-187) are protected by a distance that is greater than 130m and, therefore, greater than 0.7 times the overburden depth (equivalent to 35°angle of draw).
