*The MLC Building in North Sydney was designed by Bates Smart & McCutcheon in 1952 & completed in 1956. It is currently listed as a **local heritage item** on the North Sydney LEP 2013, item number I0893, and is one of the few remaining NSW buildings in the post-war international style.*

# EXISTING BUILDING ISSUES

# CURTAIN WALL REPLACEMENT

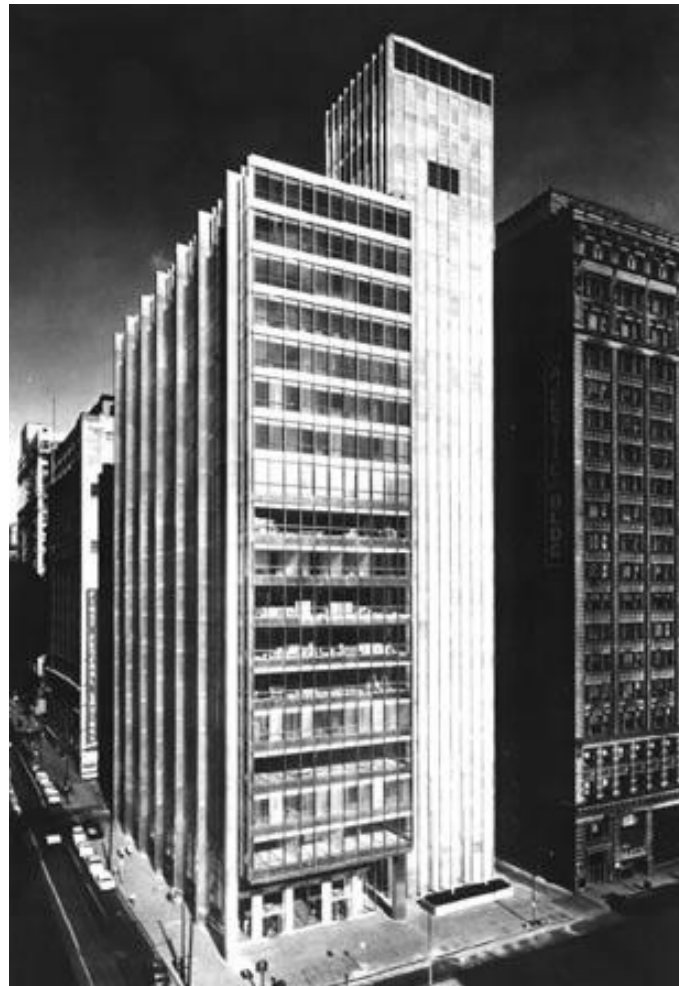
**INLAND STEEL, CHICAGO, 1957**  
SOM (Bruce Graham & Walter Netsch)

*Inland Steel, Crown Zellerbach, and ICI House had lighter refurbishments. All of these buildings had highly functional floorplates for contemporary office use.*

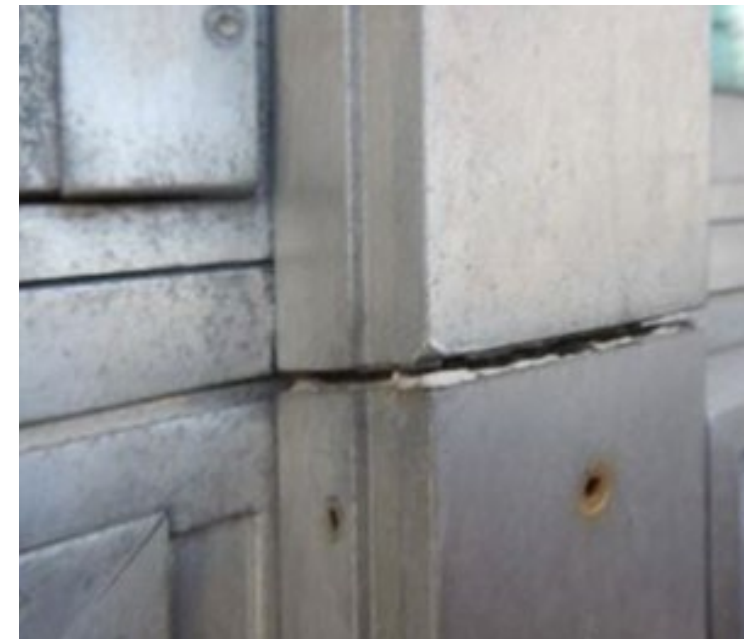
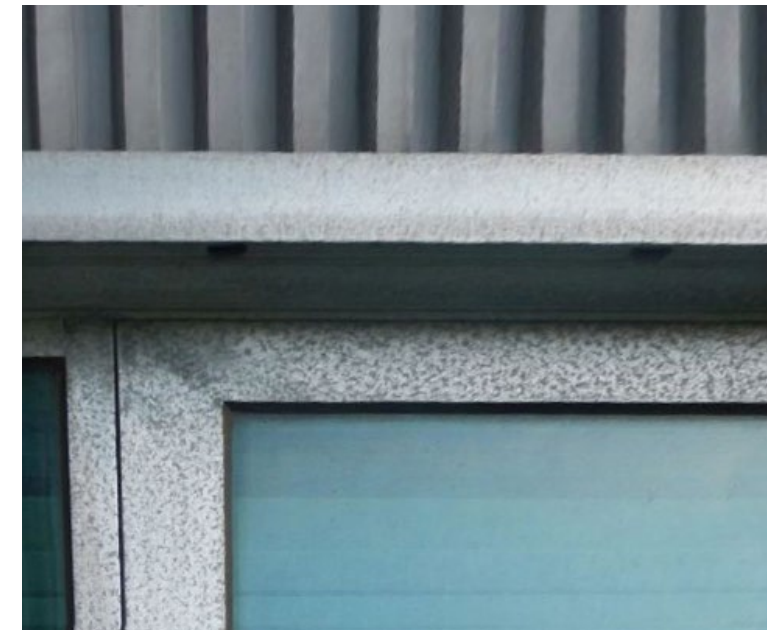
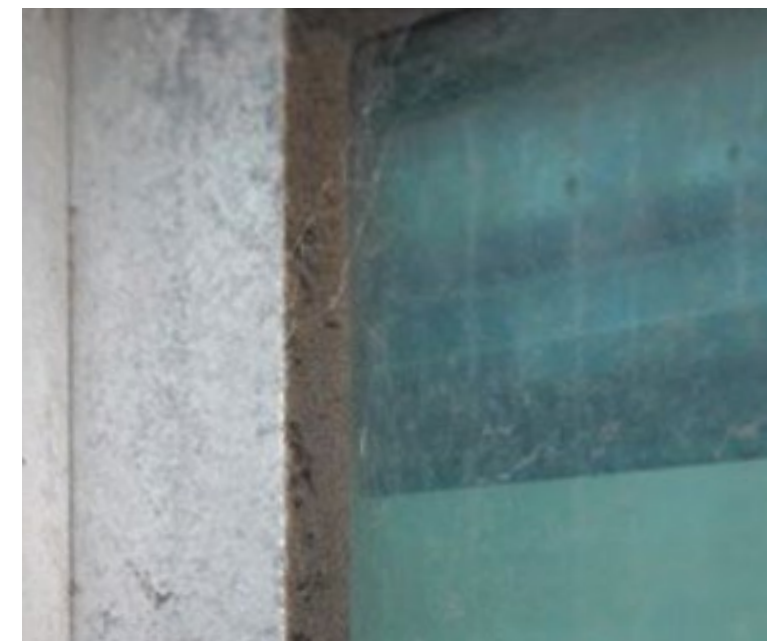
The rubber gaskets used in the glazed east and west facades have **disintegrated** resulting in these **facades leaking**. The gaskets cannot be replaced without removing the facades. Further, the aluminium curtain wall frame has **corroded**, requiring replacement.

The curtain wall is at the end of its design life and requires full replacement.

*‘The rubber gaskets used in the glazed east and west façades have disintegrated resulting in these façades leaking. The gaskets cannot be replaced without removing the façades’*

In the 2000 refurbishment of the base building, the curtain wall facade was repaired:

- mill finished aluminium was scoured to remove corrosion (this comparison has re-occurred as is visible in the photographs of the DA report and requires re-doing as part of cyclic maintenance)
- colour backed blue glass panels were replaced, working from both inside and outside
- new flashing elements were inserted working from both front and back
- operable sash were screwed shut.

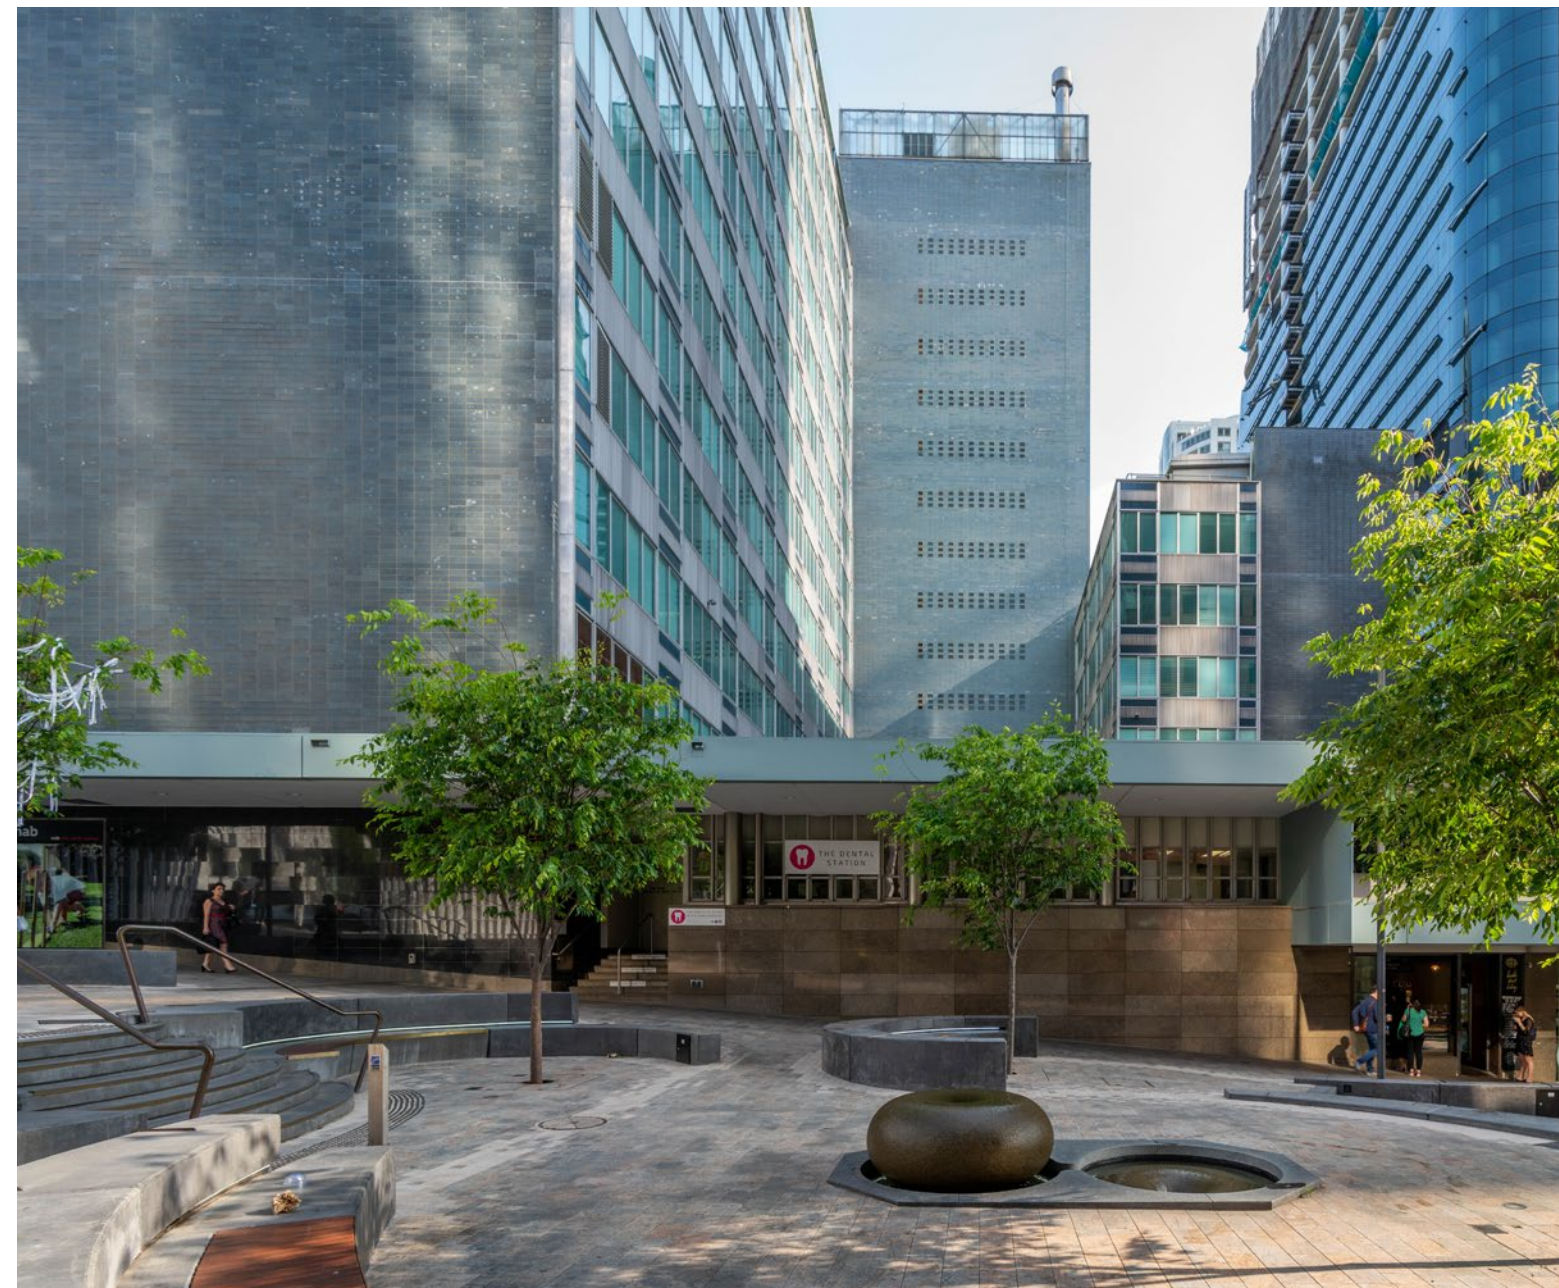
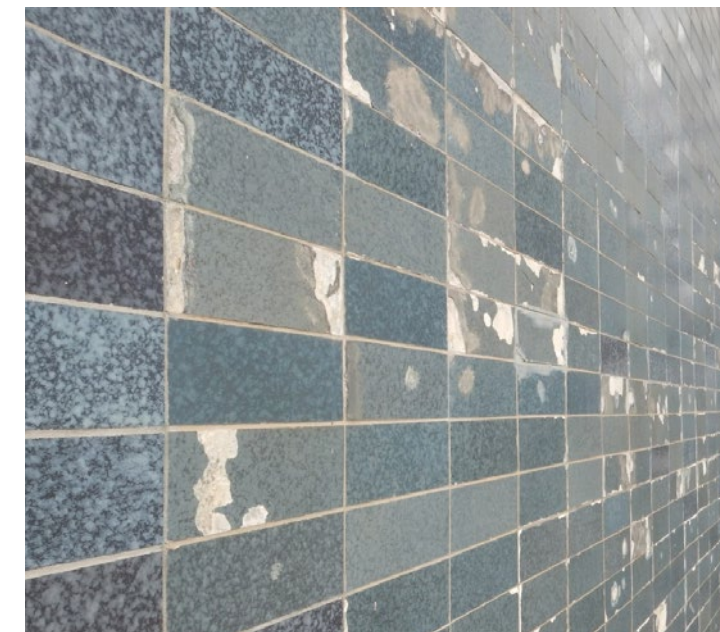
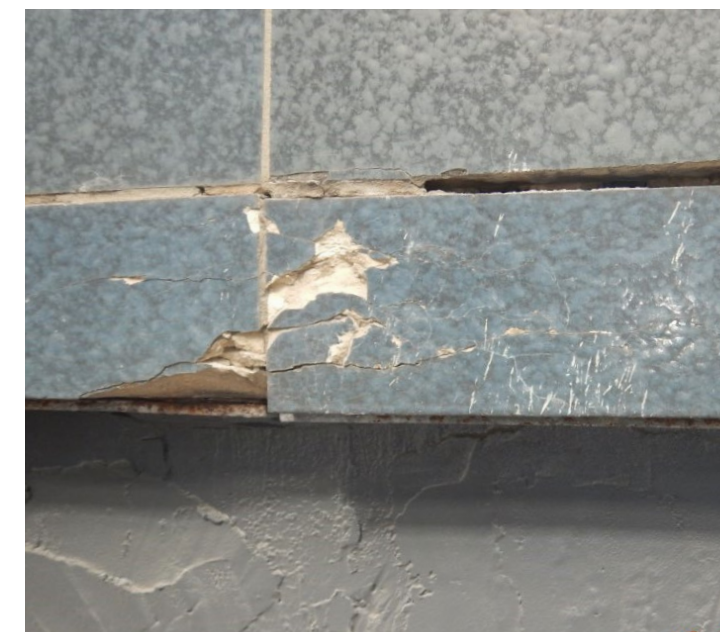
# TERRACOTTA TILE REPLACEMENT

*Terracotta tiled north and south facades are **delaminating** from their substrate as identified in a 2002 ARUP Façade Report. Loose tiles have been mechanically fixed to the substrate, however all tiles will need to be permanently fixed and/or replaced in the future.*

*There is currently an bi-annual testing regime required with all loose tiles required to be mechanically fixed.*

*‘Terracotta tiled north and south façades are delaminating from their substrate as identified in a 2002 ARUP Facade Report. Loose tiles have been mechanically fixed to the substrate, however all tiles will need to be permanently fixed and/or replaced in the future.’*

PTW notes that a second opinion was sought by the then owner. The diagnosis (by Hyder, ICS and JTCW) looked at options for conservation/repair. These repairs were undertaken by RM Watson. Please see Appendix A for a copy of the presentation to Australia Icomos ‘Unloved Modern’ conference in 2009 by the consultants describing the actual repair works undertaken.

As noted in the presentation, similar conservation work will need to be undertaken at about 15 year intervals. PTW’s informal discussions with facade engineers estimate that this may be in the order of a few hundred thousand dollars per time (which is substantially lower than the owner-estimated \$4.5m)

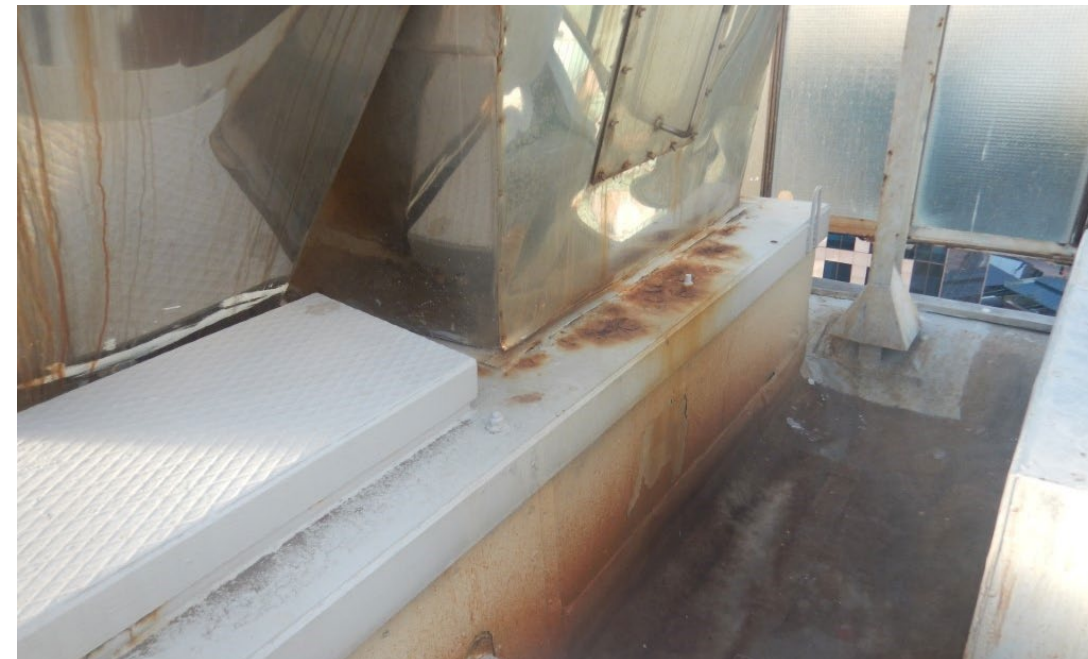
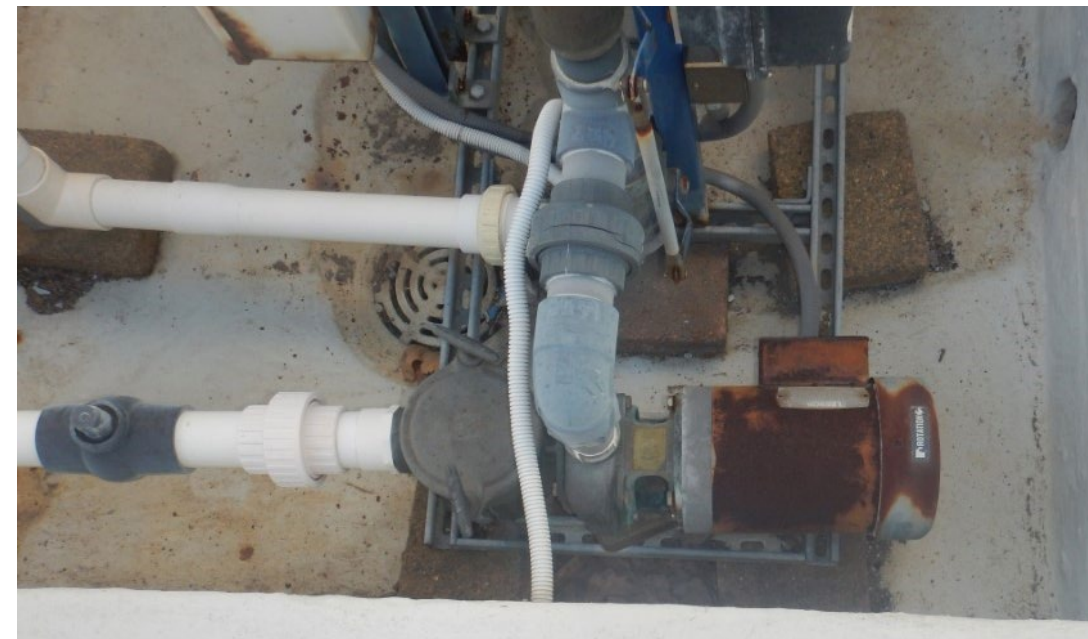
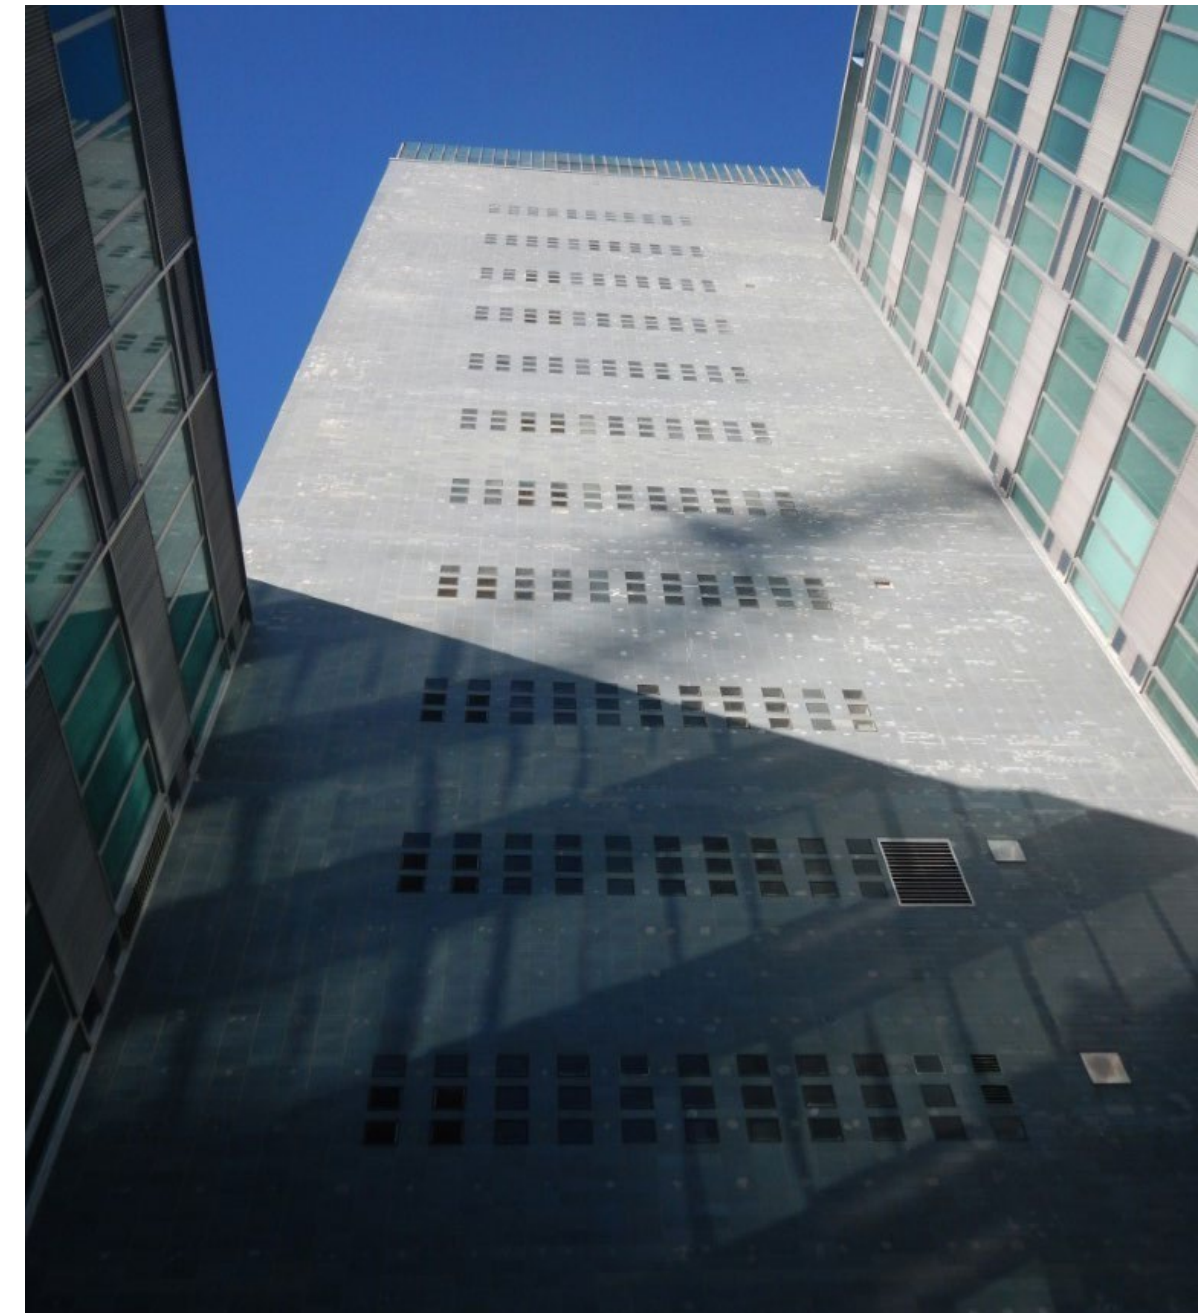
# SERVICES REPLACEMENT

*All buildings services have passed their design life and **require replacement** including rooftop plant and floor services. The lifts are also outdated & require replacement.*

*'All buildings [sic] services have passed their design life and require replacement including rooftop plant and floor services. The lifts are also outdated & require replacement.'*

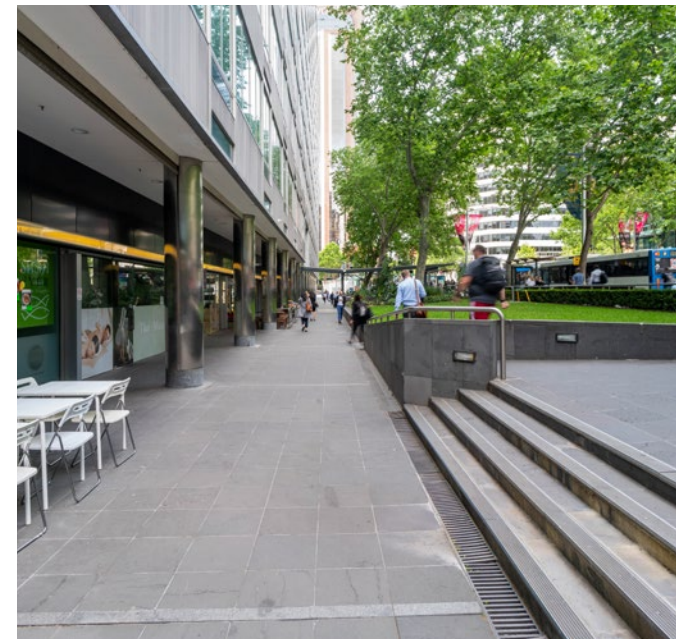
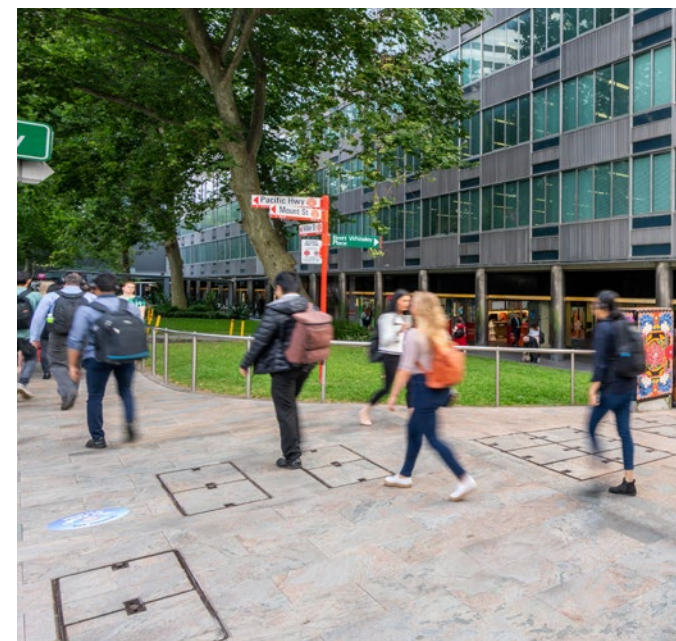
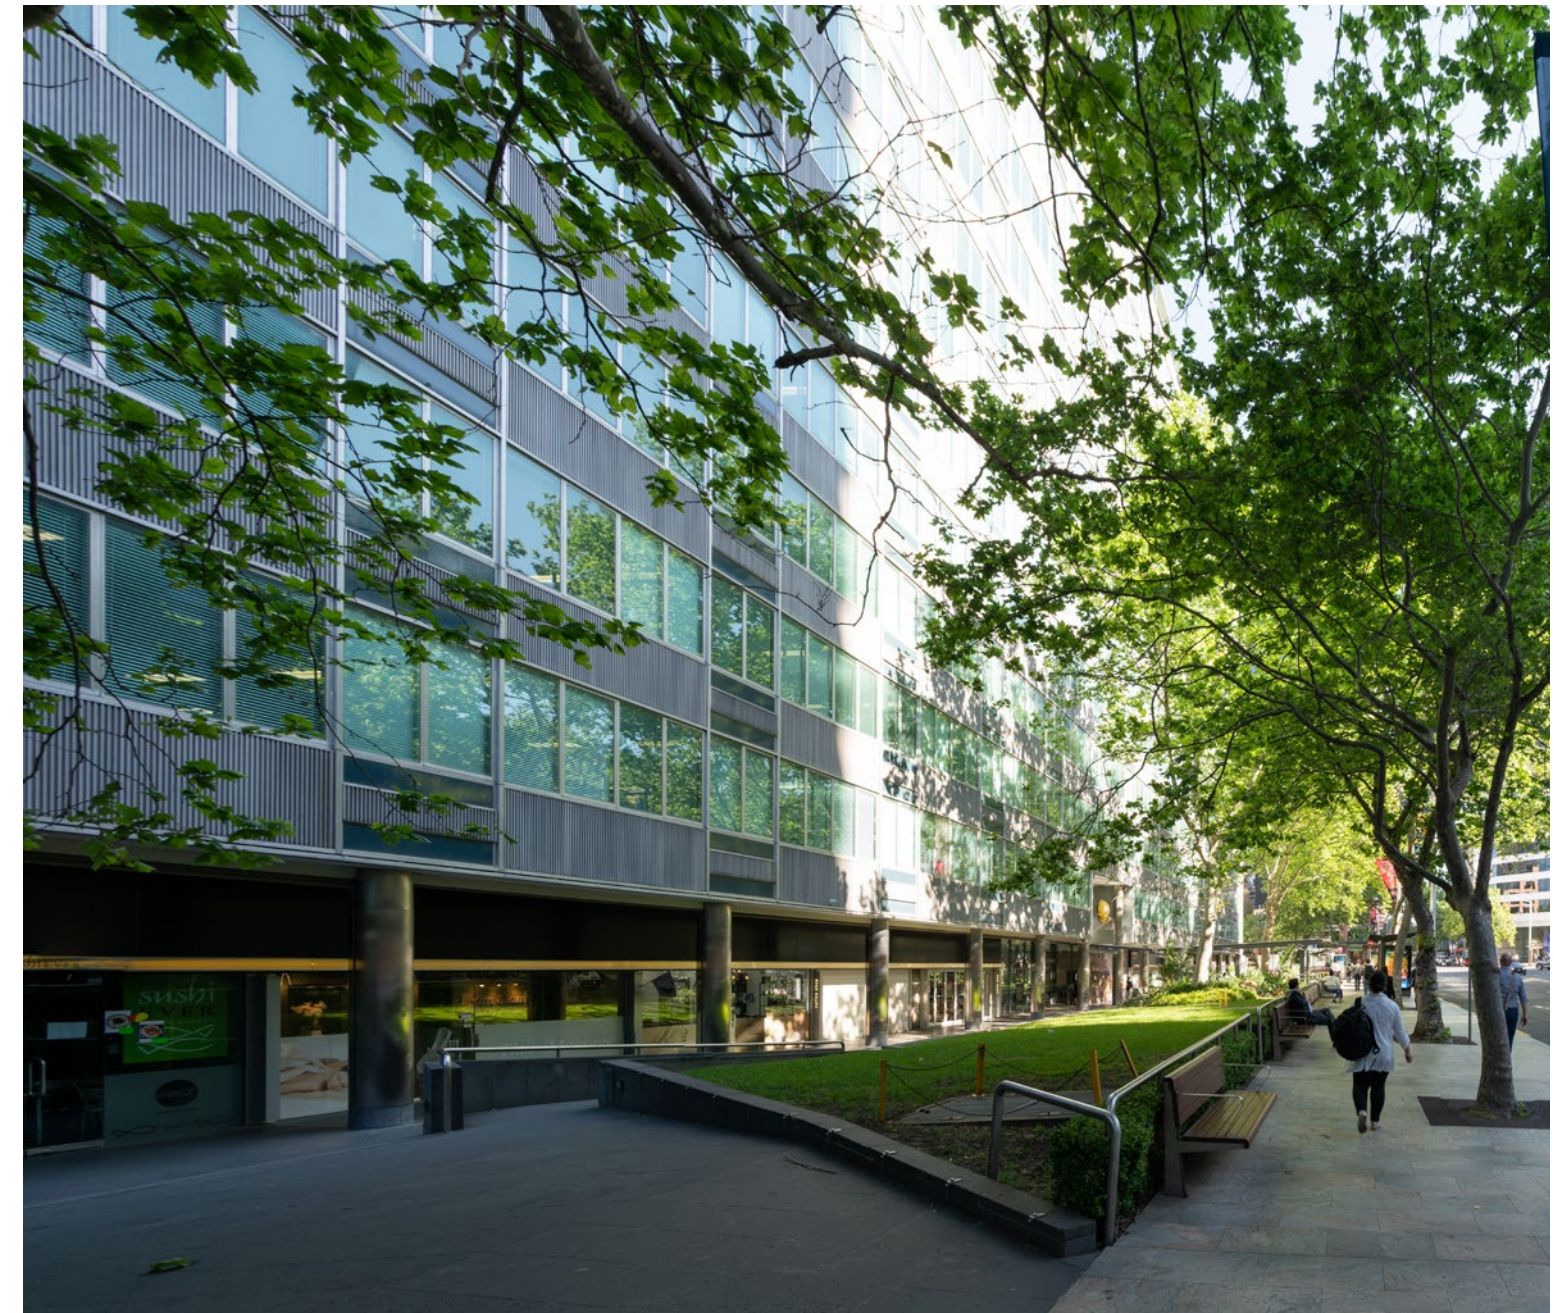
# SUNKEN WALKWAY TO MILLER STREET

Currently, the Miller Street Special Area has sunken levels away from the street. This results in **accessibility issues, compromised street activation, and overland flow issues.**

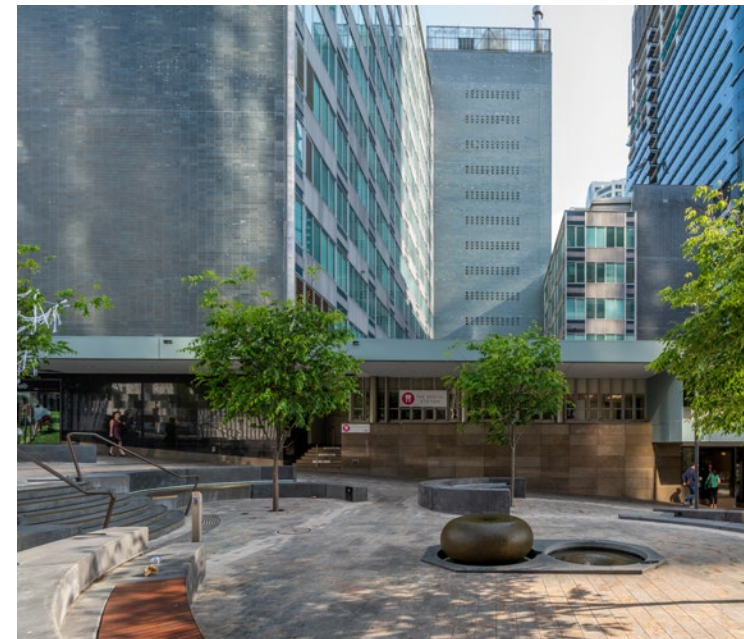
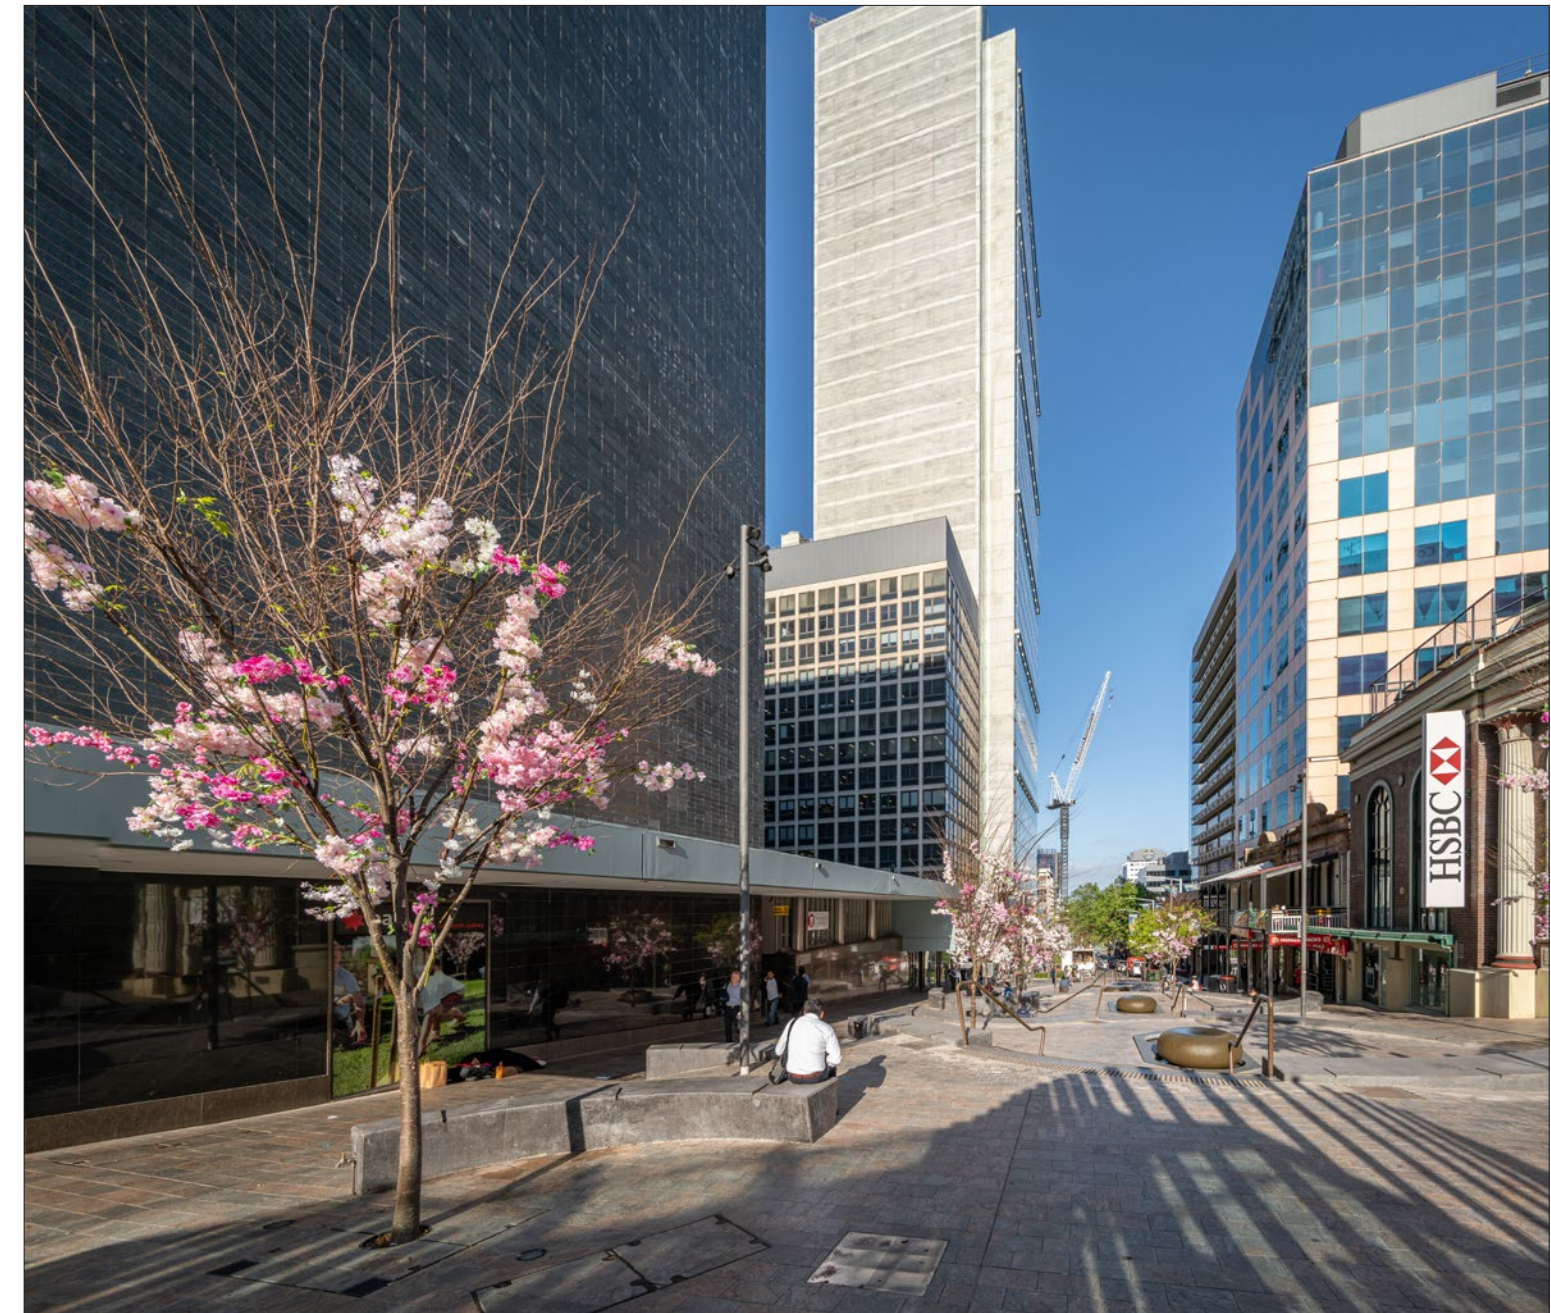
# BLANK WALL TO BRETT WHITELEY PLACE

*The Brett Whitely Place frontage contains **inactive facades** through the design of the solid north and south glazed walls to the existing building with unattractive **low canopies**. The entire frontage has no sympathetic scale or rhythm to relate to the existing heritage shops opposite.*

*The solid walls are **shear walls** for the building, and thus cannot be opened or removed. The lower portion has floor levels that do not align with the street level making it difficult to activate.*

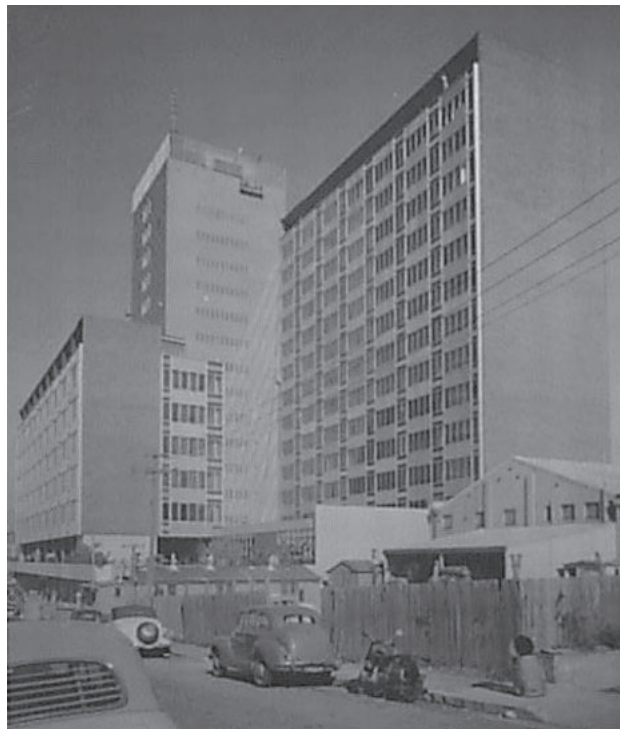
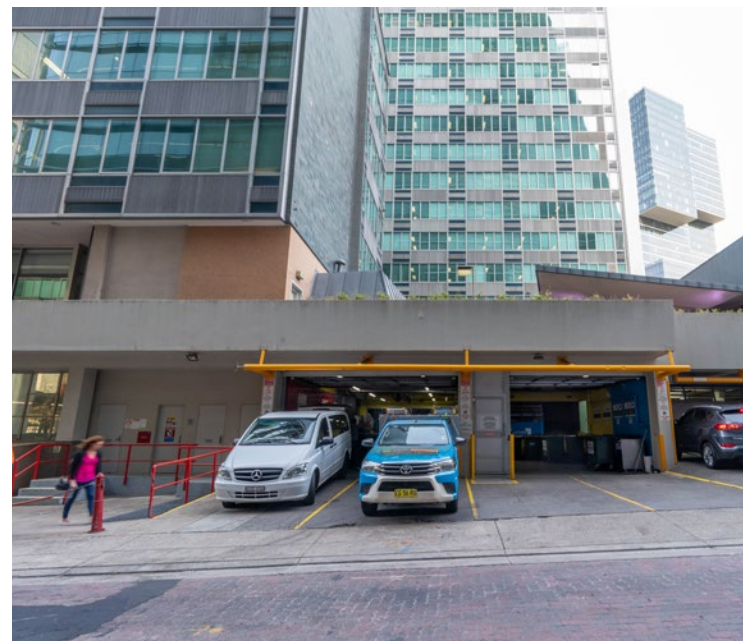
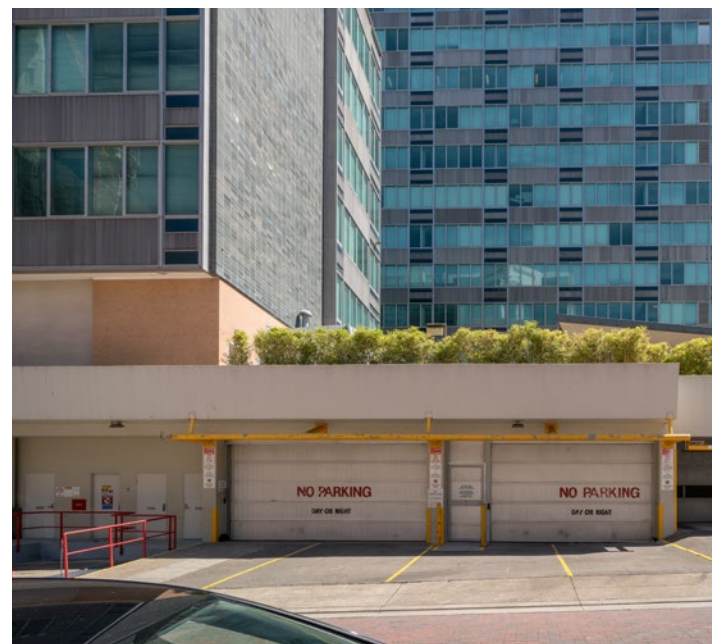
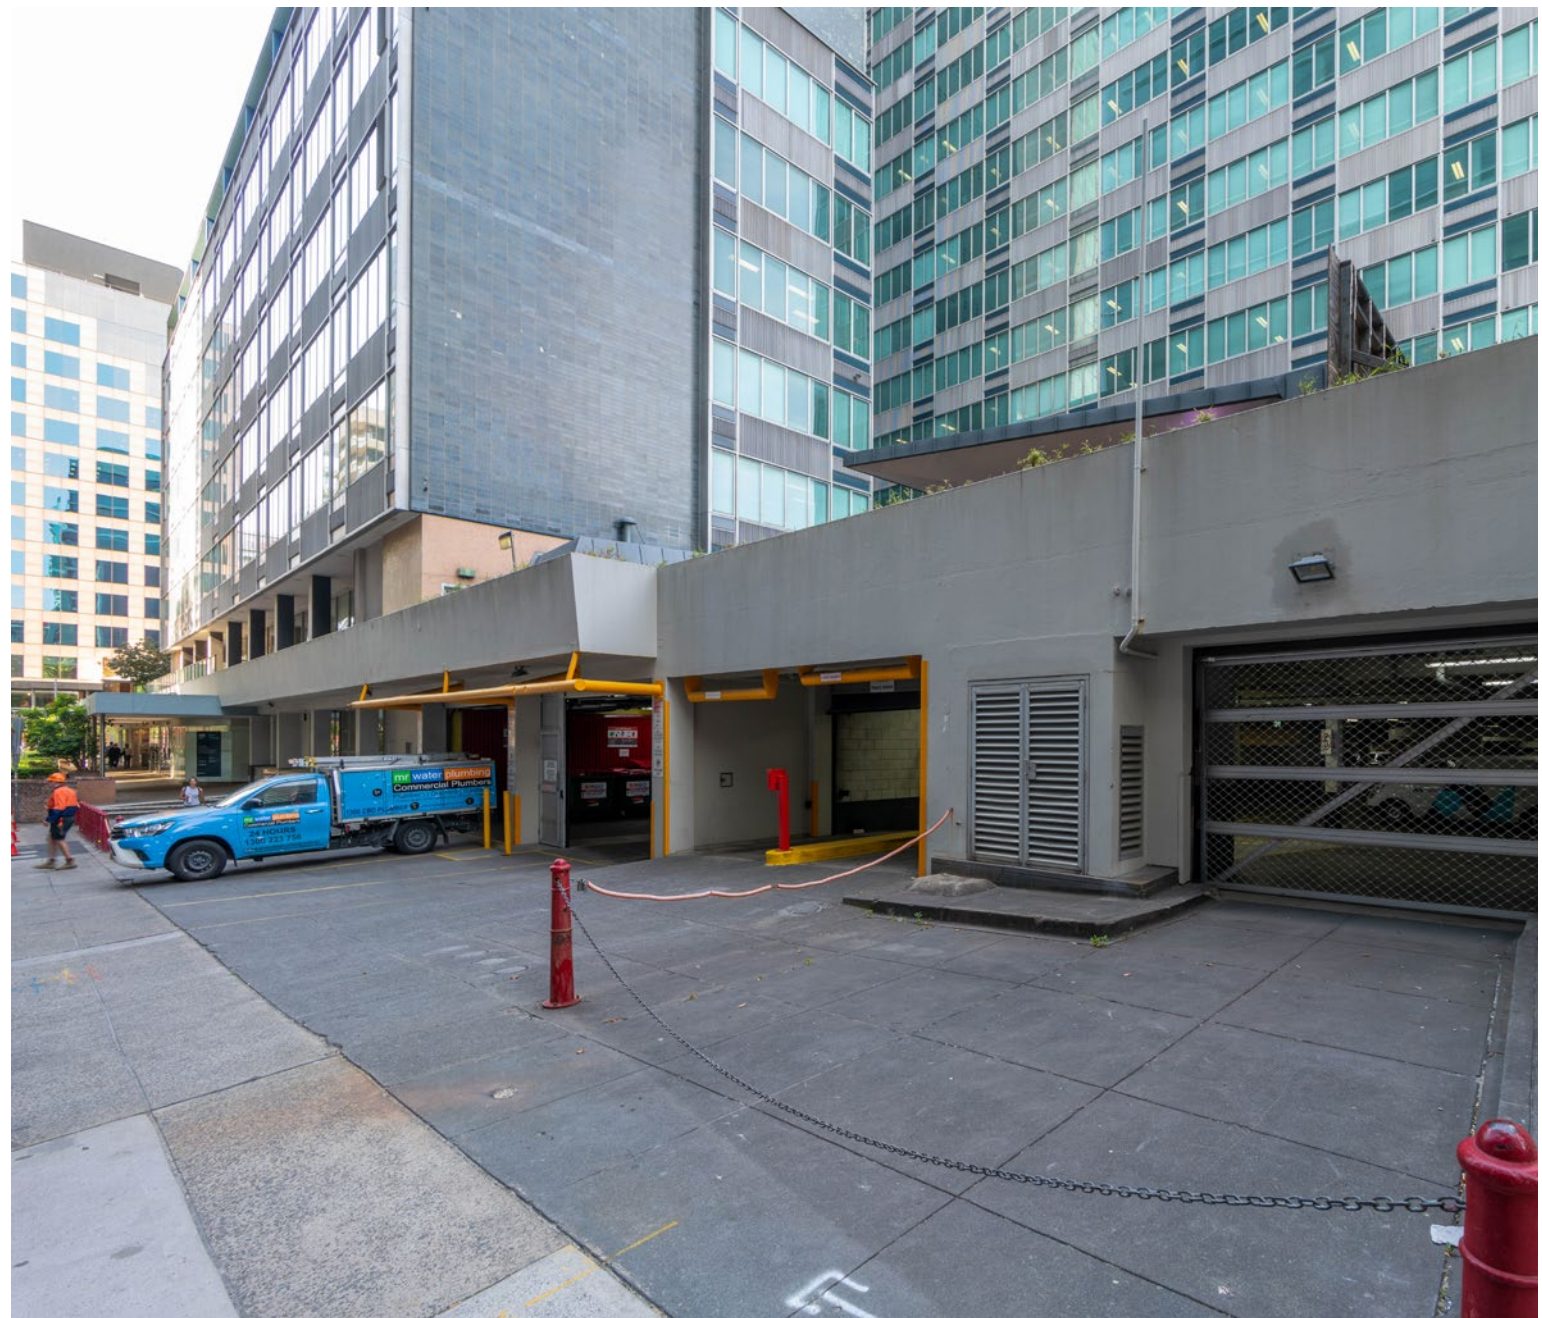
# LOADING & SERVICES TO DENISON STREET

*Denison Street was originally a **service laneway**, and as a result the existing building treats it as a back of house area, with a carpark entry, loading dock and essential services (sub-station, hydraulic, fire, etc) fronting the laneway.*

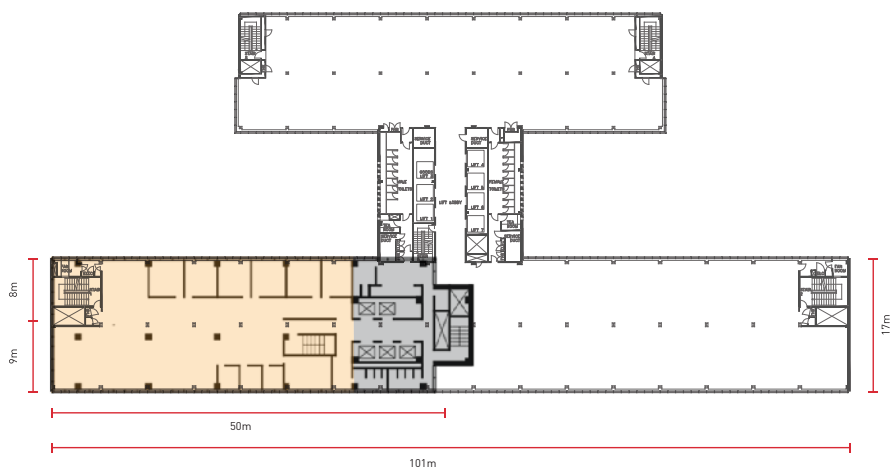
Figure 4. Comparison MLC North Sydney Floorplate with Lever House, New York (coloured orange)

*The comparative analysis of similar floorplates clearly demonstrates that MLC building is **challenged in being substantially longer** (circa 100m) than all relevant comparisons. This is not addressed by the Heritage NSW review and in fact supports our assertions of it’s commercial leasing challenges.*

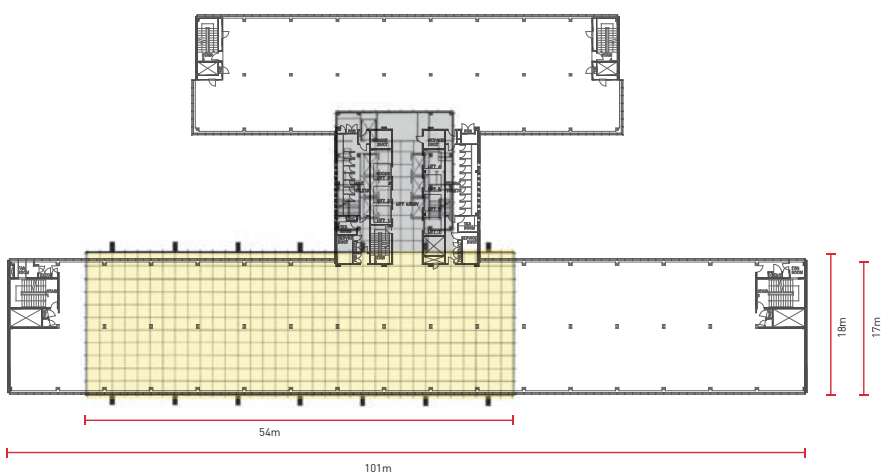
Figure 5. Comparison MLC North Sydney Floorplate with Inland Steel Headquarters, Chicago (coloured yellow)

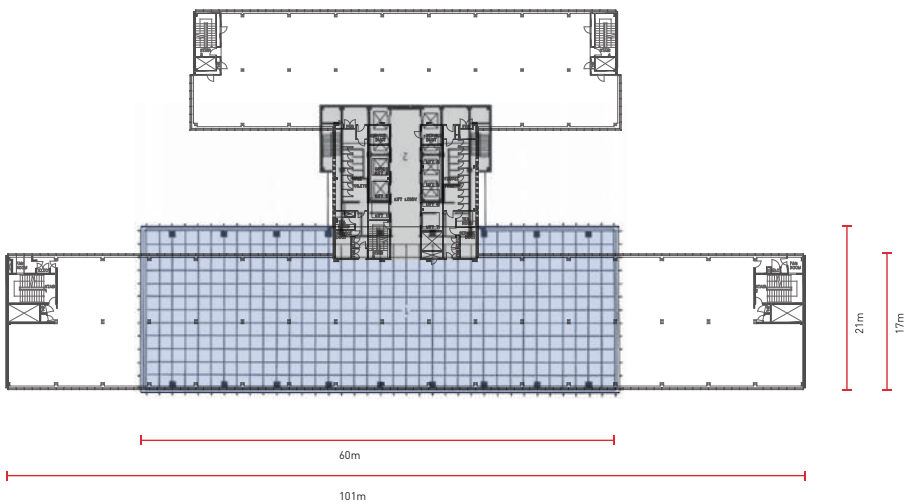
Figure 6. Comparison MLC North Sydney Floorplate with Crown Zellerbach Building SF (coloured purple)

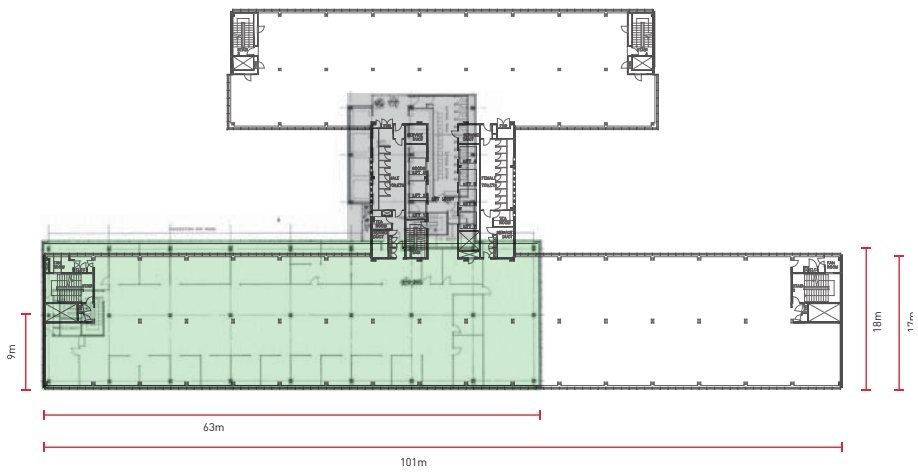
Figure 7. Comparison MLC North Sydney Floorplate with ICI House, Melbourne (coloured green)

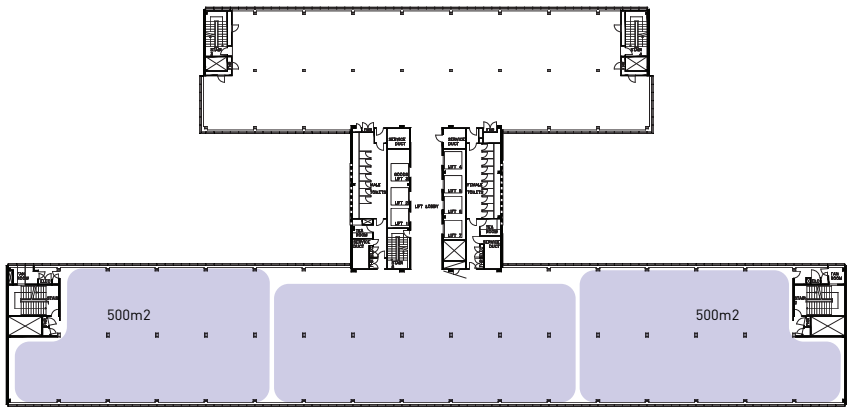
Figure 10. Three 500 m² tenancies MLC North Sydney Floorplate (Miller Street wing) using furniture layouts from Sydney 2020 Competition entry

*Tenancy layout comparisons re-arrange  
MLC layout but **ignore the building  
length issue***

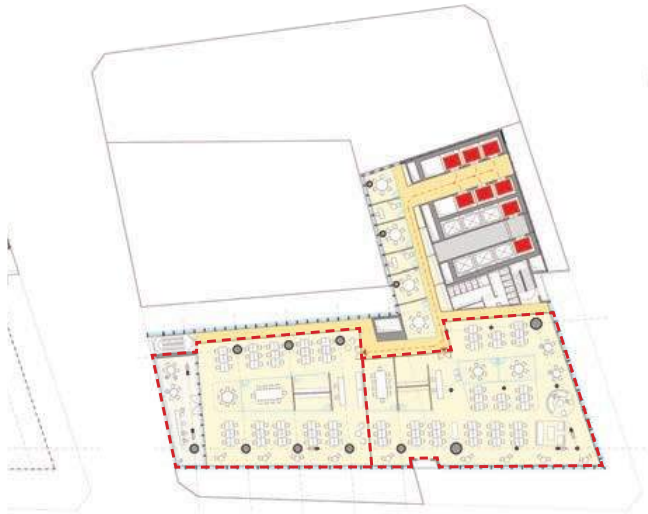
High Rise - Two tenancies  
Sydney 2020 Competition entry

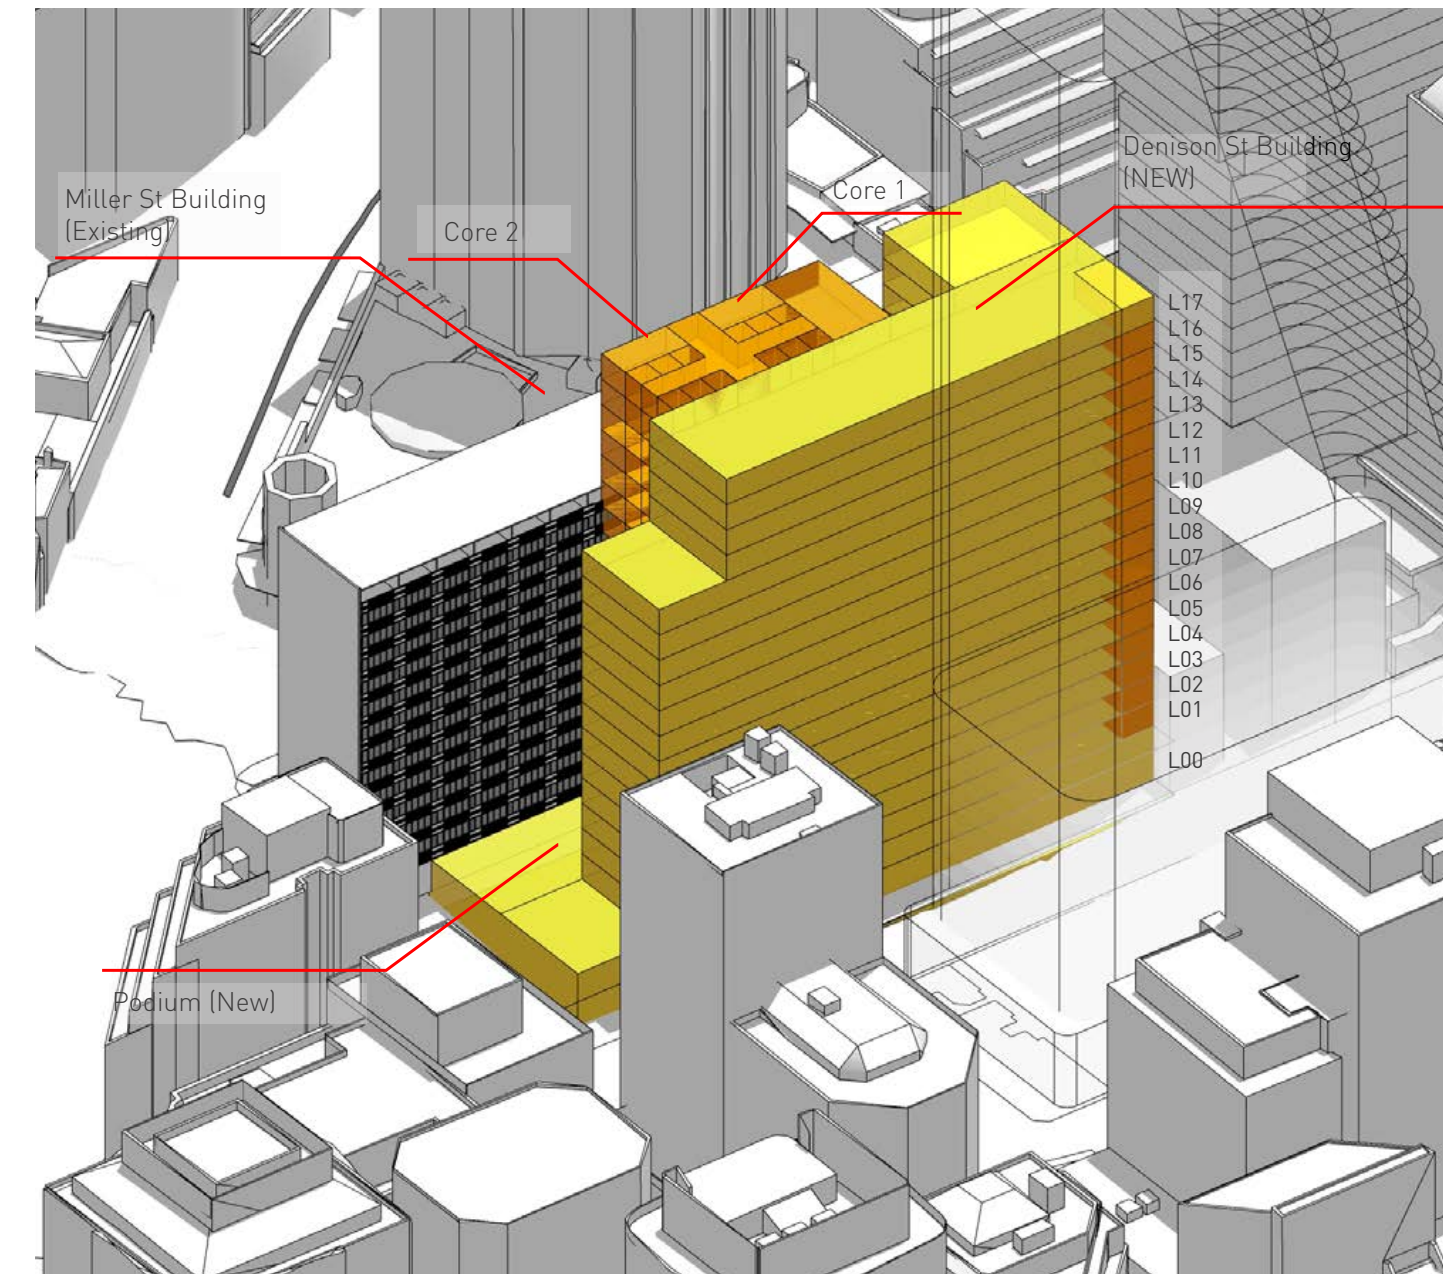
Figure 17. Indicative 3D Massing Diagram of Scenario 3 viewed from the west

A version of the Scenario 3 which appears in the DA document has been tested by this report and shown in Figures 17 to 22:

- Retain existing 13 level Miller Street building
- Demolish existing core and 5 level building on Denison Street
- New Denison Street 18 level building (13 levels at 1505 m<sup>2</sup> + 4 levels at 1315 m<sup>2</sup>)
- Rebuild 2 Cores
  - 1 to service existing 13 level Miller Street building
  - 1 to service new 18 level Denison Street building
- Rebuild/extend podium (L00) level of Denison Street building into central area (replace existing).
