*The MLC Building in North Sydney was designed by Bates Smart & McCutcheon in 1952 & completed in 1956. It is currently listed as a **local heritage item** on the North Sydney LEP 2013, item number I0893, and is one of the few remaining NSW buildings in the post-war international style.*

# EXISTING BUILDING ISSUES

# CURTAIN WALL REPLACEMENT

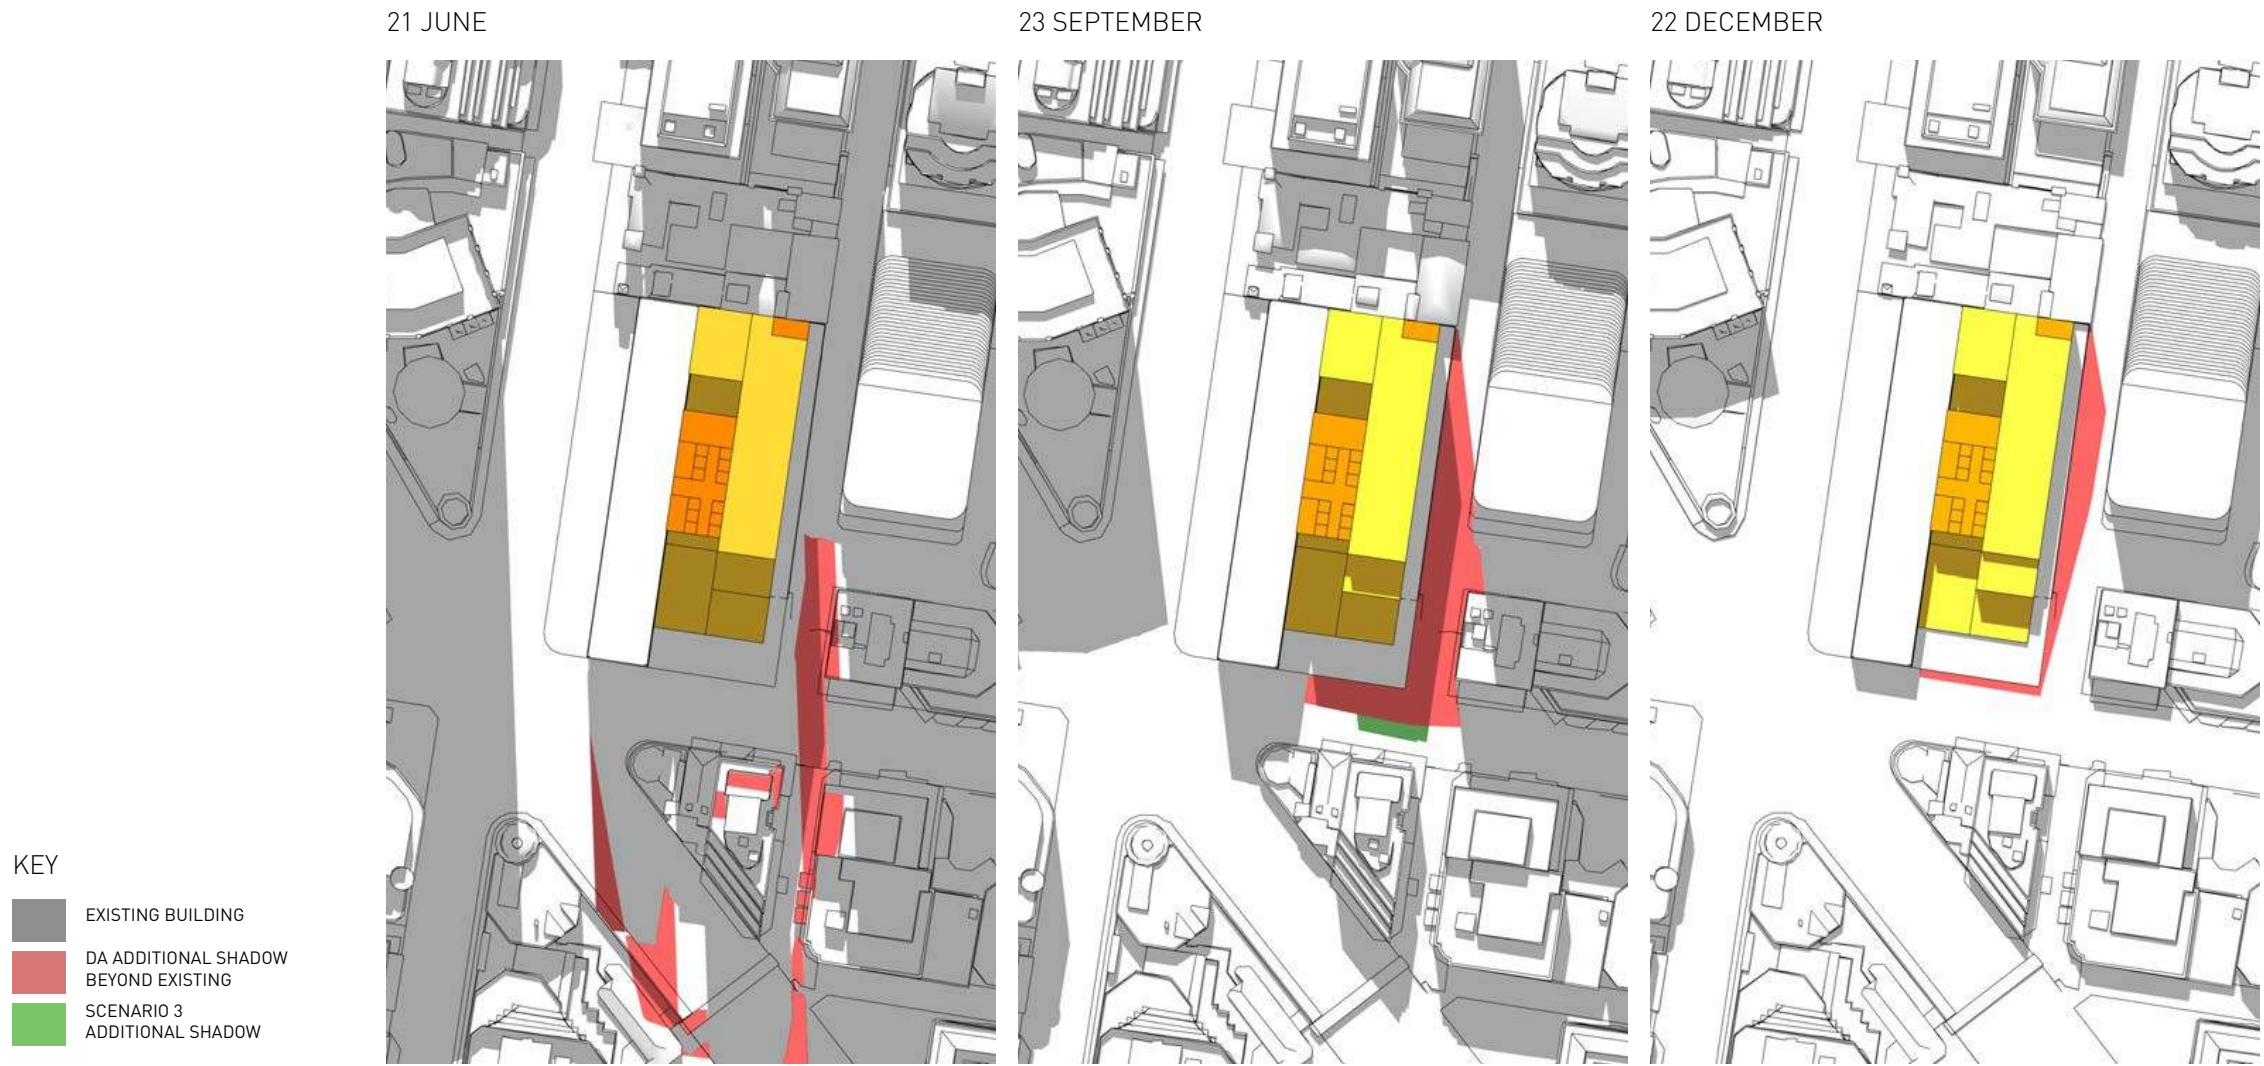
Figure 23. Shadow Diagrams for Scenario 3 - 18 Levels (L00 + 17)  
Diagrams based on current conditions.

A new eastern wing of the MLC North Sydney would add a small amount of extra shadow beyond the DA proposal (shown in green) on Brett Whiteley Place at the equinox (23 September)
