Leading Edge erosion and pollution from wind turbine blades

5 th. Edition - English

Asbjørn Solberg, Bård-Einar Rimereit and
Jan Erik Weinbach

"THE TURBINE GROUP" JULY 2021

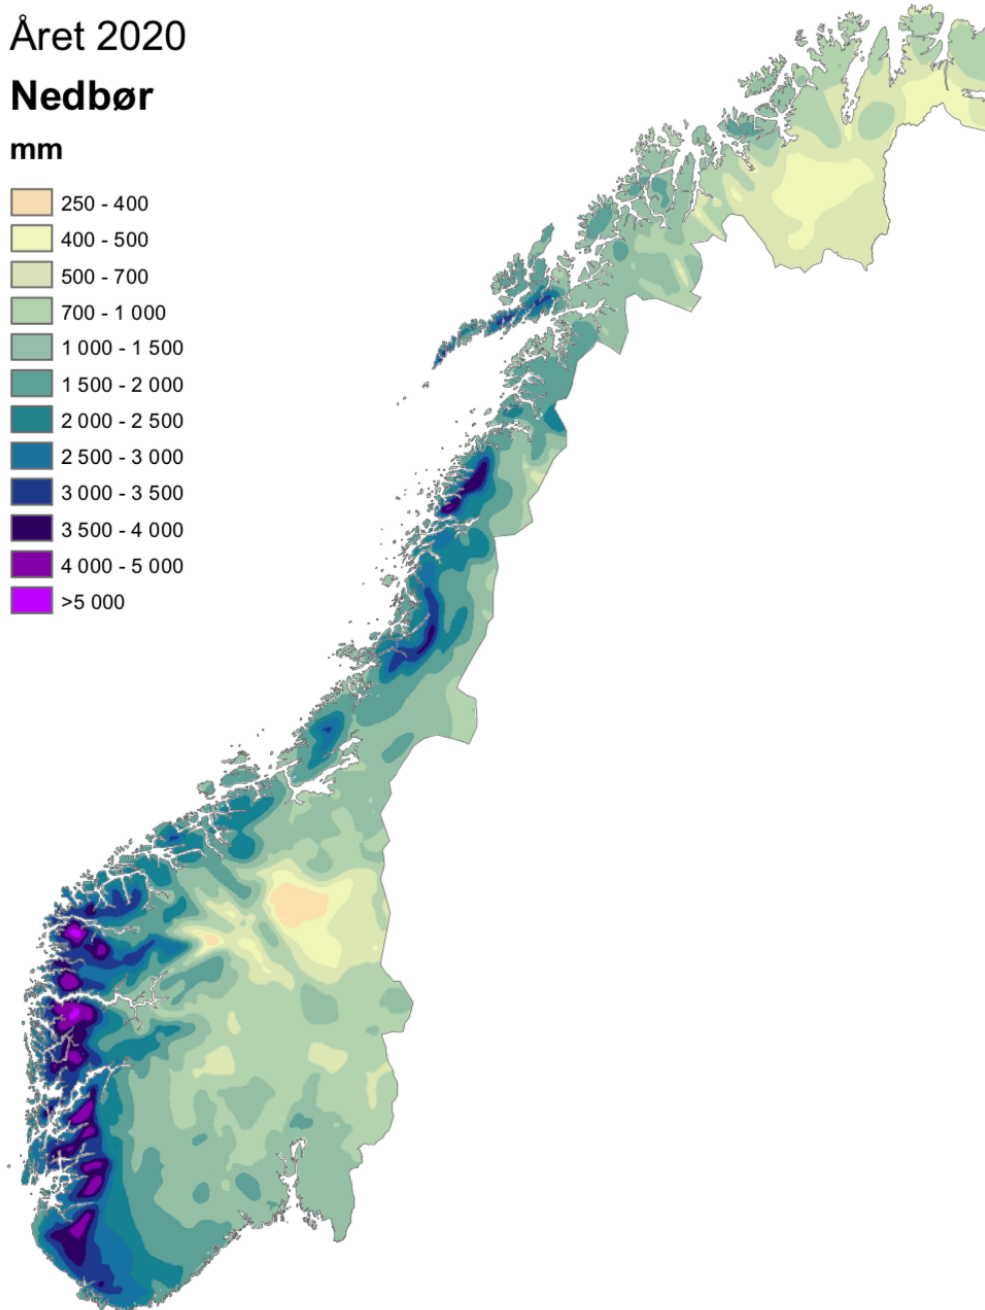
Nedbør

mm

Normalperioden er 1961 - 1990

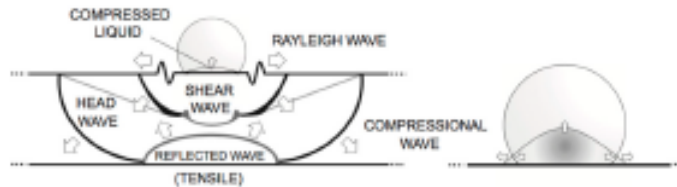
Some reports say the coating is polyurethane while "On the Material, Characterization of wind turbine-B_2017" says that the cover layer on the Leading edge is also a specially developed epoxy "*developed for Leading Edge Protection*" (LEP)¹⁰. The same report also explains the mechanisms surrounding damage caused by raindrops, defined as the Water Hammer pressure effect.

Figure 1 source: On the Material, Characterisation of wind turbine-B_2017

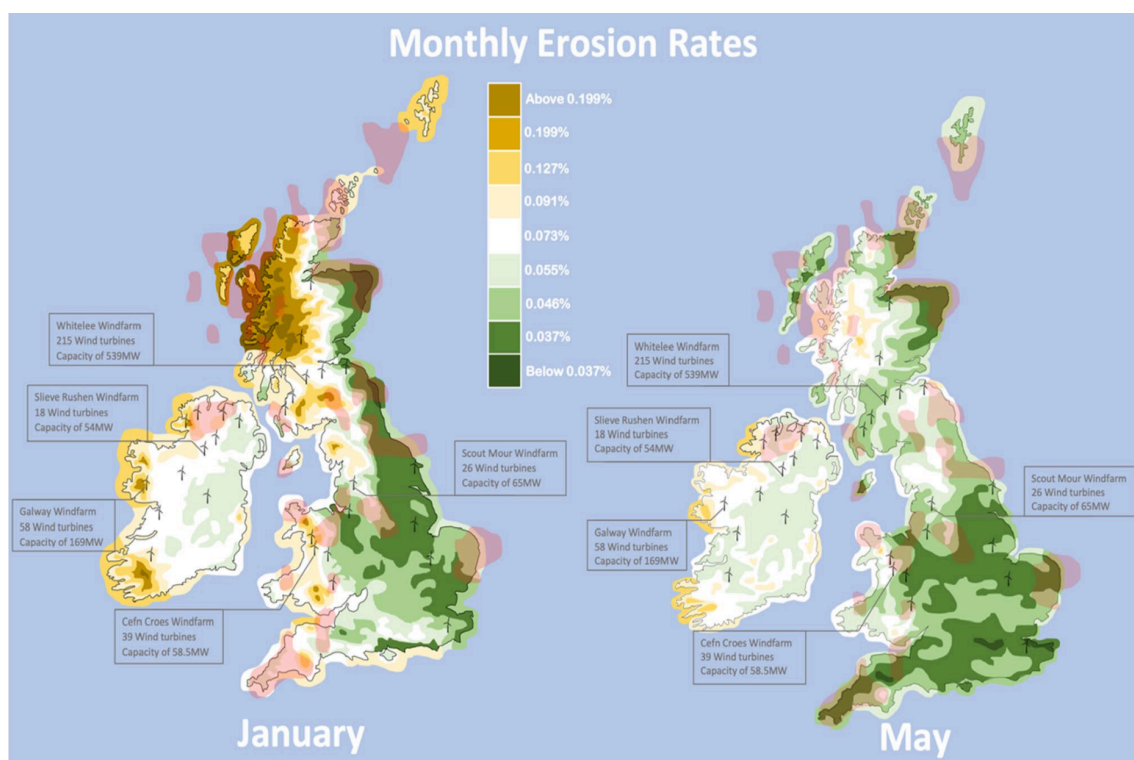
The mass of the test material was measured before the experiment and after each exposure time. This will result in a direct numerical relationship between average monthly rainfall and erosion as a mass loss.

Figure 1. The monthly erosion rates in January and May with overlays of major wind turbine farms and areas of frequent hail. Source: Journal of Bio- and Tribo-Corrosion · March 2021)

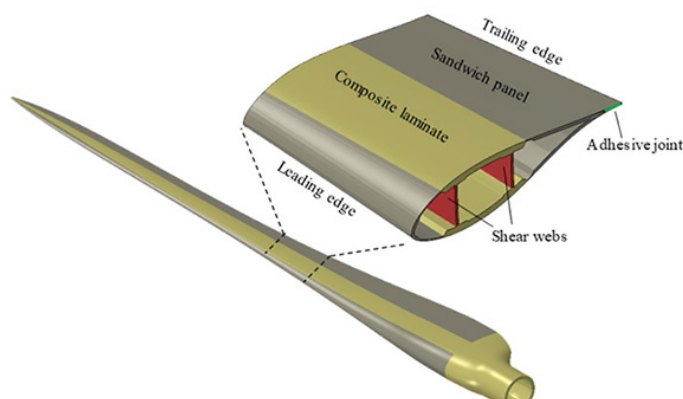
Figure 3 Typical wing profile

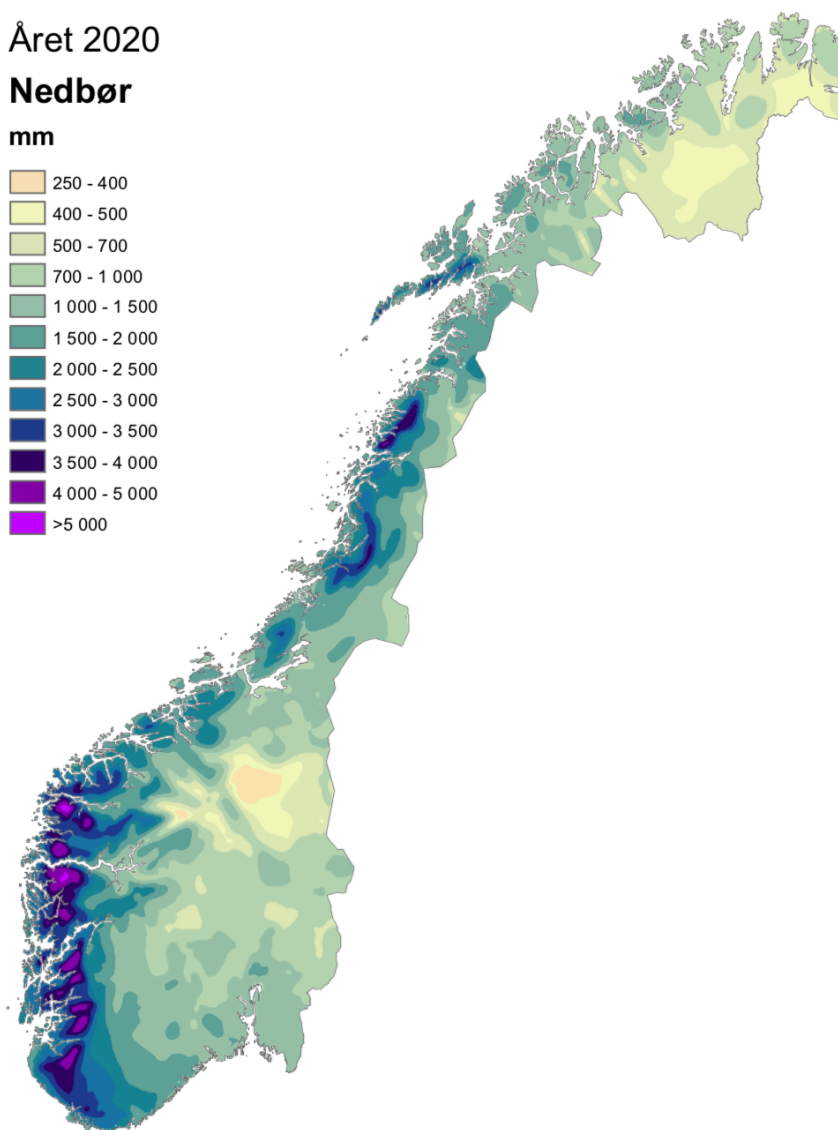
Nedbør

mm

Normalperioden er 1961 - 1990

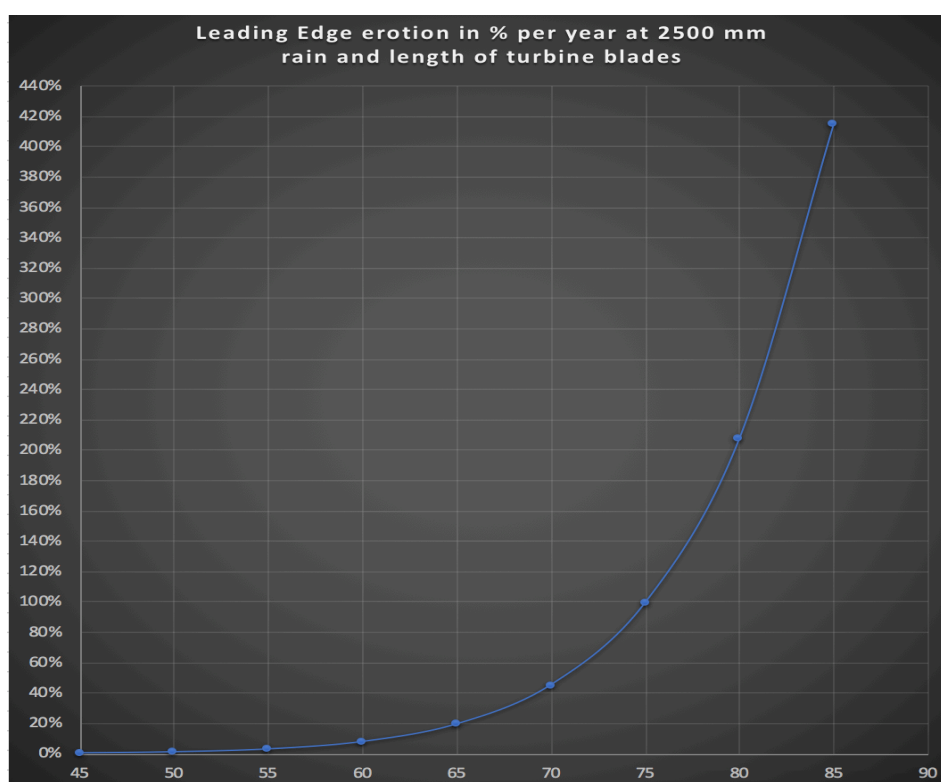
Erosion Rate is exponential to Impact Speed or Impact Energy (see graph)

Figure 4. erosion (loss in percent) as a function of precipitation, speed and length of turbine blades

Erosion Rate is exponential to Impact Speed or Impact Energy (see figure 4).

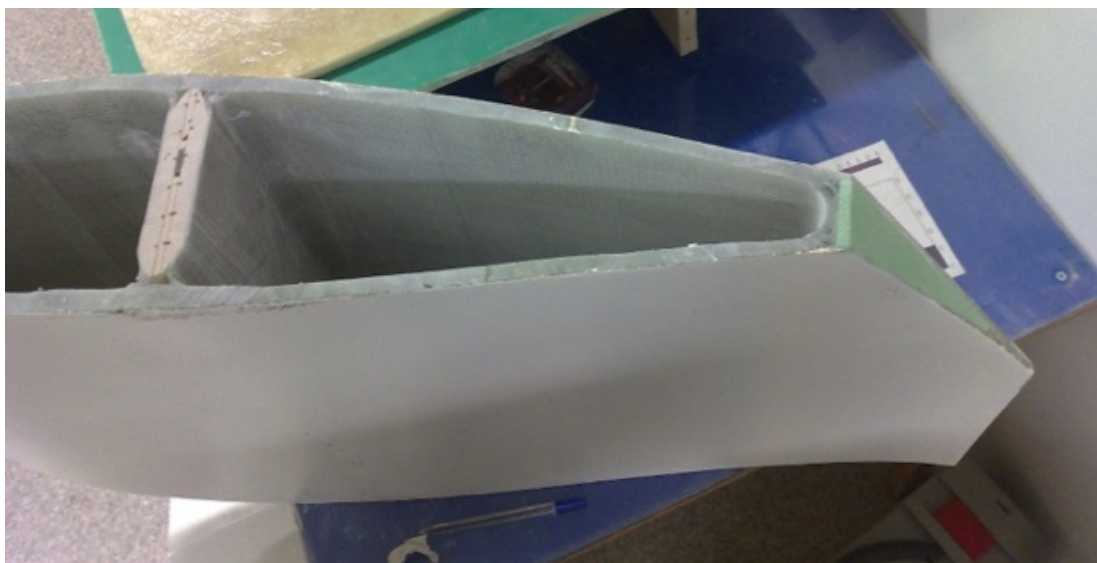
Figure 5 Photo: A small blade profile - to get an impression of proportions. Own photo, from testing

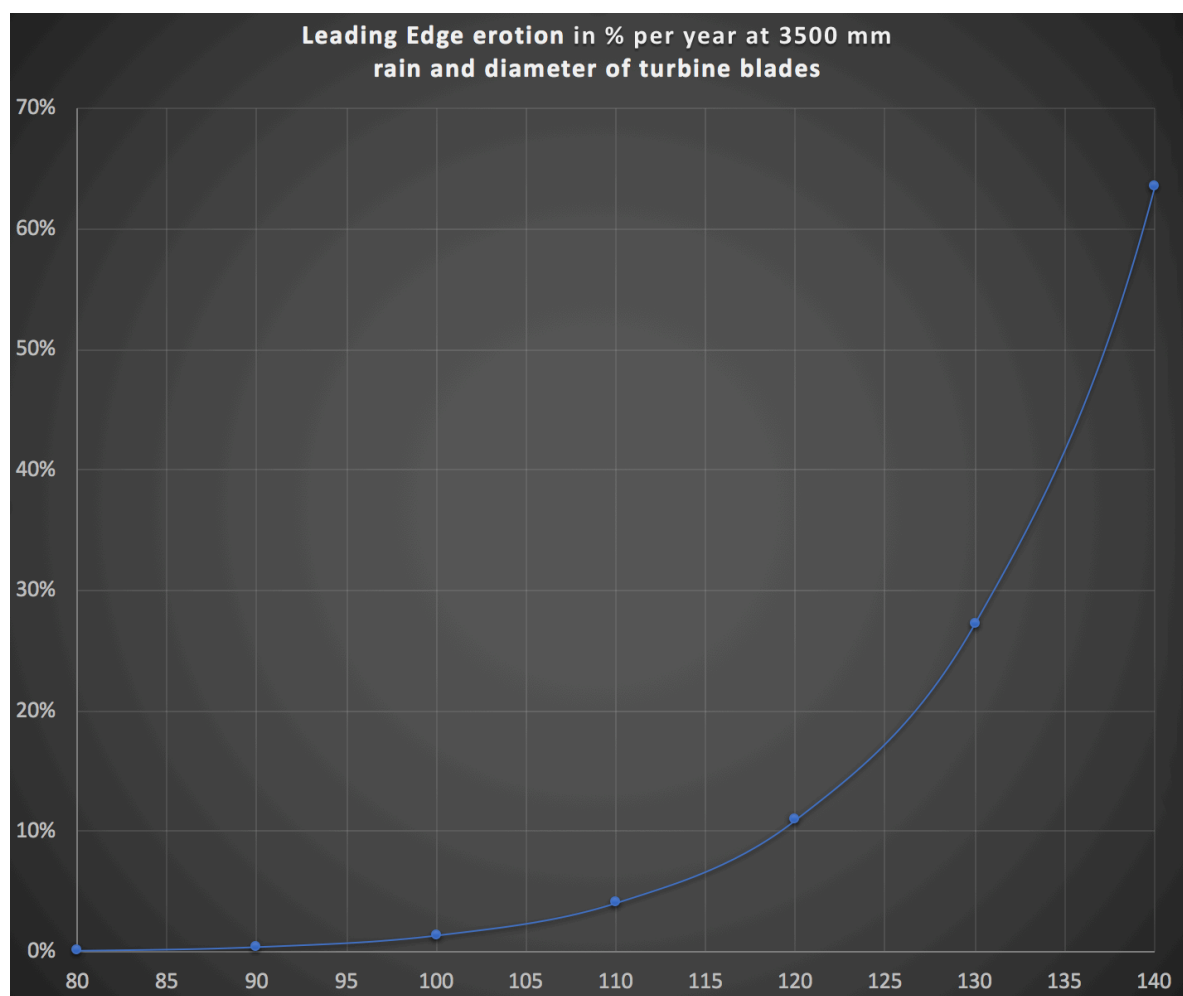
Figure 6. erosion (loss in percent) as a function of precipitation, speed and length of turbine wing
